Investigation Report 2010-R006

**Derailment of empty train due to collision with landslip debris
outside Wicklow Station,
16th of November 2009**

Title	Derailment of empty train due to collision with landslip debris outside Wicklow Station, 16 th of November 2009
Document type	Investigation Report
Document number	2010-R006
Document issue date	15/11/2010

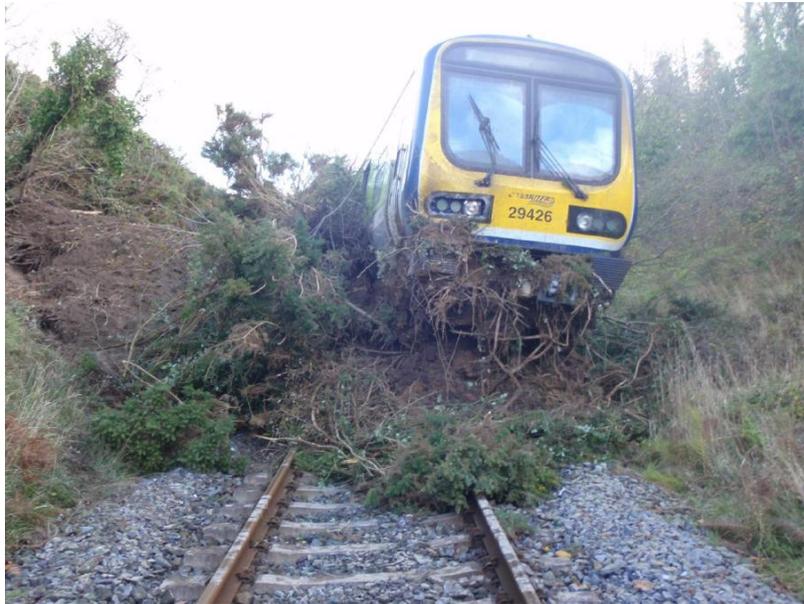
The train came to a stop approximately 300 metres (m) beyond the station with the *leading carriage* derailed and coming to a stop on top of the debris from a landslip, see Photograph 1.

Photograph 1 – Derailed train on landslip debris

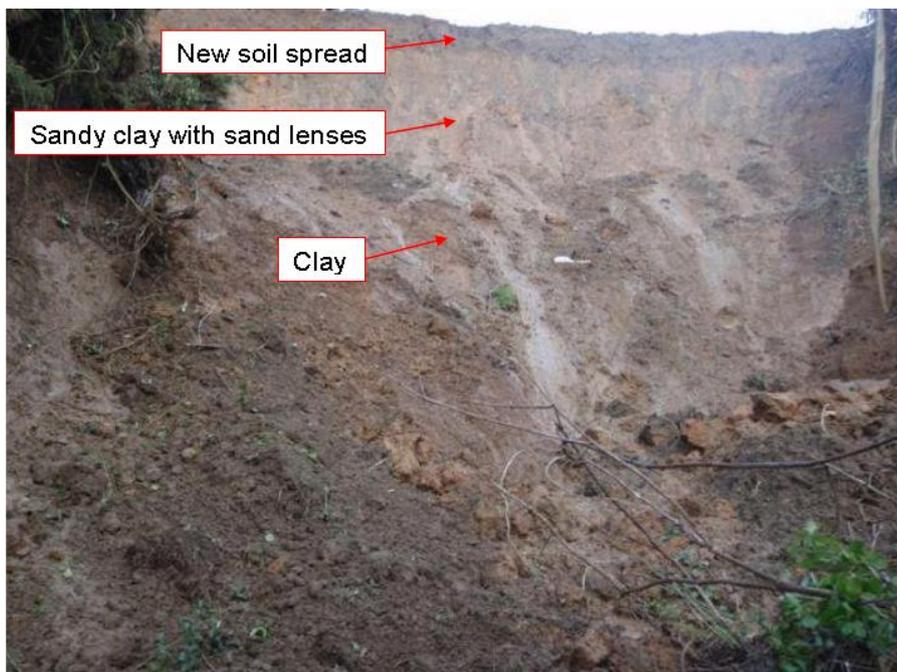
Boreholes taken from the top of the slope, after the accident, indicate that the top 4 – 5m of soil is an orange brown sandy *clay* with *sand lenses* which was soft to firm in texture. Below this, the soil consisted of clay that was medium to soft in texture, see Photograph 2.

The photograph also indicates the new soil spread material which is approximately 1m in height, this is discussed further in Section 1.5.4.

Photograph 2 – Cutting geotechnical properties

On the day of the accident, there was water pouring down the landslip scar, see Photograph 2. It was noted that the soil in the adjacent field was *saturated*, see Photograph 3. There was also water pouring down the parapet of the footbridge located in the vicinity of the land slip, see Photograph 4.

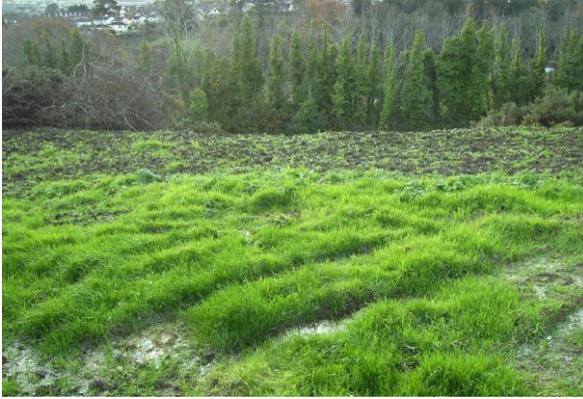
Photograph 3 – Saturated soil with standing water

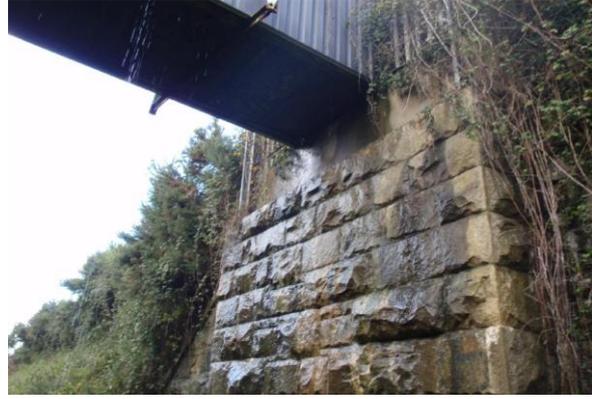
- The patrol ganger was unable to identify the water pouring down the pedestrian overbridge as an early defects associated with the failure of the cutting due to poor drainage as this was not identified as a condition to be looked for in the Track Patrolling Standard, I-PWY-1307, and not included in track patrolling training, again resulting in an unrealistic expectation that the patrol ganger could identify all signs of defects associated with cuttings;

Photograph 4 – Water pouring down the parapet of the footbridge

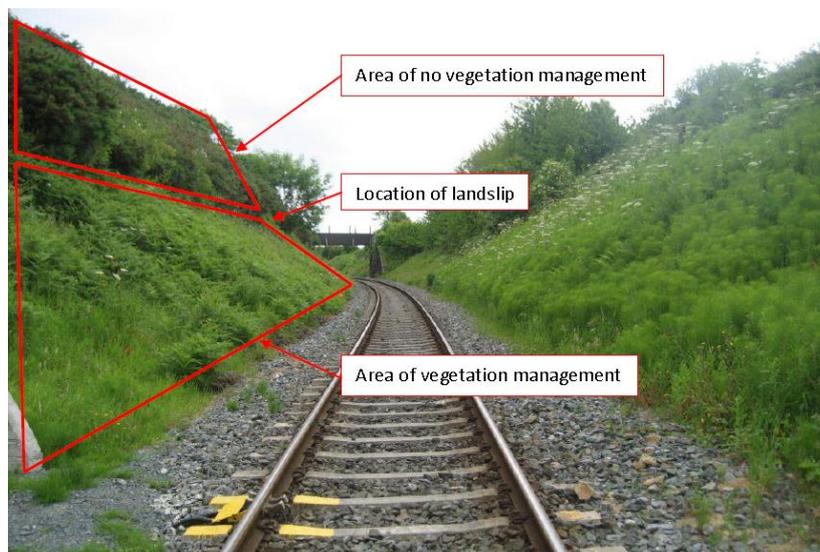
The cutting slope is covered with dense vegetation, mainly gorse bushes, with larger vegetation and small trees towards the top of the cutting slope. Vegetation management is carried out by the Permanent Way staff (patrol ganger and PWI). IÉ have confirmed that some vegetation management had occurred in the location of the cutting slope during March 2008, where a flail mower was used to reduce the vegetation at the lower section of the cutting slope. No flailing had occurred in the upper section of the cutting slope. This is clearly illustrated in Photograph 5, which was taken on the 12th of August, prior to the cutting failing.

Photograph 5 – Areas of vegetation management

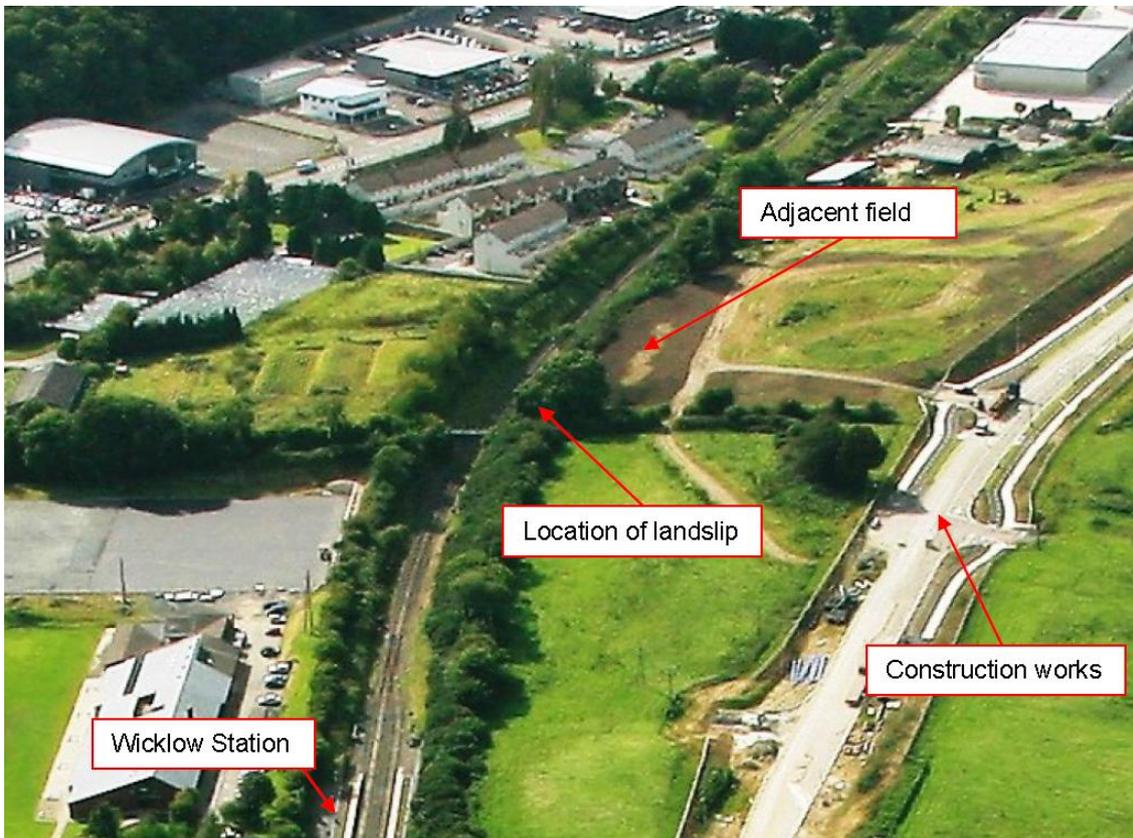
There is a privately owned field north of the cutting, see Photograph 6. Prior to the accident, a hedge marked the boundary between the IÉ and private property and a drainage *ditch* existed at the top of the cutting, which ran parallel to the railway.

Photograph 6 – Location of landslip and adjacent field
