# Railway Accident Investigation Unit Ireland

## Annual Report 2024

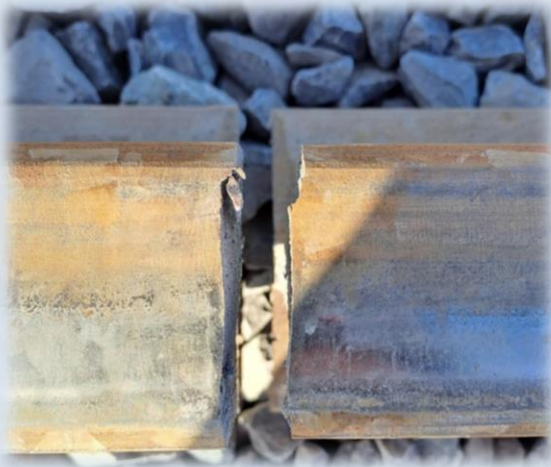
On the morning of the 23<sup>rd</sup> February 2023, a number of trains saw an abnormal CAWS downgrade on the train's in-cab display, with the drivers reporting these abnormal CAWS downgrades to the Mainline Signaller; these drivers were advised to continue and obey lineside signals which were working normally.

The IÉ-IM SET Department were advised, and an SET member of staff was dispatched to site to investigate the suspected fault. The SET staff member discovered a broken rail at 10:52 hrs and trains were stopped on the

- Safety Recommendation 2024001-01 – IÉ-IM should risk assess whether the existing rail end cleaning equipment and processes adequately control the risk of weld contamination and identify improvements where required;
- Safety Recommendation 2024001-02 – IÉ-IM to investigate altering the monitoring and detection parameters of the rail welding machine to be able to identify and highlight possible anomalies in the welding process;
- Safety Recommendation 2024001-03 – IÉ-IM to revise the risk assessments for the Portlaoise Rail Welding Plant to ensure risks in the production process affecting the quality of rail welds are understood and control measures are identified.

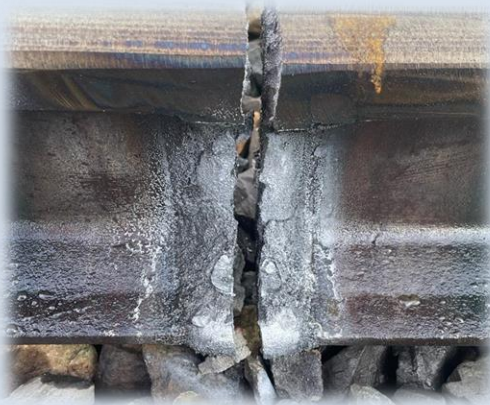
On Tuesday 21<sup>st</sup> February 2023 a T3 Possession was organised near Emly Level Crossing on the Dublin to Cork mainline to allow for a track section to undergo track maintenance.

As part of the track maintenance, stressing and welding of the rails had to be undertaken in preparation for ballast cleaning.

- Safety Recommendation 2024002-04 – IÉ-IM CCE should review and update the CWR Record Sheet to include sections for recording the serial number and calibration/ recalibration date of the Rail Tensors being used, the pressure gauge readings and the frequency of these checks on the pressure gauges. On completion, ensure staff are briefed on the changes, and changes should be incorporated into future training programmes for a Person in Charge of Stressing;

- Safety Recommendation 2024002-05 – IÉ-IM CCE should update CCE-TMS-323 to include guidance for the Person in Charge of Stressing, in relation to actions to be taken when difficulties are encountered with Thermit SoW-5 (including when Thermit SoW-5 can continue, be restarted or must be abandoned; and, who is responsible for this decision, the Person in Charge of Stressing or their Supervisor). On completion of the update, Persons in Charge of Stressing should be briefed and the training programme for the role revised with the new guidance.

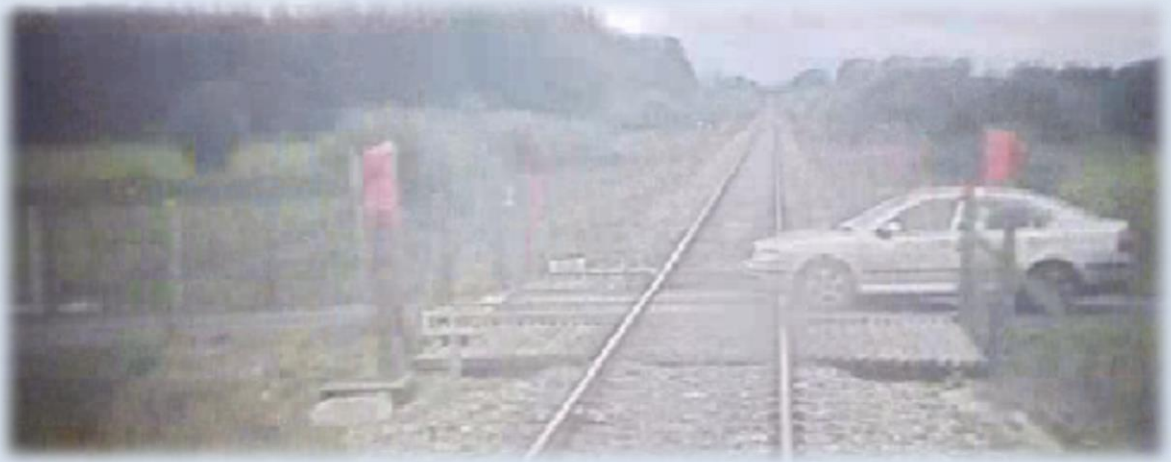
At approximately 15:15 hrs on Saturday the 9<sup>th</sup> September 2023, the IE 12:45 hrs Heuston to Westport passenger service (Train A804) was approaching Prendergast's Level Crossing (LC), asset number XM190 (to be referred to as LC XM190), located between Ballyhaunis and Claremorris (County Mayo), at a speed of 70 mph (110 km/h). The train driver (Driver A804) sounded the horn at the whistle board associated with LC XM190 on their approach.

LC XM190 is an Occupational Public (OP) user worked unattended level crossing (UWLC) meaning it is guarded by metal gates across a public road; whereby a member of the public, the "user", will have to open and shut the gates to cross the railway and continue on the road.

- Safety Recommendation 2024003-01 – The Department of Transport should continue to trial the new design sign (Sign W126), in consultation with the relevant stakeholders, with a view to replacing Sign W121. The RAIU maintain that the advance warning signs on the approaches to OP Type level crossings should portray the hazard (i.e. the road user is approaching a live railway) and indicate the severity of not adhering to the warning (i.e. possible collision with a train);
- Safety Recommendation 2024003-02 – IÉ-IM should replace their "Warning Trains" sign, located at OP Type level crossings, to the new proposed advance warning sign (Sign W126), once included in the Traffic Signs Manual.

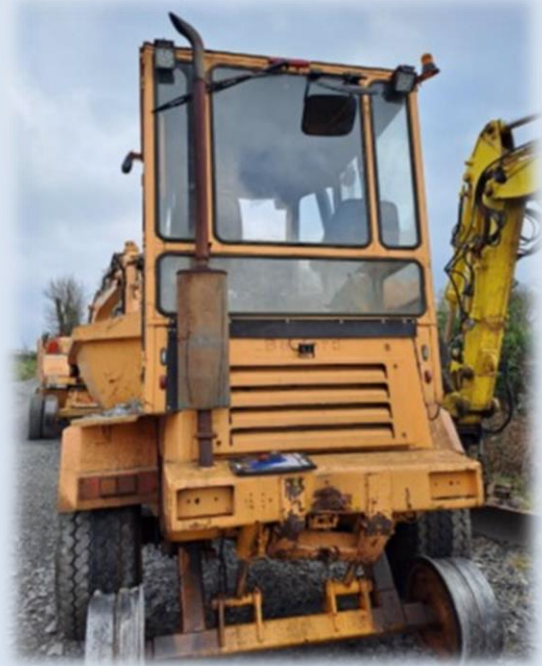
One RRV Excavator (RRV1) and two RRV Dumpers (RRV2 and RRV3) and one tracked excavator were being utilised for the ballasting works. The work involved moving ballast from the access point at Over Bridge Galway (OBG) 159 near 116 ¼ MP to 119 MP.

RRVO1 was unable to gain enough speed to move away from RRV2 and RRV2 collided with RRV1 (RRV3 was not involved in the collision). Both RRVs stopped and the RRVOs exited from the RRVs uninjured; the PIC-RRV (who sustained a slight injury to their hip) exited RRV2 and spoke to the RRVO1 and RRVO2. There was some damage to RRV1 and RRV2.

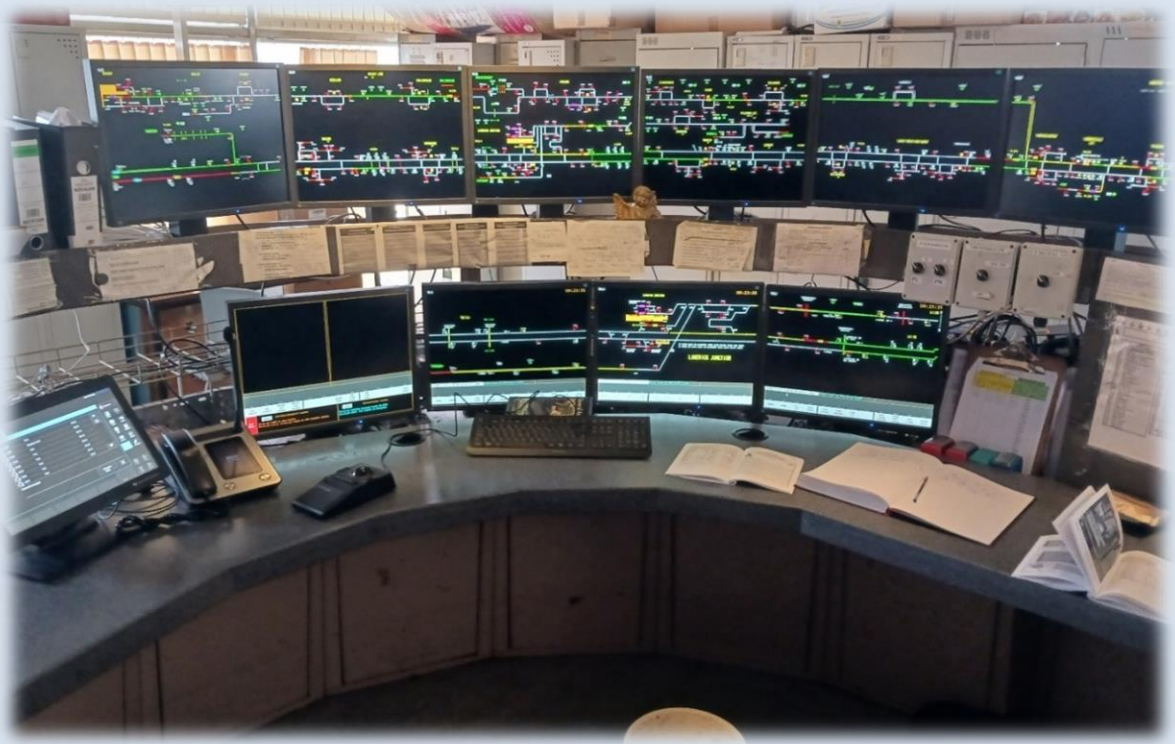
**IE operational irregularity at the 70¾ MP, near Ballybrophy, on the Cork mainline, 28<sup>th</sup> March 2024**

At 14:00 hrs on the 28<sup>th</sup> March 2024, the 13:00 hrs Dublin Heuston to Cork passenger service (Train A214) travelling on the Down line between Ballybrophy and Lisduff, County Laois, activated a HABD at the 68 ½ MP. The Controlling Signalman and Communications Signalman on the Mainline CTC Workstation heard the alarm and responded.

At this point it became apparent to the Communications and Controlling Signaller that Train A215 was on the same section of line for which signal protection had been granted to Driver A214.

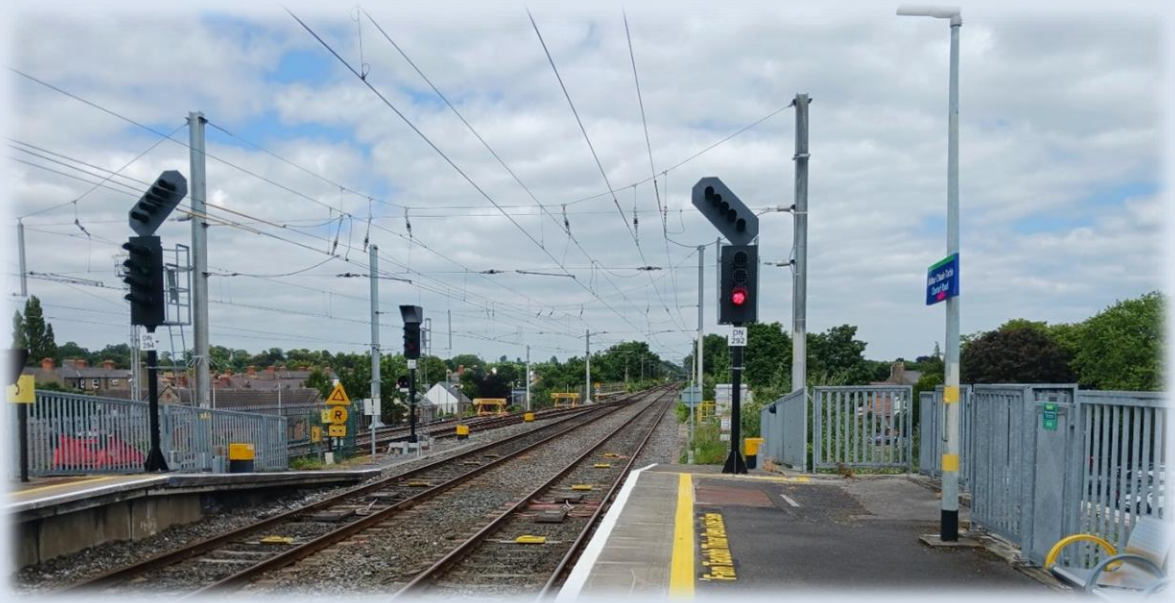
## IE possession irregularity at Clontarf, on the 1st May 2024

At approximately 21:42 hrs on the 1<sup>st</sup> May 2024 an IE Signaller signed on-duty for a night shift on the Central Workstation of CTC, located at Connolly Station, Dublin. The Signaller had qualified only two months earlier and was on only their second night shift working alone.

At 01:10 hrs, when the PICOP called the Handsignalman, positioned at Clontarf Road, to tell them to place the detonator protection. As they were talking, the Handsignal saw Train F015 approaching the location where they were to place the detonator protection; and told the PICOP. The Handsignalman remained in a place of safety and the PICOP took no immediate actions in notifying the Signalman.

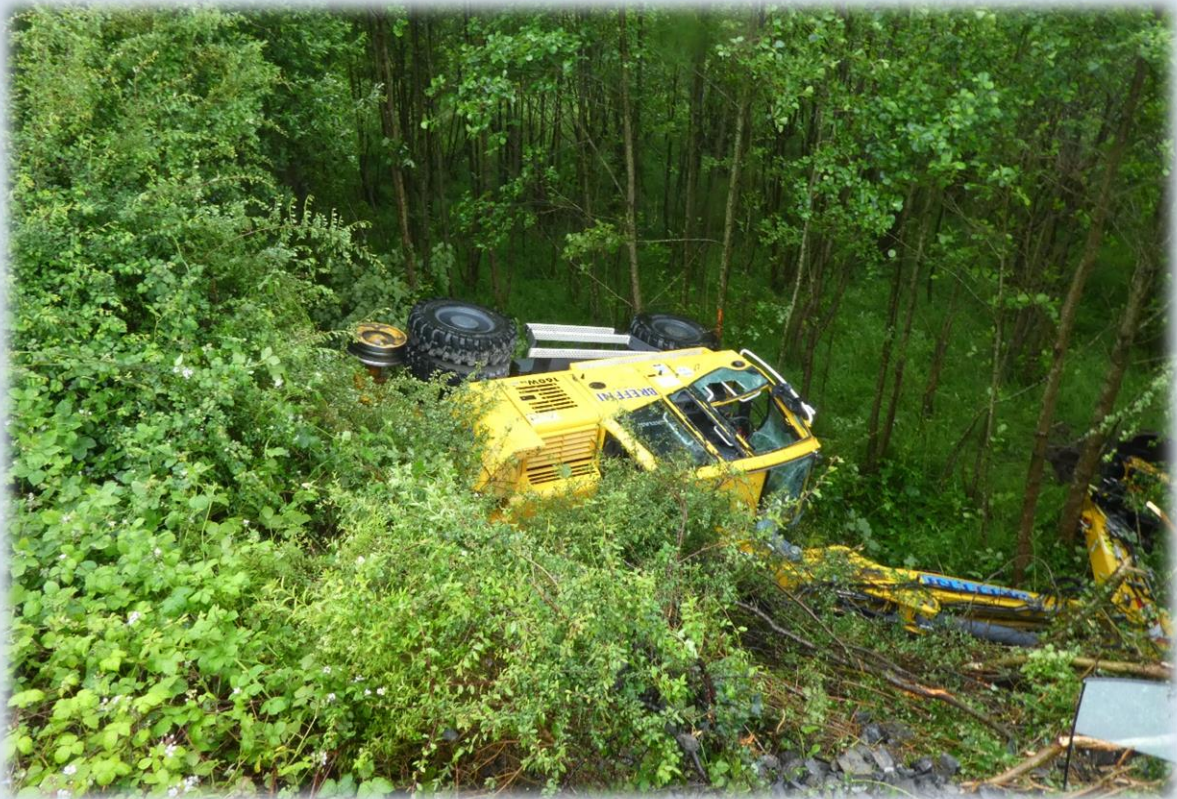
On the 12<sup>th</sup> June 2024, works was being carried out at Underbridge Athlone (UBA) 23 in relation to the erection of a new walkway and handrails onto the bridge. To facilitate the works, a tracked negative mobile elevated working platform (MEWP) was required to lift the Bridge Gang personnel while the works were being undertaken. For the MEWP to have a level platform, Strails (heavy duty panels that are inserted inside the five-foot) were required to be inserted, using an RRV Excavator, operated by an RRVO.

The PIC-RRV was not aware that the RRVO had no experience in the installation of Strails and the RRVO was having difficulty with both the controls on the RRV Excavator and inserting the Strails. After the third Strail had been placed between the rails, one of the corners of a Strail was protruding above the rail head. The PIC-RRV asked the RRVO to push down the corner with the grapple and as the RRVO pushed down on the corner of the Strail the front rail gear on the RRV Excavator lifted off the rail. The RRVO tried to let the rail gear down but due to the cant (120 mm) the rail gear slid off the rails on the lower side of the of the track causing the RRV Excavator to slew to the lower side, loose balance and topple over the steep embankment into the field below.

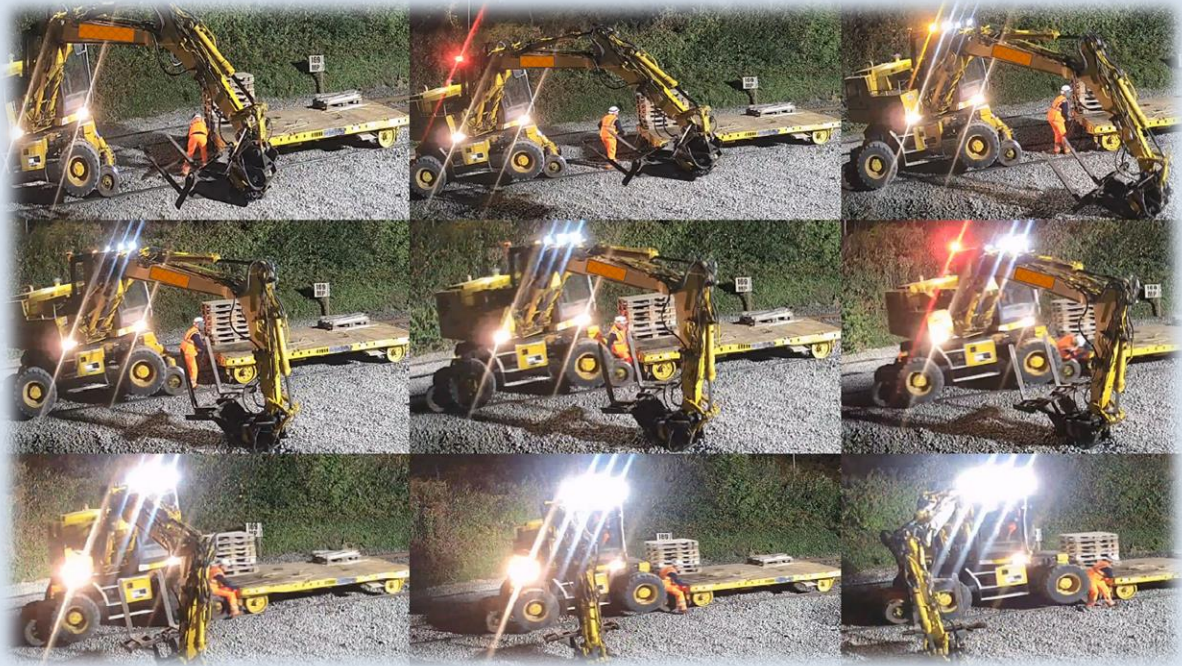
## IÉ collision between a RRV and a member of IÉ staff, North Esk, Co. Cork, 10<sup>th</sup> September 2024

On the 10<sup>th</sup> September 2024, during a T3 Possession on the Cork to Cobh and Midleton Lines, an IÉ-IM member of staff from the CCE Department was undertaking the role of PIC-RRV.

At approximately 02:50 hrs the PIC-RRV was unhooking the draw bar from the Rail Trailer and clearing some scrap pallet timber from the Rail Trailer.

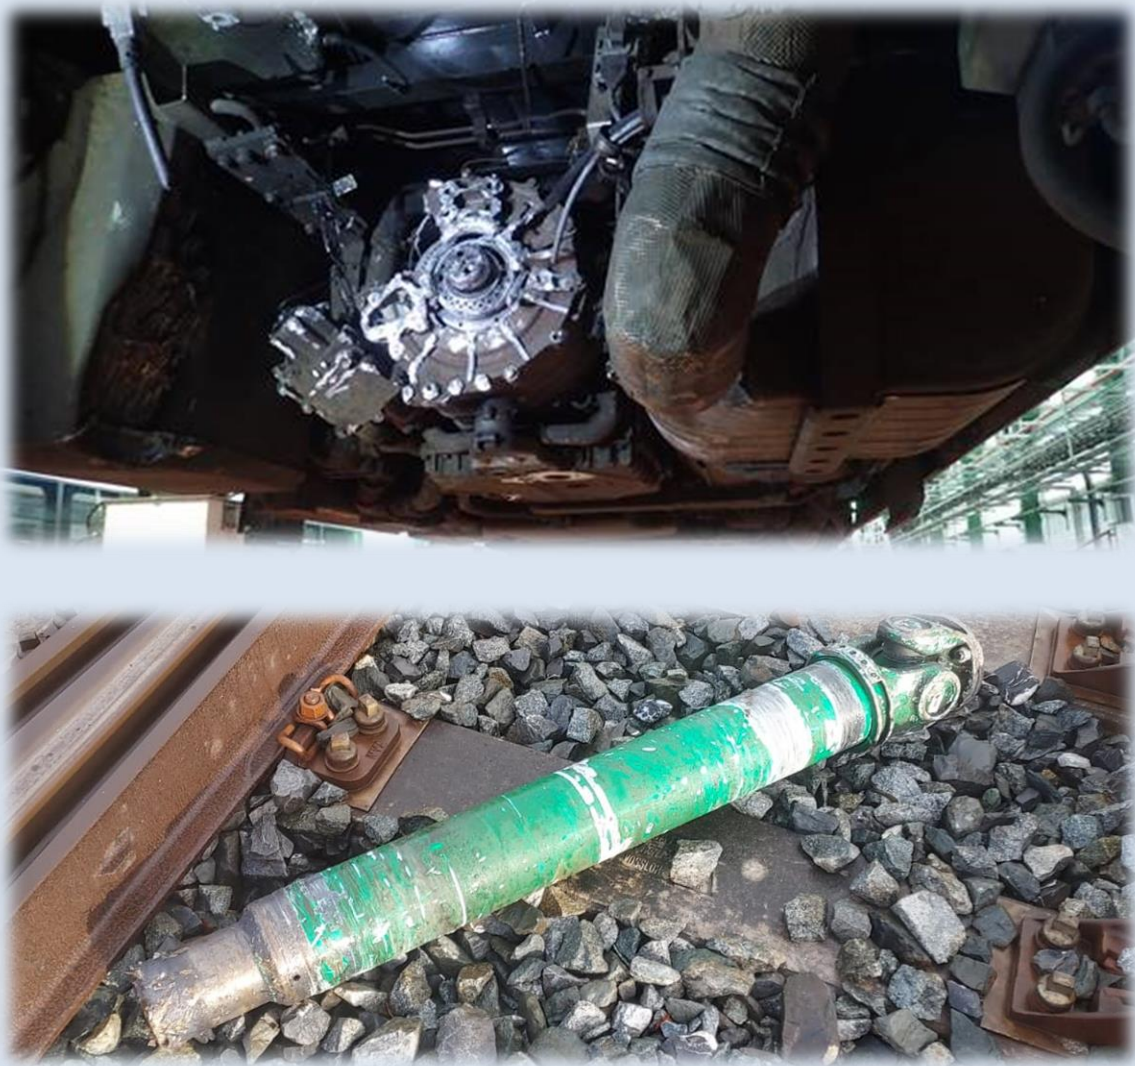
**IE cardan shaft detachment from an ICR, between Templemore and Ballybrophy, 24<sup>th</sup> November 2024**

At approximately 19:20 hrs on Sunday 24<sup>th</sup> November 2024, a warning was received in the cab for a wheel slip protection fault followed by a powerpack fault on an adjacent cab (Class 22000 ICR DMU vehicle 22646); the faults were managed individually, and the train continued on its journey.

The following morning at Laois Traincare Depot (LTCD), an examination identified that the cardan shaft from car 22646 was missing.
