Railway Accident Investigation Unit

INVESTIGATION REPORT

Collision of an ICR with a buffer stop at Laois Train Care Depot, 17th July 2018

RAIU Report No: 2019-R002

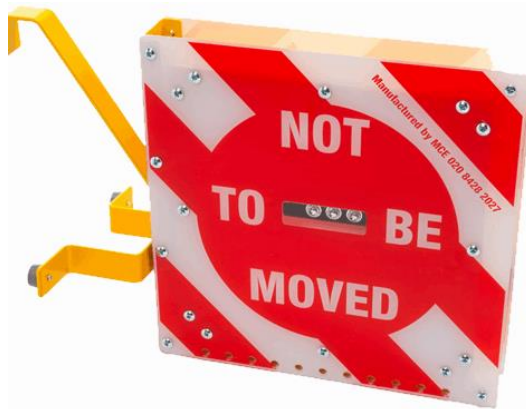
Figure 1 – “Not to be moved board”

- 79 During the day of the 16th July, while still in an unbraked condition, work is conducted on ICR 16 and a “Not to be Moved” board is placed on the train set; all workers leave the train set but the “Not to be Moved” board remains in place without any personal identification tags in place.

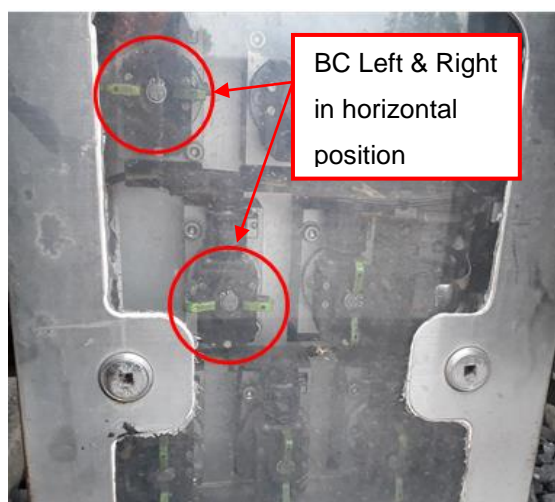
Figure 6 – BC Left & BC Right in the horizontal isolated position

- All four brake isolating boxes of ICR 16 were found to have the brake isolating cocks BC Left and BC Right in the horizontal isolated position (Figure 6 shows one isolation box, there are a total of four) resulting in no brake being present on the entire set;

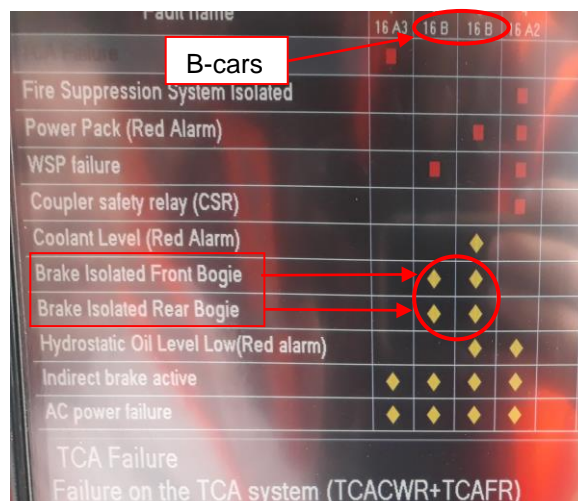
Figure 7 – MMI showing brake isolated front & rear bogies for both B-cars

- The cab brake cylinder gauge was found to have a positive brake cylinder reading;
- The MMI screen showed the message “Brake isolated front bogie” / “Brake isolated rear bogie” for both B-cars (illustrated previously in Figure 7);

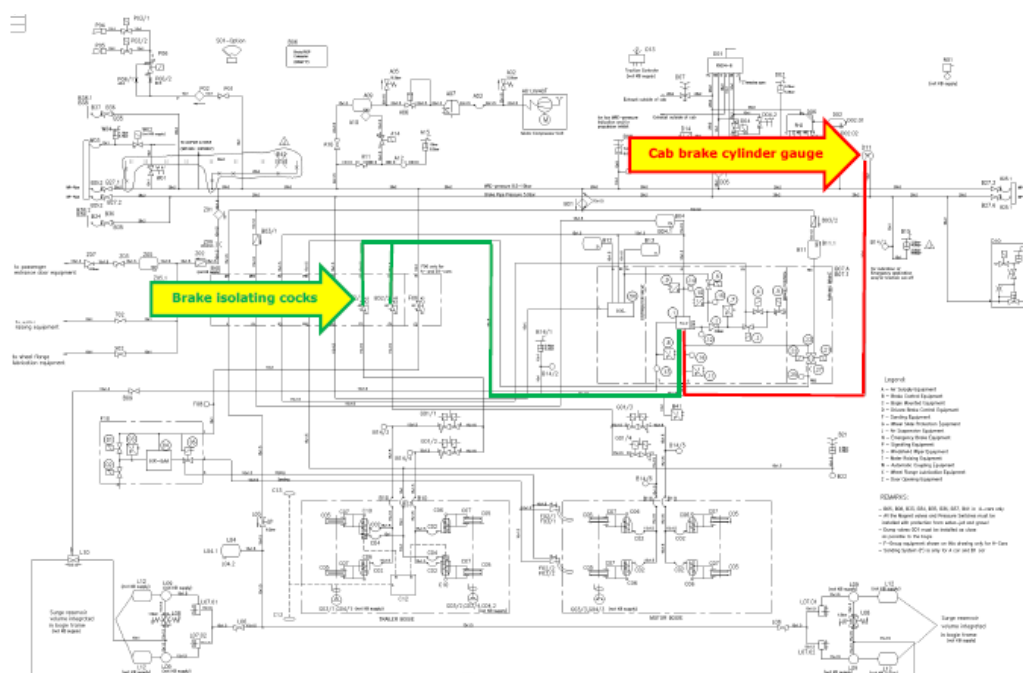
Figure 8 – ICR 22000 Brake system diagram illustrating “Brake isolation cocks (Green Line)” and the “Cab brake cylinder gauge (Red Line)”

- 37 The ICR braking system is different to other IÉ fleets. On the ICR fleet, isolation of the brake cylinder cock does not isolate both the cab gauge and the brake cylinder, it only isolates the brake cylinder; this was to allow for the brake pressure to be visible in the active cab when the brakes were isolated on the same unit.
- 38 The RAIU became aware of the presence of cab brake cylinder reading on the ICR fleet even when all the brakes are isolated; the RAIU issued an Urgent Safety Advice Notice on the 17th August 2018 recommending that “IÉ should advise all relevant staff that a positive brake cylinder gauge reading in the cab of an ICR is not an indication that a brake is present”.

125 An unusual feature to the 22000 ICR braking system is that the cab brake cylinder gauge is upstream of the brake isolating cocks; meaning the cab brake cylinder gauge can show a positive pressure reading even when the brakes have been isolated on all cars of the set (paragraph 102). On the 17th July, all four brake isolation boxes had the brake isolation cocks in the horizontal position, with the CME Driver seeing a positive reading on the cab brake cylinder pressure gauge (paragraph 103). The RAIU became aware of the anomaly and issued an Urgent Safety Advice Notice recommending that “IÉ should advise all relevant staff that a positive brake cylinder gauge reading in the cab of an ICR is not an indication that a brake is present” (paragraph 104).

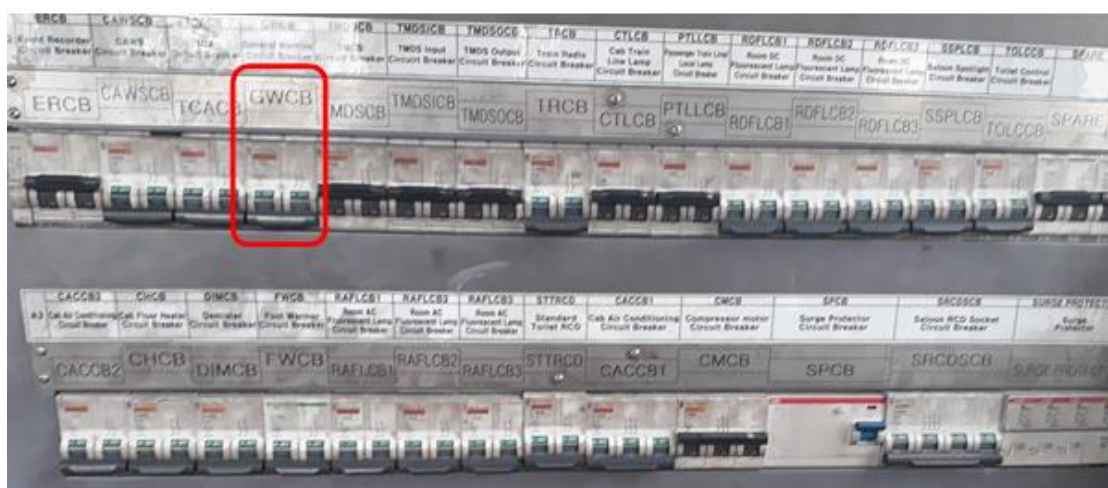
Figure 9 – Tripped GWCB on the cab circuit breaker panel

- The cab circuit breaker panel (which allows for the isolation of electrical circuits) on the two A-cars had General Warning Circuit Breaker (GWCB) was in the tripped position (see Figure 9); the RAIU cannot ascertain why this was the case. The tripping of cab circuit breaker GWCB results in no feed to the BC Right and BC Left on the MMI i.e. the isolation of the brakes on the A-car would not be displayed on the cab MMI.

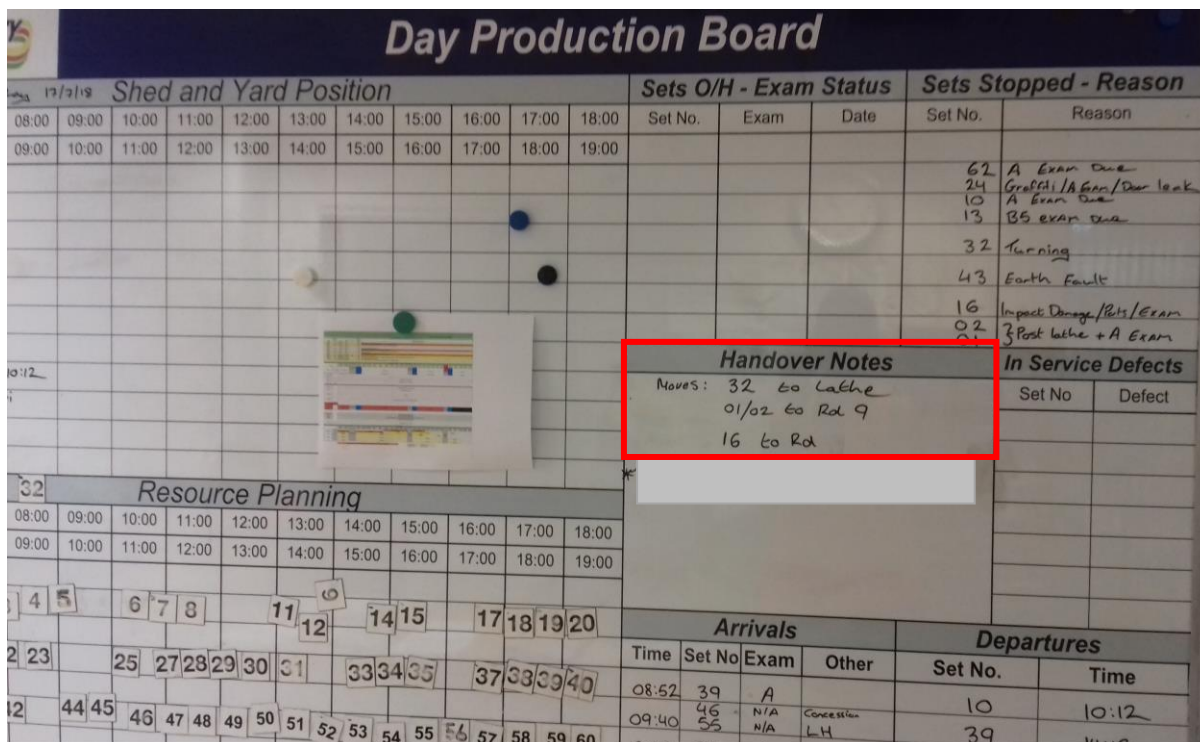
Figure 10 – Day Production Board (photograph taken on the 17th July 2018)

- 45 A photograph taken by the RAIU on the 17th July 2018, show that in relation to ICR 16, the Day Production Board states: “Sets Stopped – Reason: Impact damage/ Parts/ Exam” and “Handover Notes: Moves – 16 to Rd”. The Night Production Board states “Sets Stopped – Reason: Impact damage/ Parts/ Exam”.

- 46 There is no record of any isolation of other degraded braking systems recorded on either of the production boards in the Handover Note section (see red boxes in Figure 10 and Figure 11).

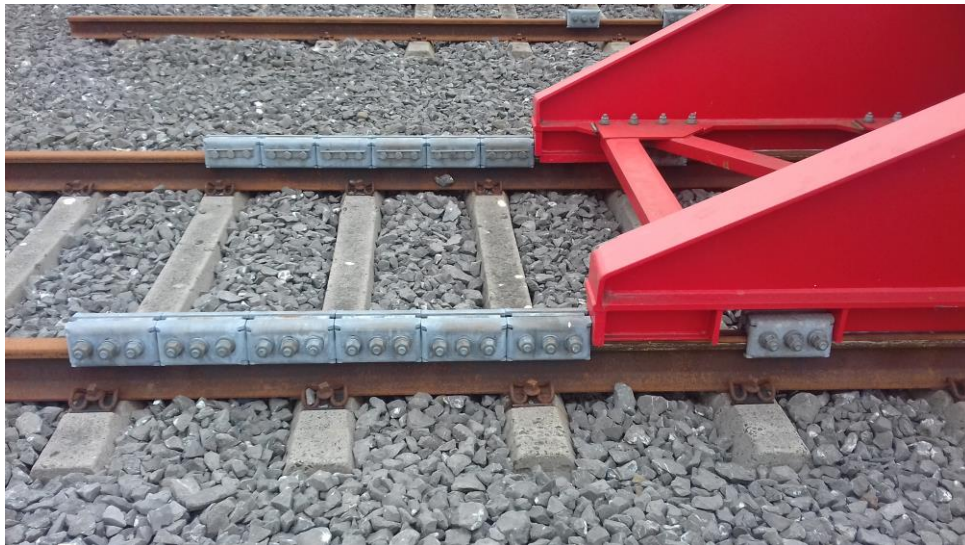
Figure 18 – Rawie buffer stop after the accident

- 24 There was damage to the headlights of ICR 16 and the buffer stop retarder blocks at Road 14 had to be repositioned and retorqued as a result of this accident.

- 96 Despite the efforts of the CME Driver, Limited Shunter and CME Driver 2, ICR 16 struck the Rawie friction buffer stop at Road 14 at 14 km/h. The force moved the buffer stop, and the buffer stop continued to move until all additional six buffer stop retarder blocks were compressed together (a distance of approximately five metres); it should be noted that the buffer stop functioned correctly; see Figure 18 for photograph of the buffer after the accident.
