**Railway Accident
Investigation Unit
Ireland**

INVESTIGATION REPORT

Near miss with an Iarnród Éireann Patrol Ganger near Woodlawn, Galway, 4th June 2019

RAIU Report No: 2020 – R002

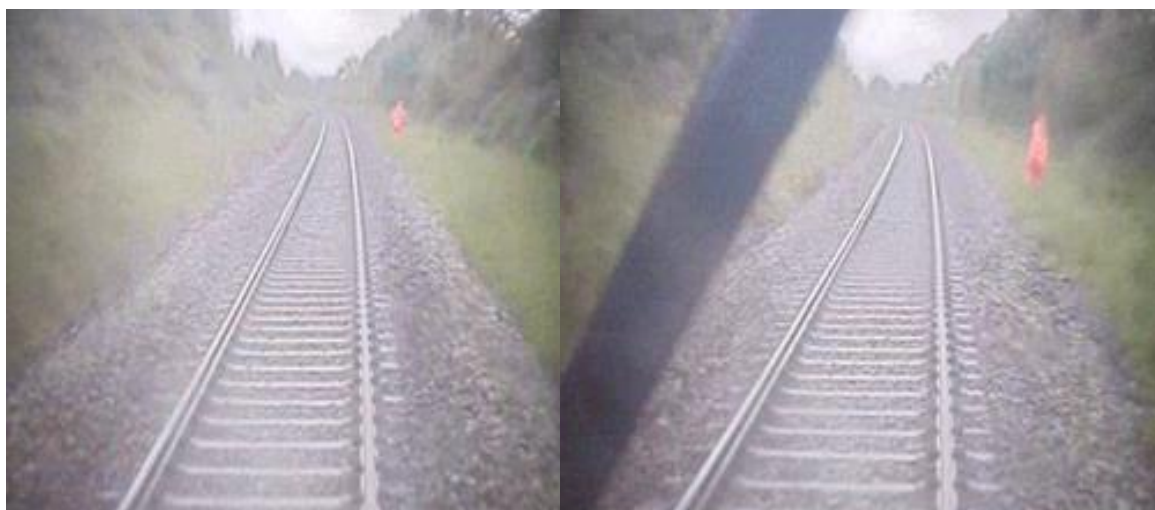
- 8 The person identified was a Patrol Ganger then stepped off the track into the cess on the Down side, into a position of safety (see Figure 1, image taken from the forward facing closed circuit television (CCTV) of the train), approximately four seconds before the train passed. The Driver brought the train to a stop and reported a Category 1 Near Miss with the member of staff to the controlling Signaller located in the Local Control Centre in Athlone.

Figure 1 – Patrol Ganger stepping into the cess, into a position of safety

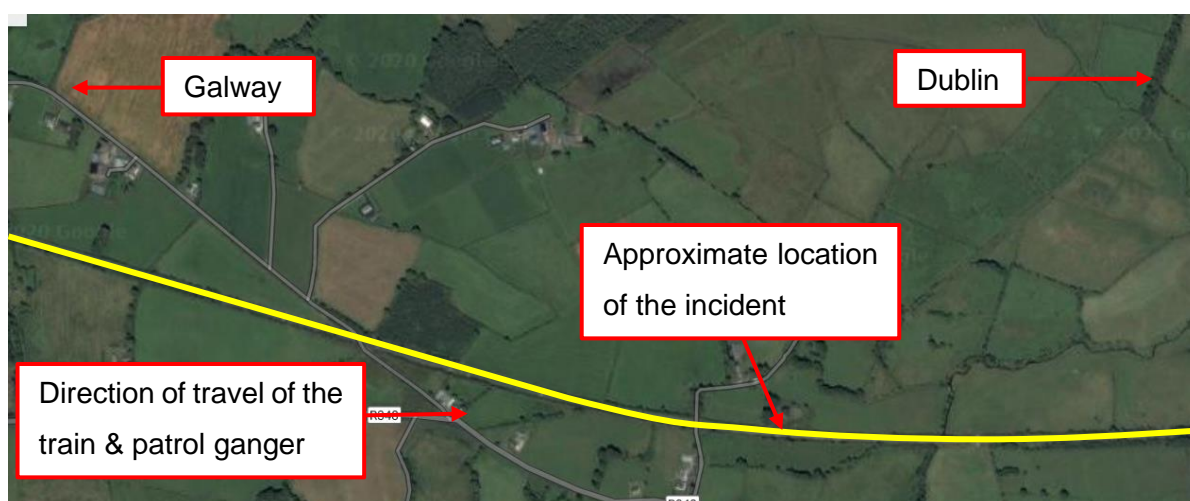
- 13 The incident occurred on a bi-directional single line section of track between Woodlawn and Ballinasloe at approximately the 95 ¼ Mile Post on the Dublin (Heuston) to Galway Line.
- 14 The track is plain line with flat bottom *continuously welded rail (CWR)* mounted on concrete sleepers in ballast.
- 15 The incident occurred on a curved section of track (see yellow line depicting the railway line and the location of the incident in Figure 2), where the maximum permitted line speed is 90 mph (145 km/h).
- 16 No factors in relation to the condition of the track were found to have contributed to the incident.

Figure 2 – Curved section of track between Woodlawn and Ballinasloe

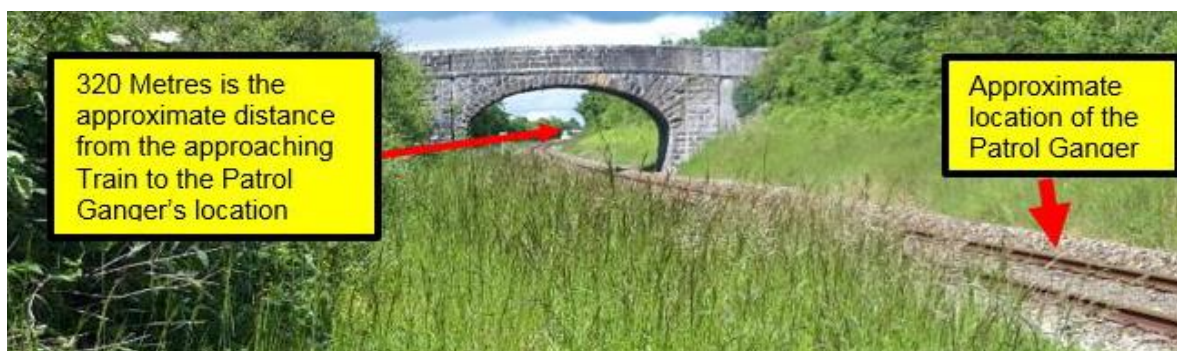
51 With the maximum speed at the location of the incident being 90 mph (145 km/h); the minimum sighting distance provided for this speed is 700 m with a warning time of 15 seconds.

52 IÉ-IM took distance measurements post-incident and found that the sighting distance was 320 m (see Figure 5, taken from IÉ-IM's Report of Investigation into this incident) as opposed to the required sighting distance of 700 m.

Figure 5 – Sighting distance, as calculated by IÉ-IM

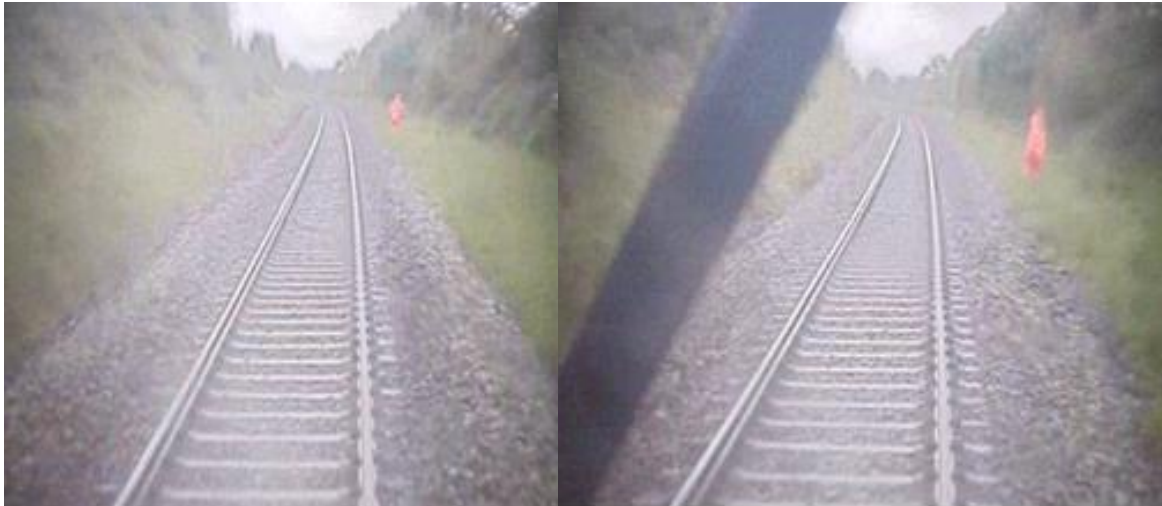
- 66 The Driver placed the train brake in the emergency position and sounded the train horn to warn of the train's approach. The Driver was unsure if the Patrol Ganger could hear the horn, so released and reapplied the train horn. The Patrol Ganger stepped off the track into the cess, into a position of safety (see Figure 6, images taken from forward facing CCTV on the train), approximately four seconds before the train passed (IE staff should be in a position of safety 10 seconds before the train arrives, paragraph 46).

Figure 6 – Patrol Ganger stepping into the cess & into a position of safety
