Railway Accident Investigation Unit

INVESTIGATION REPORT

Vehicle struck by train at Cartron level crossing, XM220, Co. Mayo, 17th August 2018

RAIU Report No: 2019 – R003
Report Published: 03/09/2019

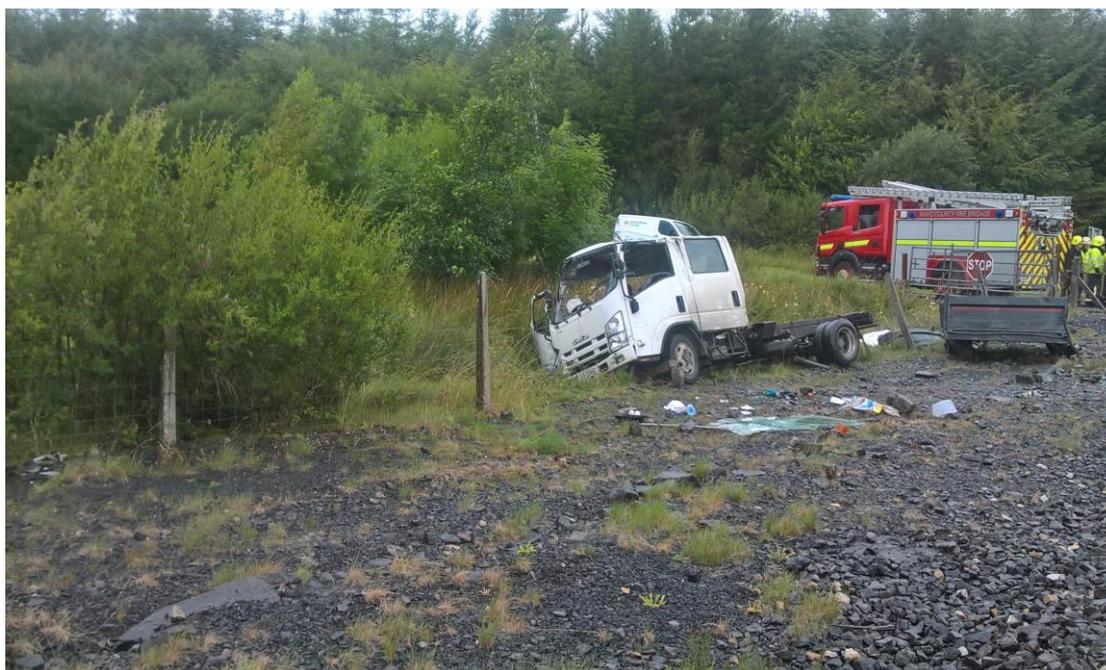
Figure 2 – Scene of the accident

- 2 At the same time, the 08:15 hrs goods train from Ballina to North Wall International Warehousing and Transport Dublin (train identification number K801) was travelling towards LC XM220 and struck the Truck. On impact, the Truck was thrown clear of the train and into the adjacent boundary fence before coming to a stop. The train came to a full stop 482.43 metres (m), measuring from the front of the train, past LC XM220, see Figure 2.

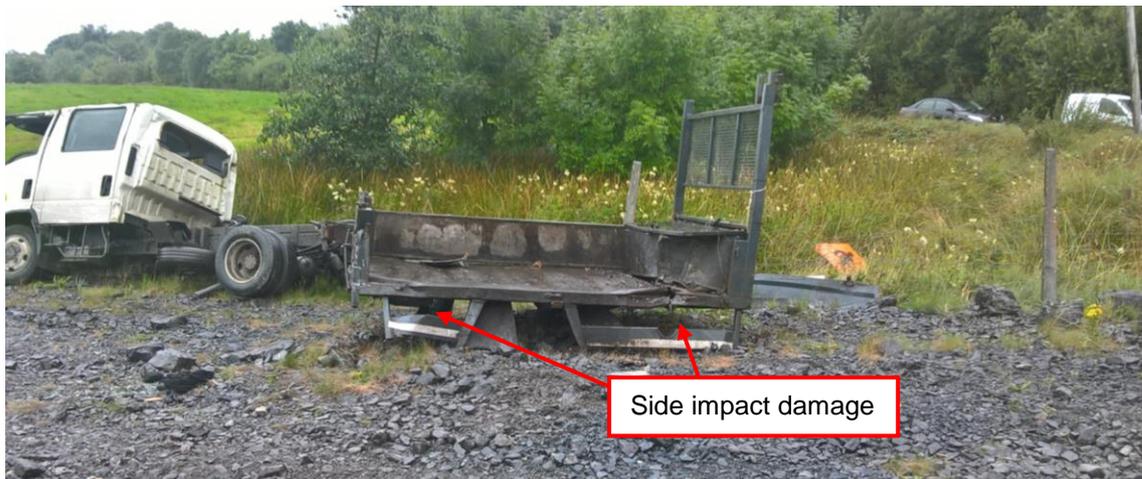
Figure 5 – Damage to the Truck and fencing

- 22 The Truck suffered side and frontal damage in the impact and the rear goods carrying flat-bed behind the crew cab was dislodged by the impact, see Figure 5 illustrating where the buffers collided with the Truck.

- 23 There was damage to LC XM220 infrastructure boundary fence and cattle grid because of this accident.
- 24 The front of the train was not damaged, there were however scuff marks where the front buffers had contacted with the side of the Truck, see Figure 6.

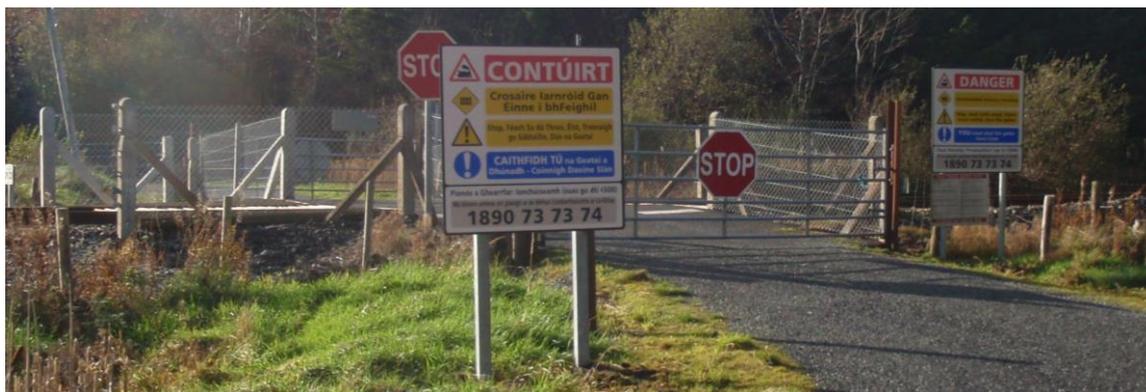
Figure 11 – Signage at LC XM220 (photograph taken on the 21st August 2018)

- 47 The signage at the LC XM220 is required to be compliant with CCE-TMS-380.
- 48 The signage at LC XM220 was replaced by IÉ-IM in January 2010, see Figure 11; cattle grids were replaced in 2013 and vegetation boards and ‘no trespass’ signs were erected in 2014. The signage at LC XM220 at the time of the accident is illustrated in Figure 11 (photograph taken on the 21st August 2018, after the accident).

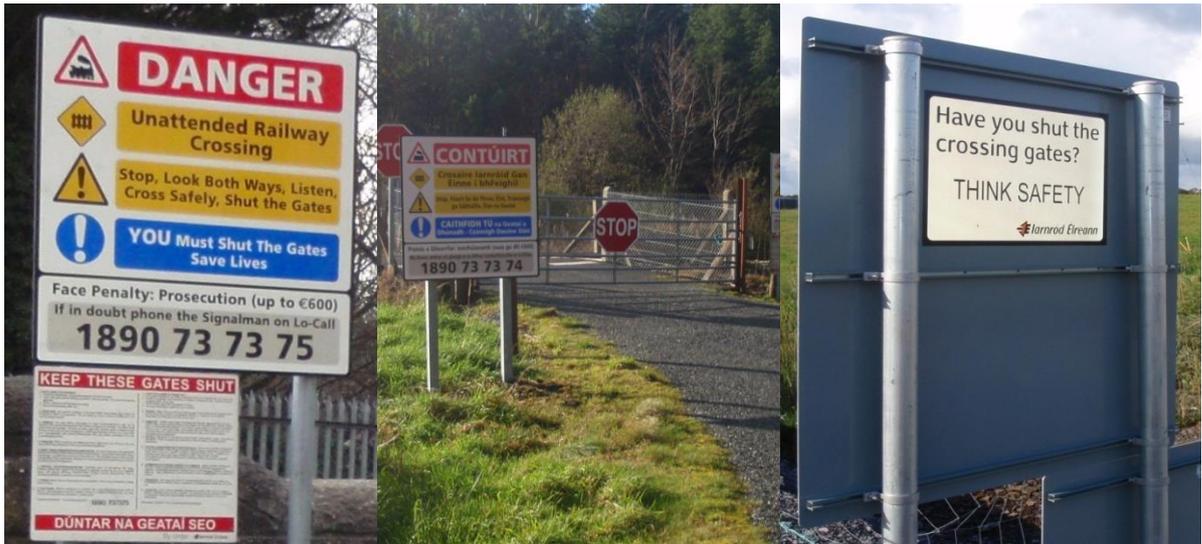
Figure 12 – Signage at LC XM220

- IÉ-IM ‘Danger’ sign in the Irish language, including the above statements in Irish, see Figure 12 (centre signage);
 - IÉ-IM ‘Keep these gates shut’ sign which includes requirements related to closure of the gates and penalty notices associated with the failure to close gates, see Figure 12 (signage on left).

- 50 Signage on exiting LC XM220 includes the:
- IÉ-IM “Have you shut the crossing gates?” signage, which is located on the rear of the IÉ-IM “Danger” signage, see Figure 12 (signage on right).

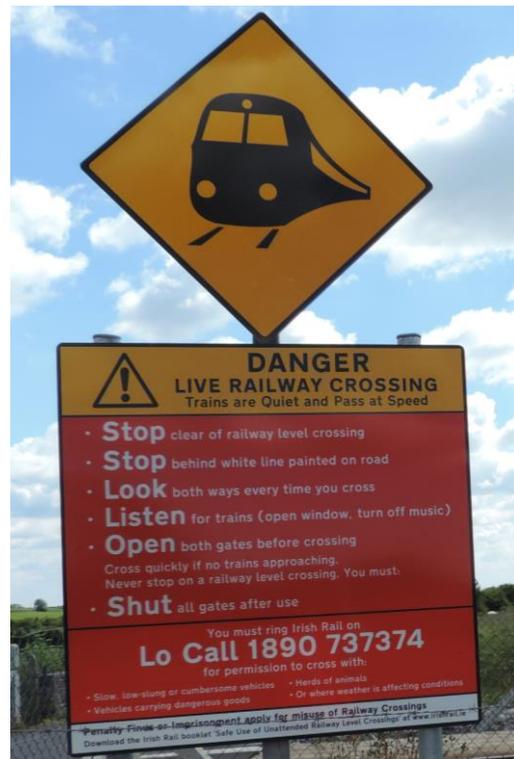
Figure 13 – New signage design

53 In relation to the new train signage (top of Figure 13), this is not an official road traffic sign as set out in the Traffic Signs Manual and it not recognised as such in the current edition of the Rules of the Road.

52 IÉ are currently in the process of fitting all O/OP crossings with the new signage. The new signage has been erected at LC XM220, see Figure 13 and Figure 14 which were photographed on site by the RAIU on the 22nd May 2019.

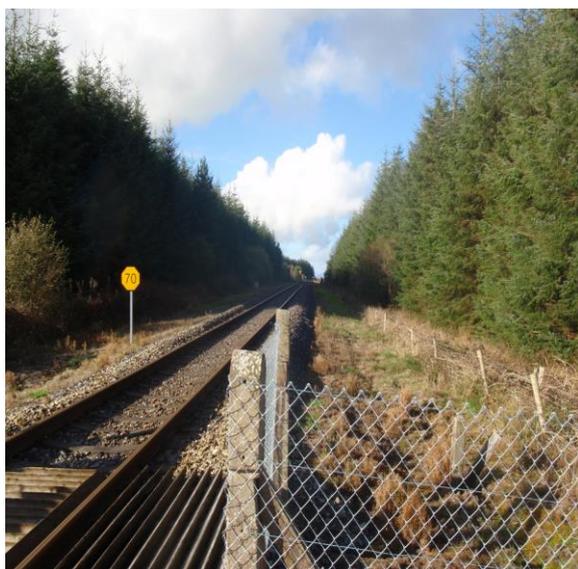
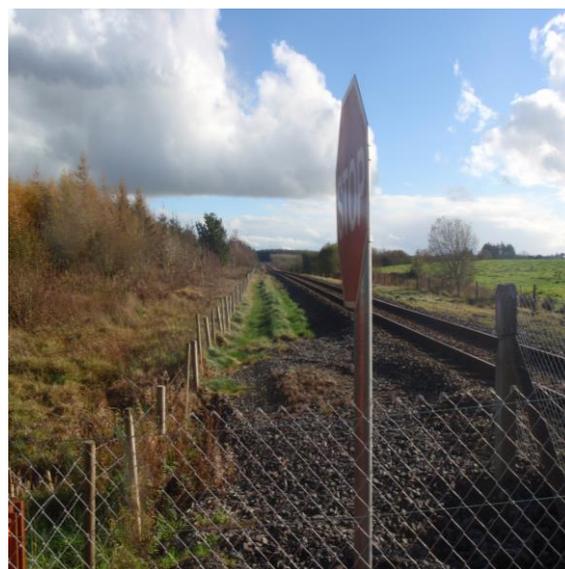
- 58 The maximum permitted line speed for the section of railway line through LC XM220 is 70 mph (110 km/h) in the Up Direction and 60 mph (95 km/h) in the Down Direction; meaning that the required *viewing distances*, as set by CCE-TMS-380, are 350 m and 300 m, respectively.
- 59 The viewing distance at LC XM220 were measured at 403 m in the Up direction and 698 m in the Down direction, which means that the required viewing distances are within tolerance in both directions.

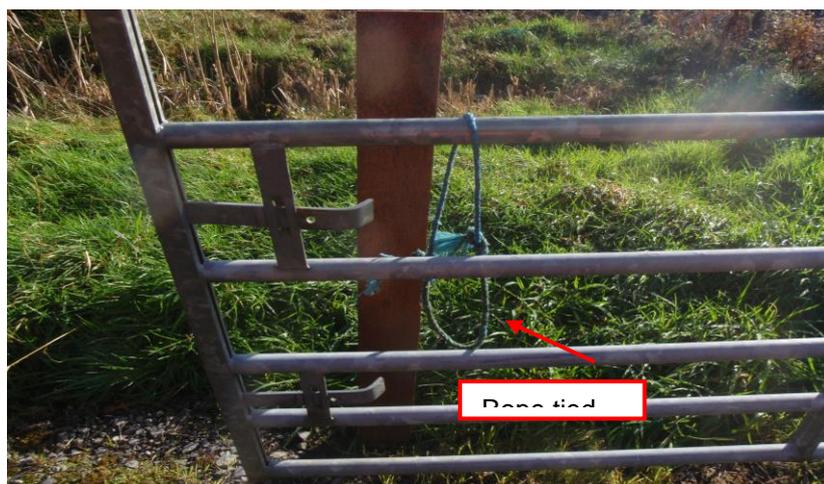
Figure 25 – LC XM220 gates tied to keep level crossing open

91 During an RAIU visit to LC XM220 a rope was seen tied around both gates to allow local level crossing users to keep them open, see Figure 25.

- 99 LC XM220 had a history of frequent misuse related to gates being left or tied open; with the gates being found to be open on every track patrol inspection in the previous six months; with the gates last being reported open on Monday 13th August 2018 (four days before the accident); on this day, the Patrol Ganger closed the gates and recorded no other faults were recorded at LC XM220.
