**Railway Accident
Investigation Unit
Ireland**

Annual Report 2011

Report number: 2012-AR2011

Published: 21/09/2012

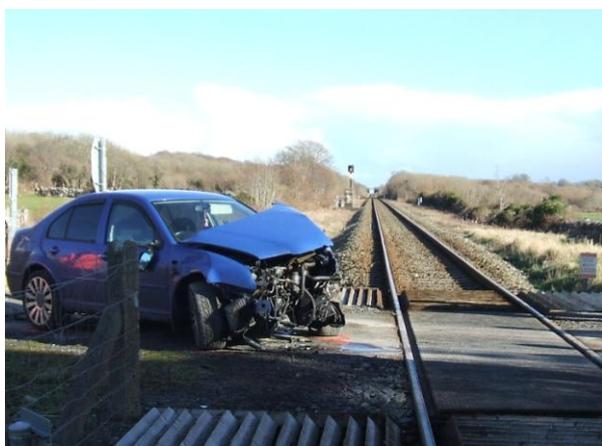
Figure 3 – Car strike at XG173

At approximately 12:13 on the 14th February 2011 a car was struck by the 09:30 passenger service from Heuston Station (Dublin) to Ceannt Station (Galway) at user worked level crossing XG173. As the train approached XG173, the train driver observed a car encroaching onto the line, sounded the horn and applied the emergency brake. The train struck the car as it was attempting to reverse clear of the railway line. The occupants of the car were hospitalised for their injuries and released the same day. The train sustained minor damage to its suspension and damping equipment. The car sustained substantial front end damage.

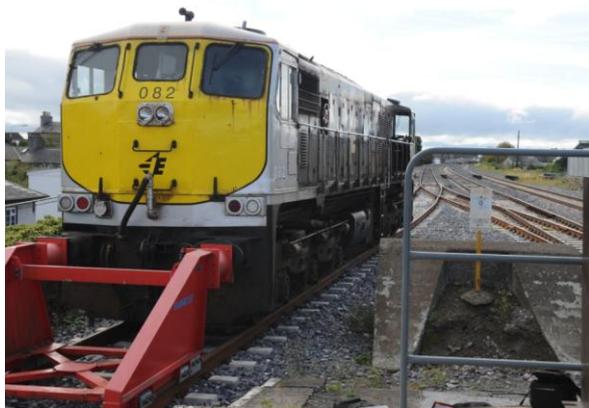
Figure 4 – Runaway locomotive

At approximately 11:35 on the 29th September 2011, locomotive 083 was travelling from Limerick Junction to Portlaoise Rail Depot when it was stopped on Portlaoise Loop. The train driver disembarked the locomotive in order to set the route for the locomotive to travel into Portlaoise Rail Depot. While the driver was on the ground, the locomotive began to roll towards Portlaoise Station, passing a signal at danger and colliding with a buffer stop at Portlaoise Station.

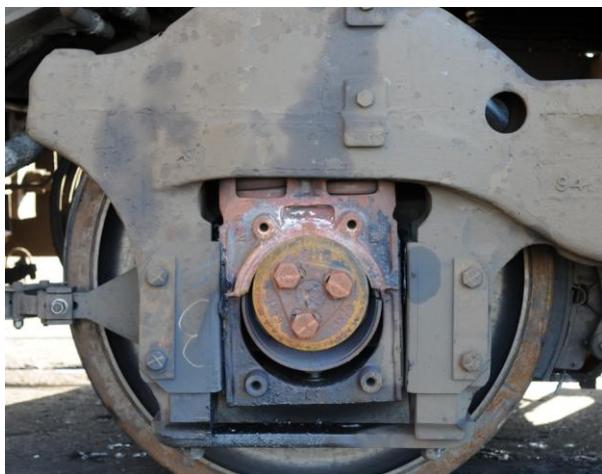
Figure 5 – Failed bearing on locomotive 233

At approximately 18:35 on the 18th October 2011, the 16:10 passenger service from Belfast to Dublin arrived into Connolly Station (Dublin). A member of the rolling stock maintenance staff inspected the train and found that one of the axleboxes on the locomotive was glowing and smoking. The train had set off a hot axlebox alarm whilst travelling from Belfast but no fault had been found upon inspection. There was a bearing failure on the last axle of the locomotive, which had been operating in push pull mode with the locomotive at the rear of the train pushing the carriages.

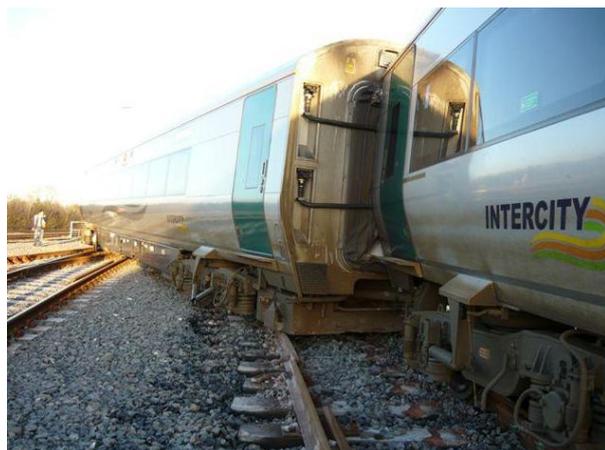
Figure 6 – Laois Traincare Depot Derailment

At 15.25 hours on the 20th January 2010 a Class 22000 six carriage train was scheduled to leave Laois Traincare Depot after routine servicing. The intended destination of the train was Heuston Station. The Train Driver performed his pre-departure checks and the Shunter authorised the train to proceed out of Laois Traincare Depot as far as signal PL278, which controls the exit from the depot onto the down loop adjacent to the main line. The Shunter set the number 2A points for the train to leave the depot. The Train Driver stopped at signal PL278

- IÉ should ensure that the risks relating to use of spring assisted manual points are identified and that appropriate control measures are implemented based on the risks identified;
- IÉ should ensure that the Signal Sighting Committee is informed when train drivers report difficulties viewing a signal and the Signal Sighting Committee should verify that the reported difficulties are addressed effectively.

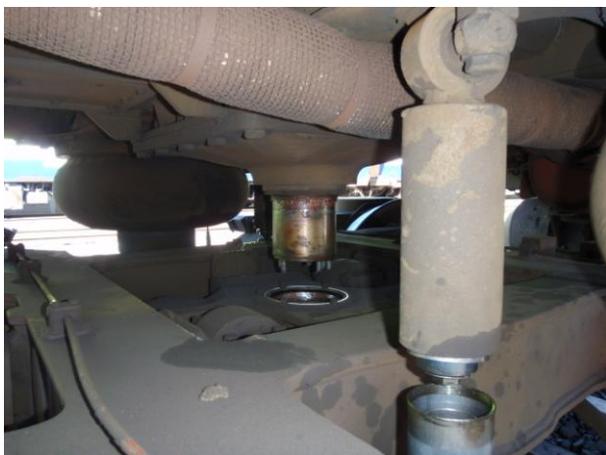
Figure 7 – Failed bogie to carbody connection

At approximately 22:50 on the 7th May 2010 the 21:05 passenger service from Longford to Connolly Station arrived into Platform 1 at Connolly Station in Dublin. The service was operated by a four carriage Class 29000 Diesel Multiple Unit referred to as Unit 10. A member of the contract cleaning staff subsequently observed that there was a problem with one of the carriages and advised IÉ personnel. Unit 10 was found to have returned from passenger service with its secondary suspension system over-inflated on one of the bogies of carriage

29310. The over-inflation had led to the failure of the centre pivot retaining plate bolts and the airbags lifting the centre pivot pin out of the bogie centre. Unit 10 had been undergoing maintenance prior to being released for passenger service on the 6th May 2010 and had entered passenger service with the secondary suspension functioning incorrectly on the trailer bogie of carriage 29310.

- The design of the secondary suspension system allowing the fault to develop to the point that the train entered an unsafe state;
- The ineffectiveness of maintenance and operational controls in place in managing the risks relating to over-inflation of the secondary suspension;
- The ineffectiveness of the hazard log in addressing the hazards relating to the over-inflation of the secondary suspension;
- The ineffectiveness of the hazard log in addressing the hazards relating to the failure of the centre pivot pin to perform its intended function.

- IÉ should ensure that the risks relating to use of spring assisted manual points are identified and that appropriate control measures are implemented based on the risks identified;
- IÉ should ensure that the Signal Sighting Committee is informed when train drivers report difficulties viewing a signal and the Signal Sighting Committee should verify that the reported difficulties are addressed effectively.

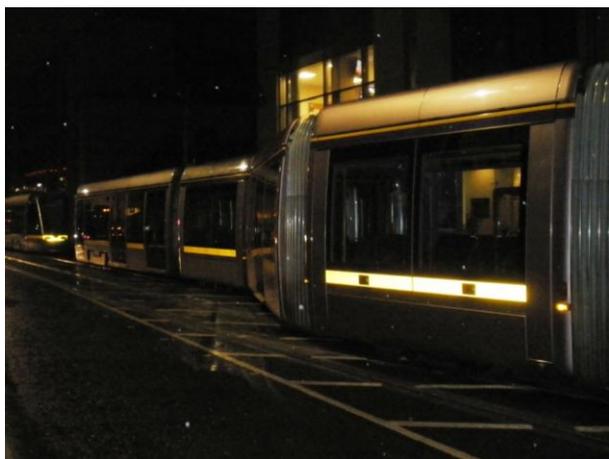
Figure 8 – Derailed tram at Point stop

On the 13th May 2010, Luas Tram 3006 was travelling on the shuttle service between Dublin Heuston Railway Station and the Point Stop on the Luas Red line. At 22:10 Tram 3006 proceeded into The Point Stop with the intention of stabling at the Inbound Platform, however the tram travelled towards the Event Platform, and not the Inbound Platform as intended. The Tram Driver stopped Tram 3006 and after communicating with the Controller in the Central Control Room, changed driving cab ends and drove Tram 3006 outbound, derailing the third

- Veolia should introduce a communication protocol between normal and emergency for given situations where a clear understanding between a tram driver and Central Control Room are required.

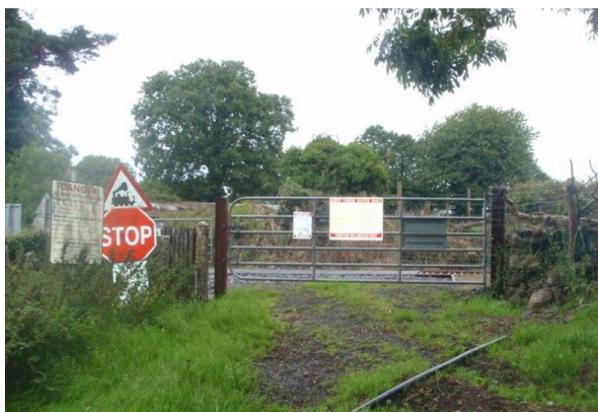
Figure 9 – Level crossing XE039

At approximately 22:00 on the 27th June 2010 the Train Driver of the 21:45 service from Ennis to Limerick sounded the horn on the approach to user worked level crossing XE039. As the Train Driver was sounding the horn he observed a farmer, 162 metres ahead of the train, pushing a cow through the gates of XE039 onto the railway, approaching the railway line from the Train Driver's right. As the train continued to approach

XE039 the Train Driver applied the brake and sounded the horn twice. As the Farmer continued to push the cow, the train struck the Farmer and the cow. As the train passed over XE039 the Train Driver heard a noise and saw the cow fall to the left of the train, he was not aware that the train had struck the Farmer. The train stopped 200 metres beyond XE039. The Train Driver went back to XE039 on foot and found both the Farmer and the cow on the side of the track on the opposite side of the track to the one had they approached from. The Train Driver requested the assistance of the emergency services, who were contacted by the Galway Line Signalman. The ambulance service arrived via a bridge over the railway 552 metres from XE039 and was then guided to the access road for XE039. The Farmer was fatally injured and pronounced dead at the scene.

- IÉ should ensure that risk assessments are produced for all user worked level crossings to identify all hazards specific to particular level crossings;
- IÉ should review their documentation on the measurement of viewing distances at existing user worked level crossings to ensure that the viewing distances provide sufficient views of approaching trains to allow level crossing users cross safely;
- IÉ should review their procedures for the management of accidents to ensure that communication with the emergency services is clear and provides the necessary information to locate an accident site without undue delay and access it by the most appropriate point.

- IÉ to develop and implement a vegetation management programme that addresses vegetation management on a risk basis, prioritising high risk areas.

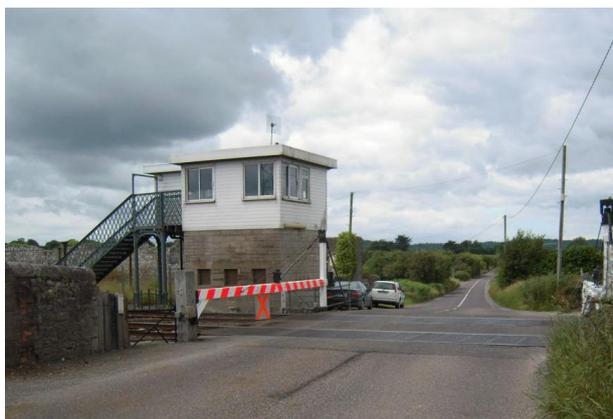
Figure 10 – Level crossing XC219

At 10:22 on the 2nd July 2010, the 08:00 Heuston to Cork passenger service passed through Level Crossing XC219 without incident. Approximately thirty seconds later a Track Recording Vehicle approached XC219 in the opposite direction, as the Gate Keeper was in the process of closing the gates across the railway line. The Track Recording Vehicle struck one of the gates which resulted in damage to the gate and the Track Recording Vehicle. There were no injuries or fatalities as a

- IÉ should identify similar manned level crossings where human error could result in the level crossing gates being opened to road traffic when a train is approaching; where such level crossings exist, IÉ should implement engineered safeguards; where appropriate;
- IÉ should review its risk management process for manned level crossings to ensure that risks are appropriately identified, assessed and managed to ensure that existing level crossing equipment is compliant with criteria set out in IÉ's signalling standards, where appropriate.

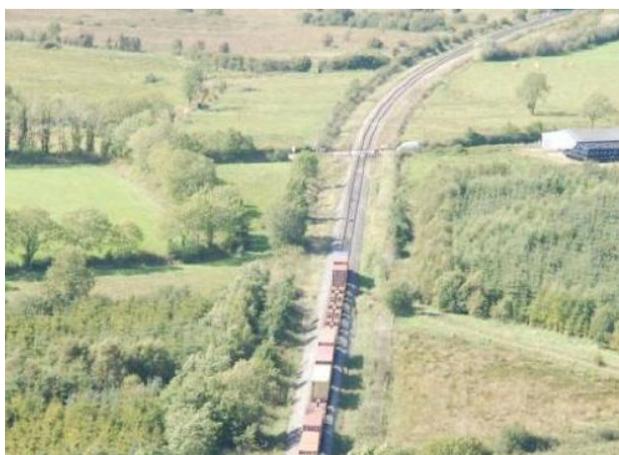
Figure 11 – Level crossing XM096

At approximately 11:13 on the 2nd September 2010, the 09:30 freight service from Ballina to North Wall was travelling along the left hand curve on the approach to user worked level crossing XM096. As XM096 came into view, the Train Driver observed a tractor stationary on the track at the level crossing. The Train Driver sounded the horn and applied the brake. The Farmer driving the tractor was looking downwards as the train approached and had

- There was no formal process in place to ensure communication with the known users of the level crossing other than through the signage at the level crossing, including addressing known issues in relation to their use of the level crossing;
- The information provided to level crossing users through signage at the level crossing was found not to include information provided in the level crossing user booklet relating to the advice that the signals are solely for the control of train movements and on what to do in case of difficulty when crossing the railway.

- The system of risk management in place was not found to provide for interim measures to be taken to mitigate risk in advance of more long term control measures;
- The shortfall in the viewing distances at the Level Crossing were not proactively managed;
- The warning time of an approaching train specified in the governing documentation only takes into account a normal movement across the railway and does not include a safety margin to allow for difficulties that may arise when a level crossing user is crossing the railway;
- The robust nature of the fencing at the Level Crossing, which was made up of disused rail, could lead to increased severity of the outcome of a collision between a train and a road vehicle.

- IÉ should update its risk management system to ensure that interim control measures are put in place where longer term controls to address risks require time to implement;
- IÉ should review how it determines the safe crossing time for user worked LCs to ensure the safe crossing time allows adequate time for movements and includes a safety margin, over and above the crossing time;
- IÉ should review its use of disused rail as fencing at user worked LCs to ensure it cannot potentially increase the severity of a collision and where this is the case, replace the disused rail with appropriate fencing.

- IÉ to develop and implement a vegetation management programme that addresses vegetation management on a risk basis, prioritising high risk areas.

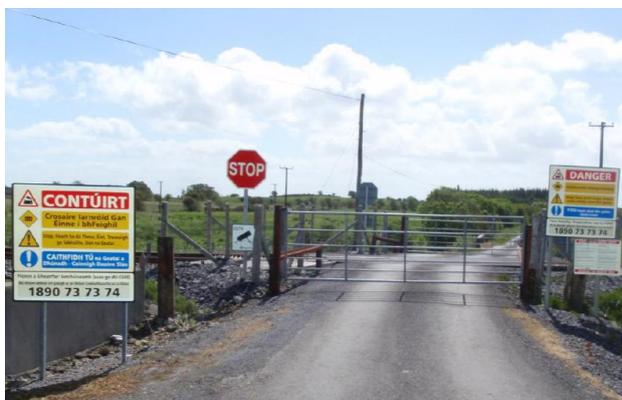
Figure 12 – Level crossing XM250

At approximately 10:50 on the 24th October 2010 as the 10:15 passenger service from Athlone to Westport approached Level Crossing XM250, the train driver saw a car approaching the level crossing while the level crossing gates were open to the railway. The train driver sounded the horn and applied the emergency brake; however the train struck the car whilst it was trying to reverse away from the level crossing. There were no fatalities or

injuries as a result of this accident. There was damage to the front of the car.
