**Railway Accident
Investigation Unit
Ireland**

INVESTIGATION REPORT

Trend investigation into Signals Passed At Stop on the LUAS network

RAIU Report No: 2022 – R003

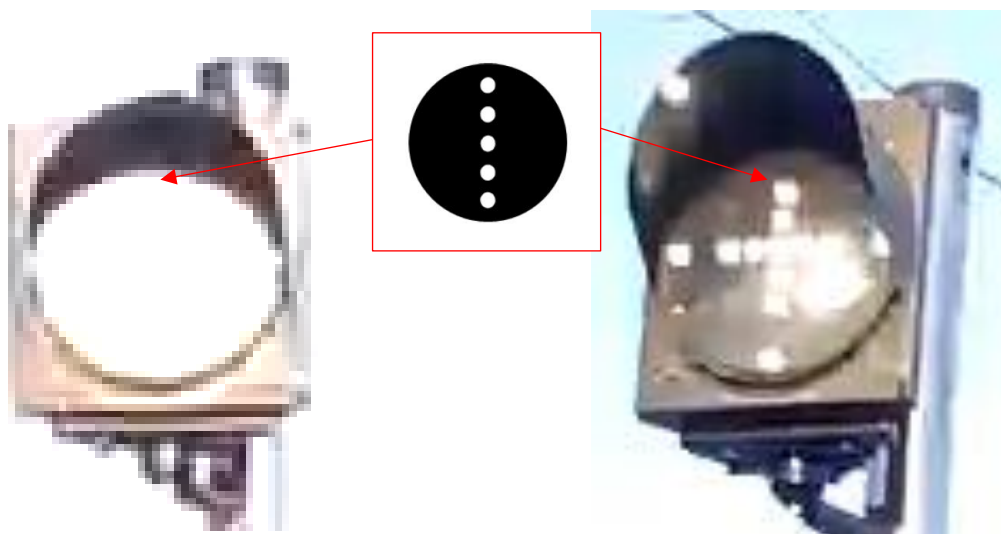
Figure 9 – Signal S-2e at the time of the incident

112 At 15:08 hrs, Tram 3007 approached Signal S-2e at Stop, images in Figure 9 taken from the FFCCTV, both within a second, do not clearly indicate what aspect was being displayed due to sun glare, see Figure 9. Driver 3007 looked at the darkest part of the signal and thought that the top dot was lit (see inset in Figure 9) which would indicate a Proceed. Driver 3007 slowed his tram but proceeded towards the interchange.

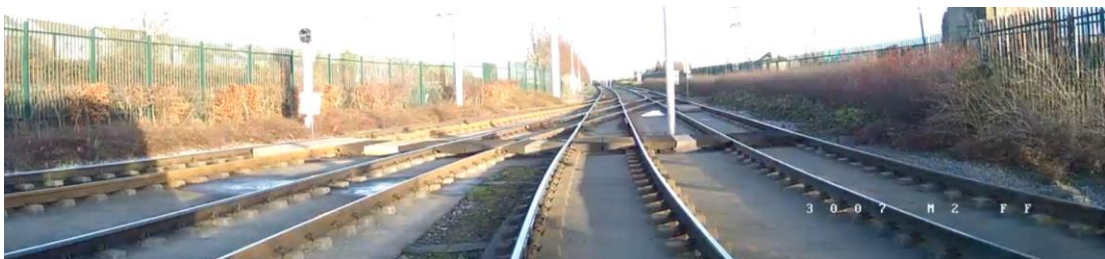
Figure 13 – Tram 3007 re-starting through Cookstown Interchange

- 115 After Tram 3025 travelled over the interchange; Tram 3007, progressed through the interchange; Driver 3007 had no signal indicating that it was safe to proceed, as Tram 3007 had already passed Signal S-2e, see Figure 13. Irrespective of whether Driver 3007 thought he had a proceed signal, Driver 3007 should have contacted LNMC to inform them that he did not have a signal to proceed through the interchange.

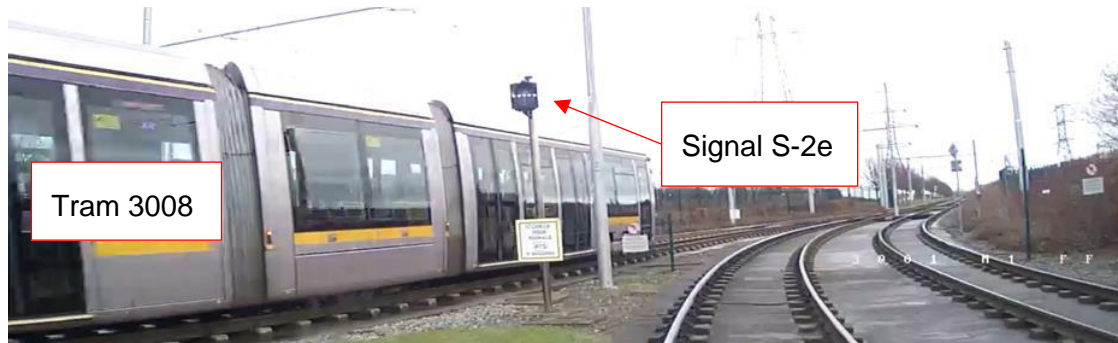
Figure 14 – Signal S-2e at Stop and Tram 3008 travelling outbound

117 On the 13th February 2020, Driver 3001 was operating the inbound Tallaght to Point passenger service. When Driver 3001 departed Cookstown, he approached Signal S-2e, at the Cookstown LSS, displaying a Stop aspect, as another tram (Tram 3008) was exiting Cookstown LSS in the outbound direction, see Figure 14. Driver 3001 assumed that the signal had upgraded for him and may have been distracted by Tram 3008 as he travelled past Signal S-2e at Stop.

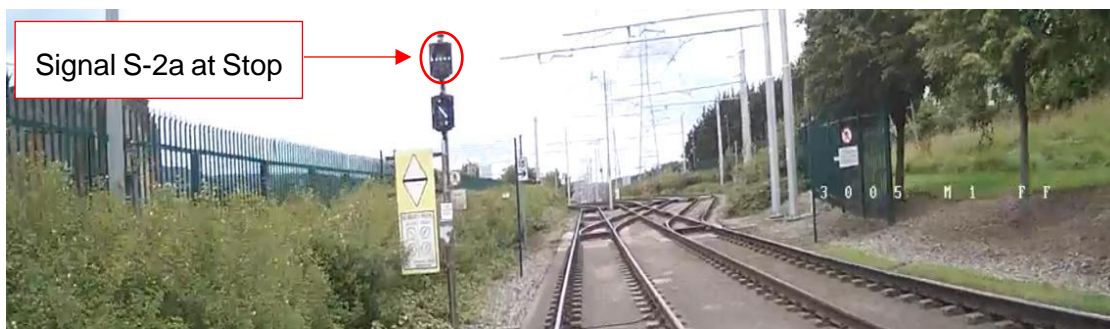
Figure 15 – Signal S-2a displaying a Stop aspect

¹⁴ As part of the review of Cookstown Interchange, the RAIU found that, at the location of a signal (and PPI), there was a regulatory Stop sign where drivers are not required to stop in accordance with the TSI Manual, which is contradictory to the Road Traffic Act (see Figure 15). TII have replaced the sign (see Figure 16) and conducted a review off all signage on the network to ensure all signage is correct.

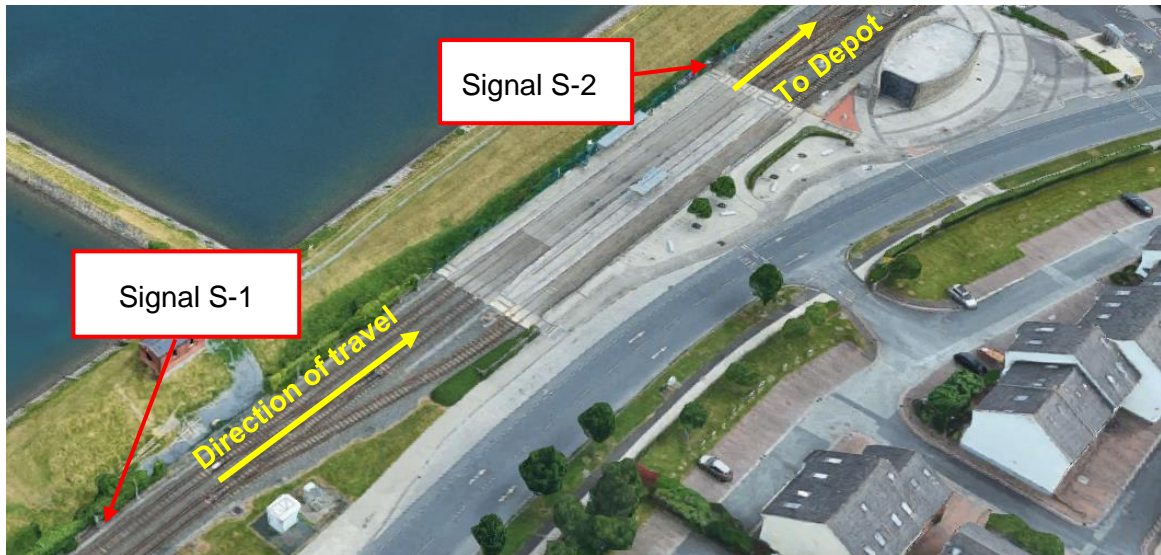
Figure 18 – Location of the incident

125 On Friday 18th January, Driver 5025, was travelling to Sandyford Stop; he was going to serve Sandyford Stop and to enter Sandyford Depot to take his meal break. At the same time, there were two trams at Sandyford Stop (on the southbound and central tracks), Tram 5025 was waiting on the loop on the northbound track, at Signal S-1, which was displaying a Stop aspect (see Figure 18).

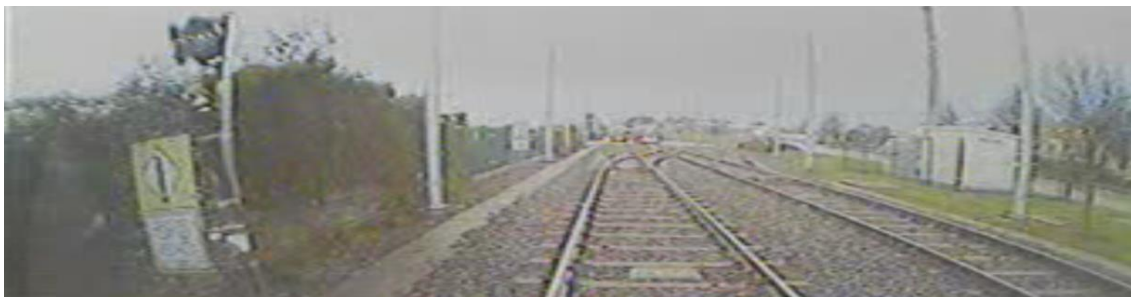
Figure 19 – Tram 5025 stopped at Signal S-1

126 After approximately a minute, when the other tram on the southbound track cleared the Sandyford Stop, Driver 5025 did not input the RTS request and proceeded towards Sandyford Stop, passing Signal S-1 at Stop (see Figure 19), assuming the signal has cleared.

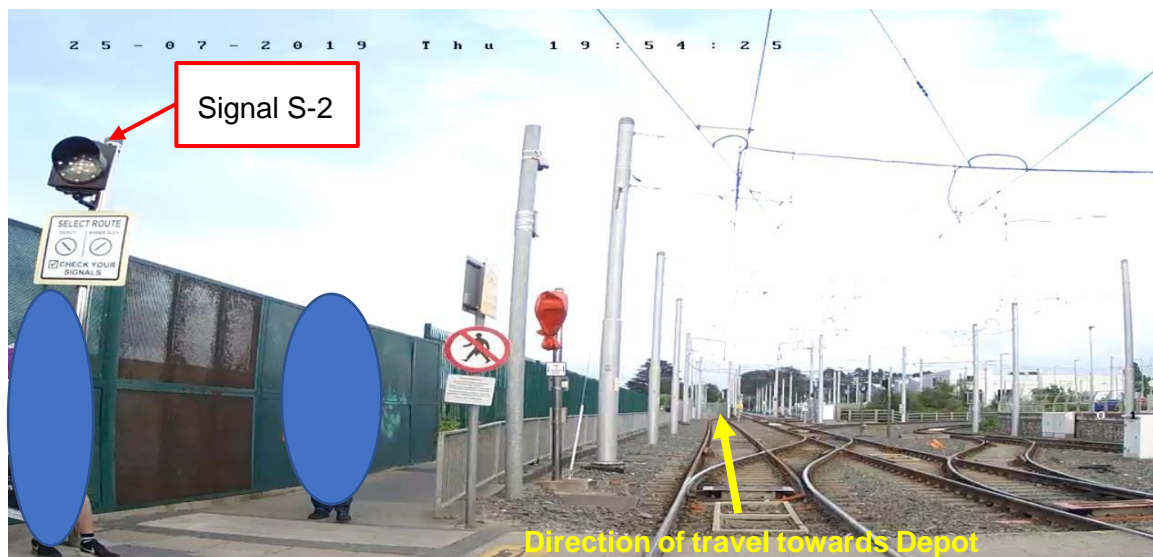
Figure 20 – Stopped position at Sandyford Stop at 19:54:25 hrs

129 Tram 4012 was stopped at Signal S-2 Southbound (Figure 17)¹⁵; points were set for the depot movement. Driver 4012 did not input an RTS request to for a proceed aspect from Signal S-2. Driver 4012's focus was on the passengers/pedestrians (Figure 20 shows two pedestrians in the area of Signal S-2 at the time of the incident).

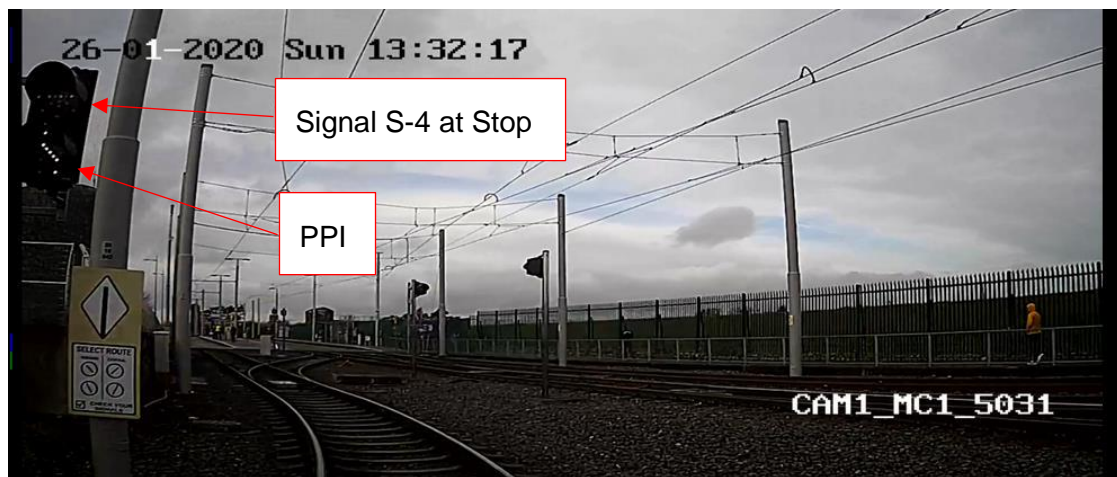
Figure 23 – Signal S-4 at Stop and PPI indicating route set for northbound platform

- 137 Driver 5031 did not look at the signal and instead looked at the PPI (Figure 23) to see if his route was set for the northbound platform, which it was. Driver 5031 did reduce the speed of the tram, but did not stop, passing the signal at Stop.

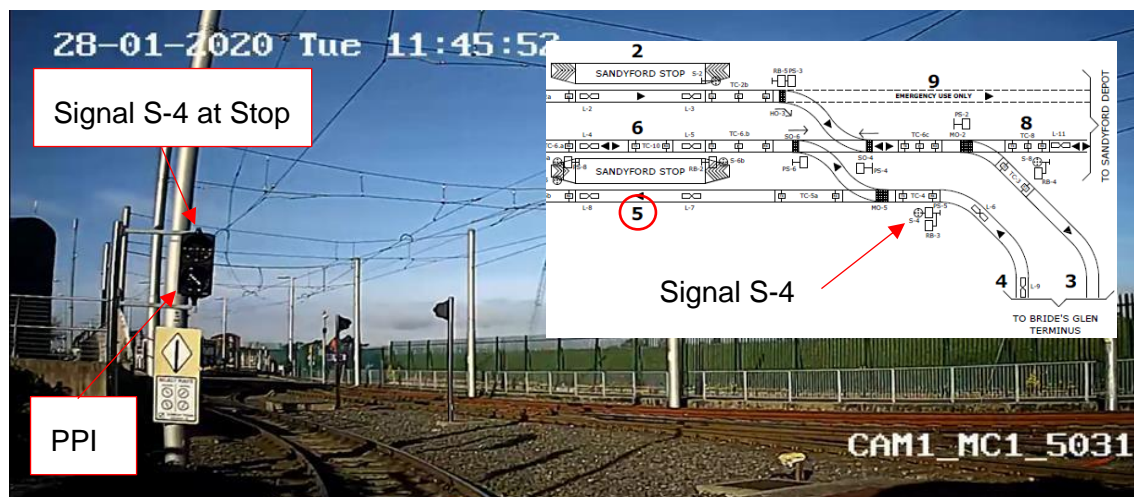
Figure 24 – Signal S-4 at Stop and PPI indicating route set for northbound platform

139 On the 28th January 2020, Driver 5031¹⁶ was operating the Brides Glen to Parnell passenger service. On approach to Sandyford northbound platform (Route 5 in Figure 24), Signal S-4 (see Figure 22 for location of signal) was displaying a Stop aspect (Figure 24) and the PPI was set for the northbound platform (Figure 24).

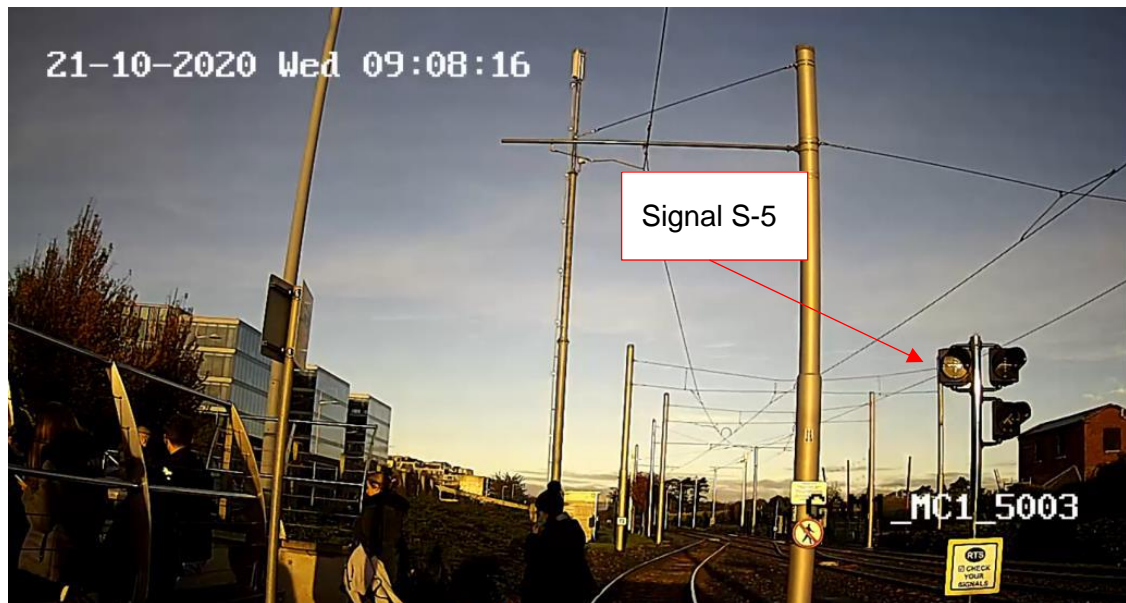
Figure 27 – Signal S-5 at Stop

147 The signal to proceed northbound is Signal S-5, which was displaying a Stop aspect. There were a number of pedestrians crossing in front of the tram and Driver 5003 thought he inputted the RTS but may have pressed the chimes button; however, Driver 5003 did not input an RTS command and proceeded past Signal S-5 at Stop, see Figure 27, and continued northbound.

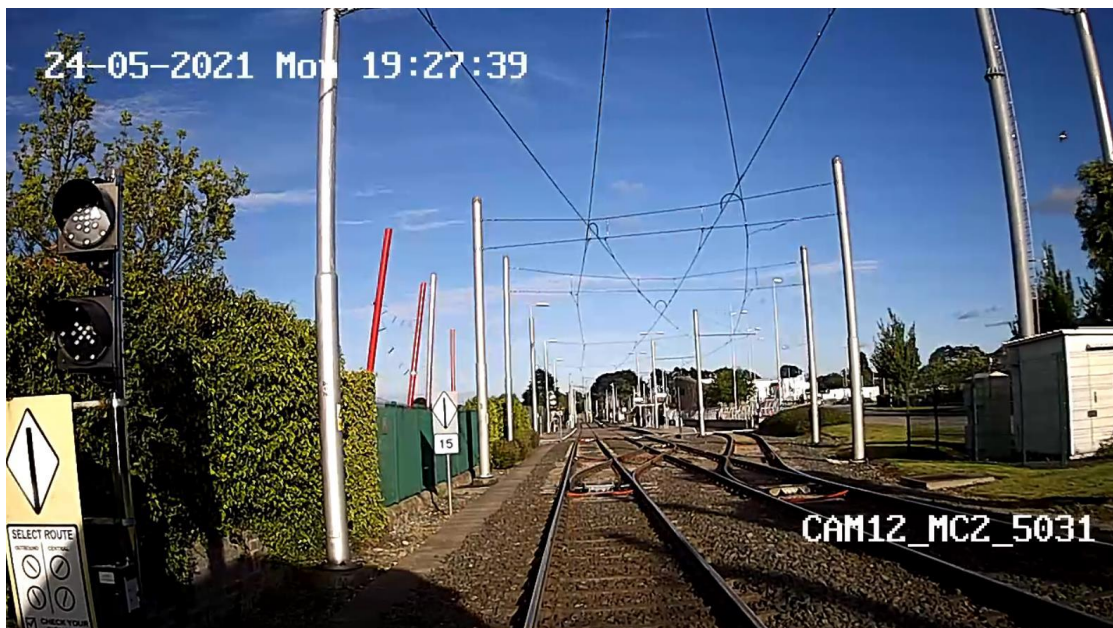
Figure 28 – Signal S-1 with sun glare

149 On the 24th May 2021, Driver 5031 was operating the Broombridge to Sandyford service. As Tram 5031 approached Signal S-1 (Figure 18) into Sandyford Southbound Platform, the signal was displaying a Stop aspect; and, the points were set for the required movement (note: Driver 5031 had not inputted the AVLS correctly, with the wrong route set, although, it is noted that this does not guarantee a Proceed signal). Driver 5031 stopped his tram on the control loop for the signal; however, four seconds later took traction and passed Signal S-1 at Stop without inputted an RTS request. The FFCCTV of Tram 5031 (Figure 28) stopped at Signal S-1 shows that, from the perspective of the FFCCTV, the aspect cannot be determined due to sun glare.

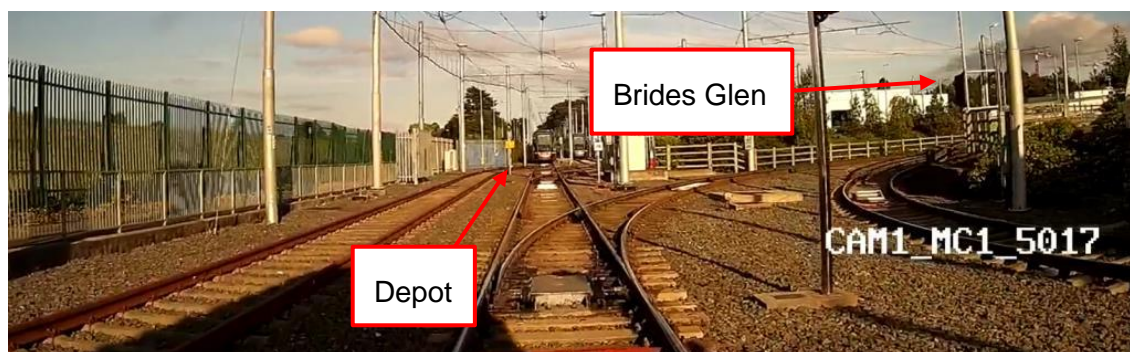
Figure 30 – Points set for Depot entry

154 As Driver 5017 approached the points, he saw that the points were not set for Brides Glen, but for entry back into Sandyford Depot, see Figure 30. Driver 5017 stopped the tram and contacted LNMCC.

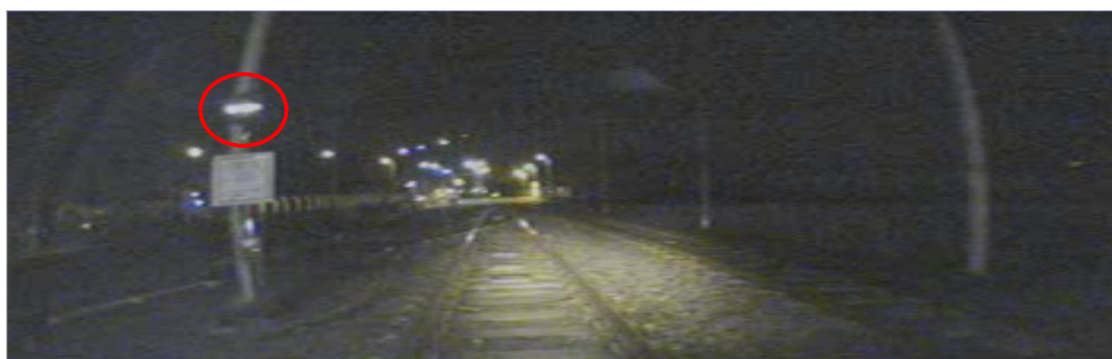
Figure 31 – Tram 5002 stopped at the depot gates

164 At approximately 22:47 hrs, LNMC authorised the movement of Tram 5002 from the depot gates (see Figure 31 for CCTV image of Tram 5002 stopped at the depot gates with Signal S-8 displaying a "Stop" aspect) to Sandyford Central Platform, "on signals".

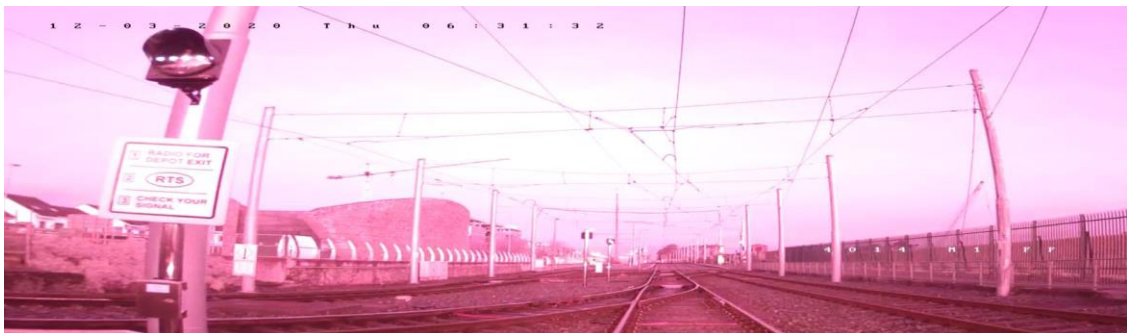
Figure 33 – Signal S-8

169 At 06:30 hrs, Driver 4014 requested permission to travel from Storage Road 6 to the Depot Gates, which was granted, and Tram 4014 travelled to the Depot Gates and stopped at Signal S-8, which was displaying a Stop aspect, see Figure 33.

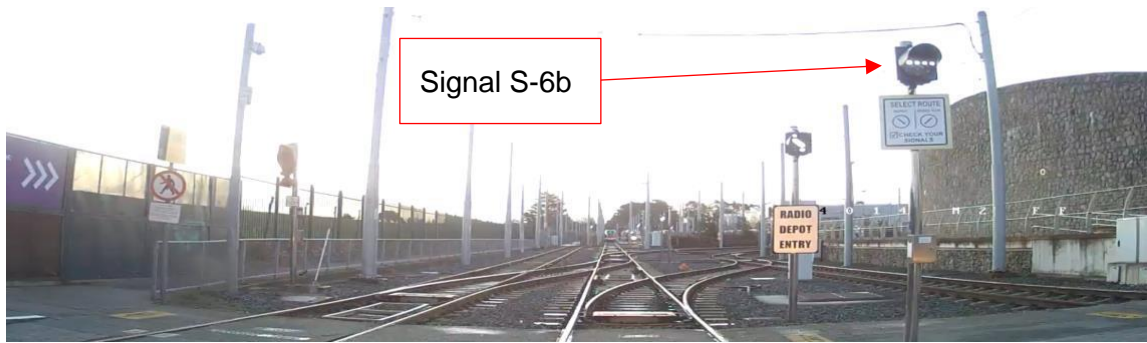
Figure 34 – Signal S-6b at Stop

- 171 Driver 4014 continued onto the Central Platform, where he saw “Stop – Single Dot” aspects and contacted LNMC who suspected a SPAS had occurred and requested that Driver 4014 return Tram 4014 to the depot.
- 172 At 06:40 hrs, Driver 4014 was now required to input an RTS command for Signal S-6b (see Figure 32), to re-enter the depot, however he did not and proceeded past Signal S-6b at Stop, see Figure 34.

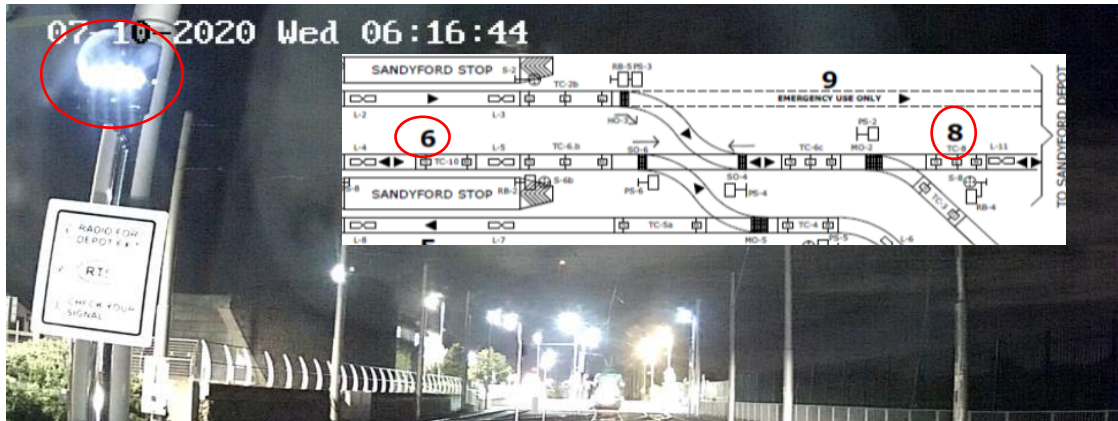
Figure 36 – Tram at Depot Gates, Signal S-8 displaying a Stop aspect (circled)

175 At the Depot Gates, Driver 5014 requested permission, from LNMCC, to exit the Depot onto the mainline (movement 8 to 6 inset Figure 36). Signal S-8 was displaying a Stop aspect (see Figure 36).

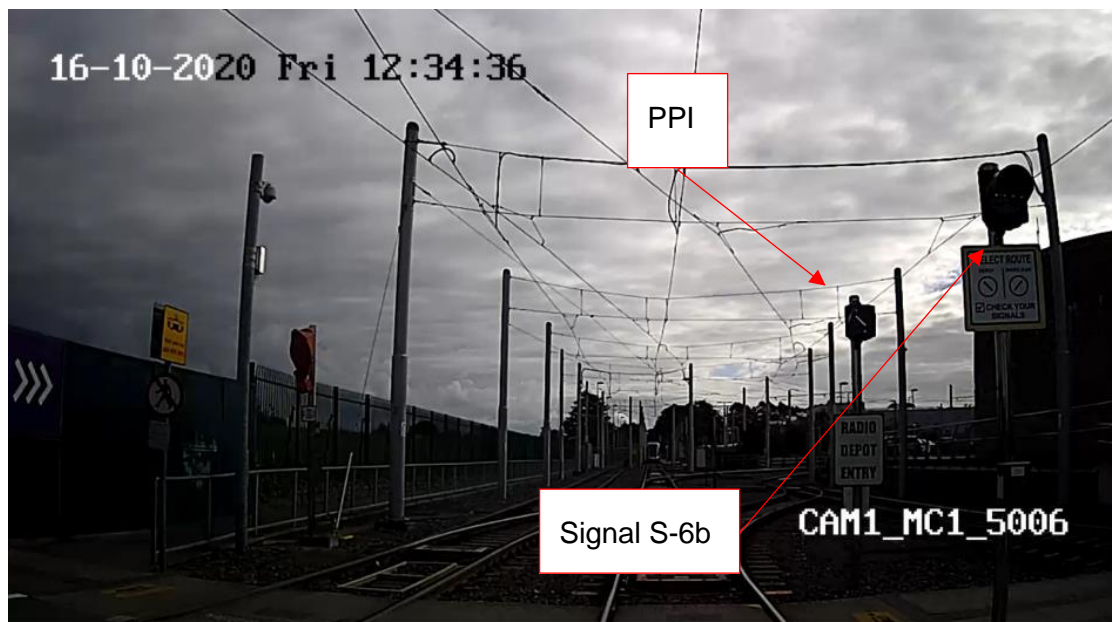
Figure 37 – PPI and Signal S-6b

180 Driver 5006 observed the PPI and not the signal and did not enter an RTS request and proceeded past Signal S-6b displaying a Stop aspect, see Figure 37.

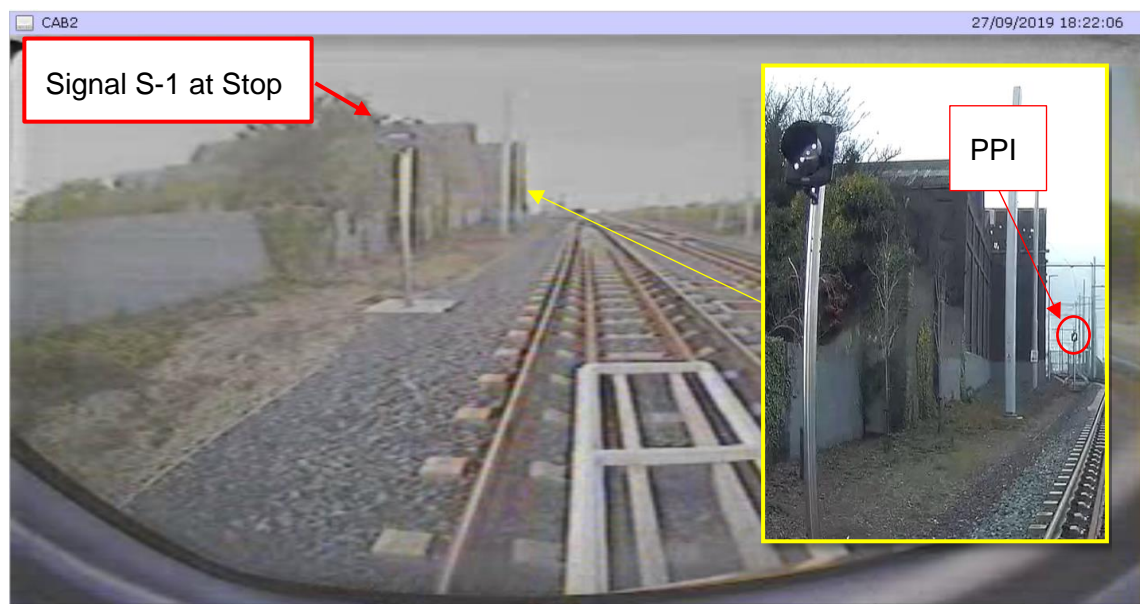
Figure 40 – Signal S-1 at Stop at Broombridge East Gate (Northbound)

196 As a result, Driver 5001 was looking at the PPI at Broombridge Depot (see inset Figure 40) and was not looking at Signal S-1 and passed it displaying a “Stop” aspect; he had an incorrect expectation that Signal S-1 would be displaying a “Proceed” as he normally received a proceed at this signal. Driver 5001 normally approaches Signal S-1 on a “Proceed” aspect. Driver 5001 was unaware that he passed Signal S-1 at Stop, therefore, continued onto Broombridge Stop.
