RAIU: Safety Advice Notice

SAN 001: Suitability of Fixed Buffer Stops

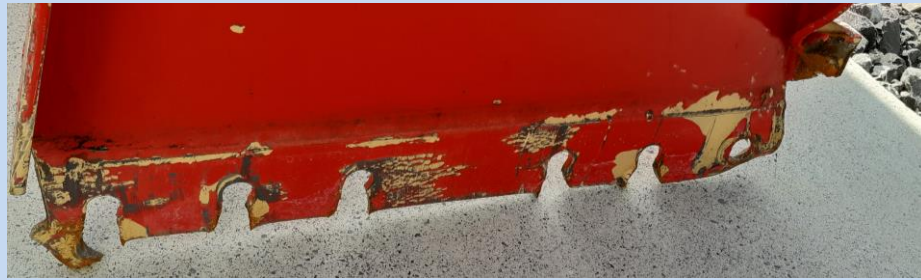
Time & Date	15:06hrs 06/07/19
Organisation	IÉ (IM-CCE & RU-CME)
Occurrence Type	Collision with a fixed buffer stop
Location	Laois Train Care Depot – Pit Road 8
Rolling Stock Type	Inter City Rail 22000, InterCity Railcar set 22216 (ICR 16). Consist 22216 leading, 22816, 22416 & 22316.
Infrastructure Asset Type	Fixed Buffer Stop
Accident Description	<p>While undergoing maintenance intervention on Pit Road 8, LTCD, ICR 16 was moved approximately 8.25 meters under its own power before colliding with a fixed buffer stop.</p> <p>The train rode up on, and moved, the buffer before coming to a stop.</p> <p>There was a CME Craft worker in cab 22216 at the time of the accident. No other persons were in the vicinity of the train at the time of the accident.</p> <p>The train was in a normal state with no bypasses or isolations activated or circuit breakers tripped.</p> <p>The fixed buffer stop was significantly damaged.</p>

Photograph 1 – Image of buffer stop after accident:

SAN Date	02/10/19
SAN Title	Suitability of Fixed Buffer Stops
SAN Number	SAN 001
Issued to	IÉ-IM & and CRR
Implementer	IÉ-IM
System/Equipment	Buffer Stops
Safety Issue Description	The fixed buffer is not suitable in depot locations which are close to staff walkways and structures.
Circumstances	ICR 16 moved unintentionally at slow speed, striking and damaging a friction buffer stop.
Consequences	The safety consequence as a result of the unintentional movement of a rail vehicle at speed would be injuries to staff and potential structural damage.
Reason for Issue	To prevent the possibility of injury to staff and damage to structures.
Safety Recommendations	<p>SAN001-01: IÉ-IM should review the selection of fixed buffer stops at locations at LTCD for their suitability and efficacy in protecting staff and infrastructure.</p> <p>SAN01-02: IÉ-IM should conduct review of their current specification for fixed buffer stops and their associated design forms to ensure they are fit-for-purpose; and fixed buffer stops are only selected where appropriate. Based on this review, IÉ-IM should commence a programme of inspections for fixed buffer stop at all locations on the IÉ network to ensure their suitability and effectiveness at protecting passenger, staff, track and infrastructure.</p>

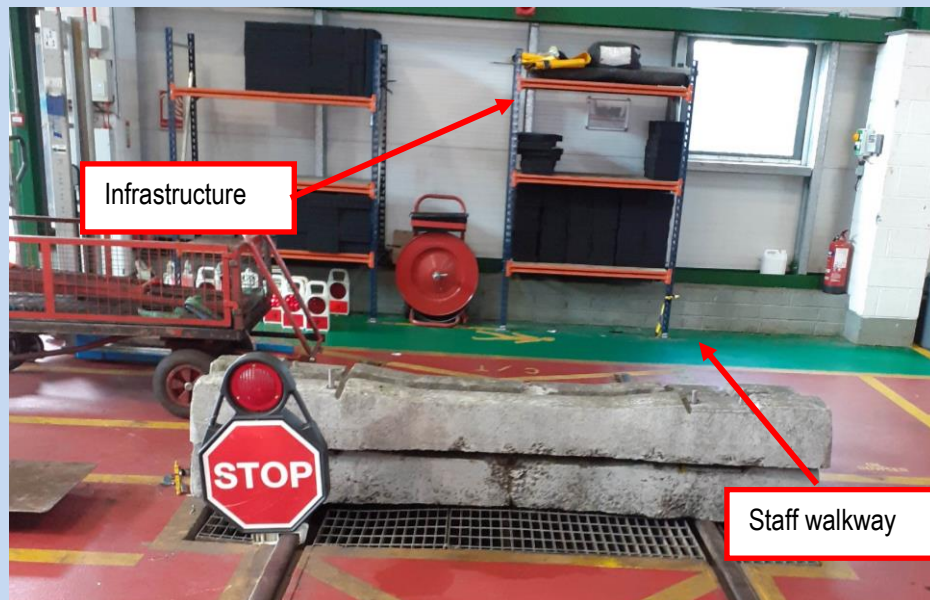
Photograph 2 – Location of buffer stop involved in the accident, now with concrete block

Note: The measurements from the face of the buffer to the inside staff walkway and to the infrastructure wall are 2600 mm and 3900 mm, respectively.

The RAIU conclude that a fixed buffer stop is not suitable at the location where the accident occurred in LTCD, as it does not adequately protect the staff (at its current distance of 2600 mm from walkway) and does not adequately protect the shed infrastructure (at its current distance of 3900 mm from the structure).

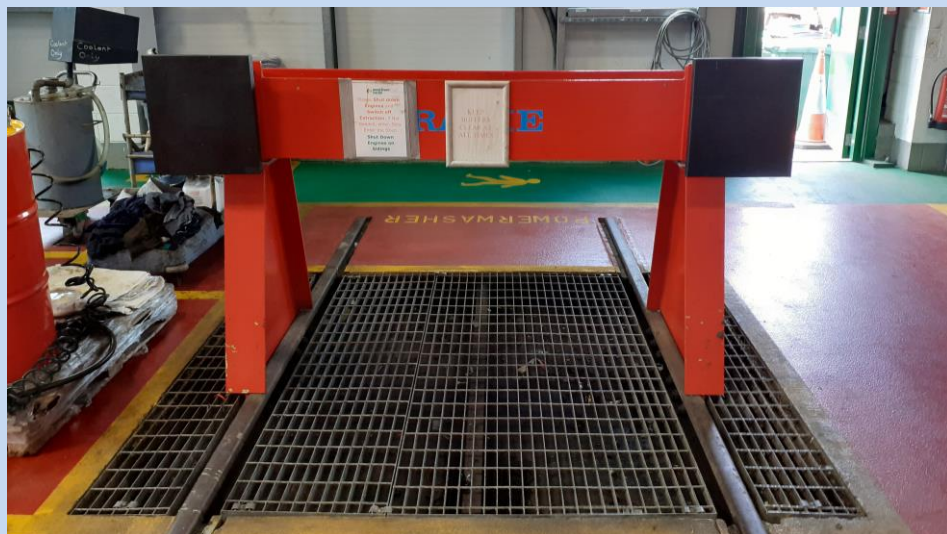
Photograph 3 – Example of fixed buffer stop insitu:

CCE-TMS-386 defines Fixed Buffer Stops as a “A fixed assembly provided at the end of a line to stop rail vehicles. It provides no energy absorption”. Paragraph 4.1.5.1 & 4.1.5.2 state that: “A fixed or static buffer stop is not an energy-absorbing device. It is used for track demarcation to show where a track ends and to stop stock accidentally rolling off the end of the rails. A fixed buffer stop cannot be calculated to provide any protection for a specific train weight or speed, due to its lack of energy-absorbing capacity. In the event of a serious
