PART 1 – Occurrence Description

Time & Date	31/01/2025 between 06:45 hours (hrs) and 09:30 hrs
Organisation	Iarnród Éireann Railway Undertaking (IÉ-RU) & IÉ-Infrastructure Manager (IÉ-IM)
Location	Navan Road Parkway
Parties	<p>Other parties involved, directly and indirectly, were:</p> <ul style="list-style-type: none"> • Passengers alighting onto Platform 2, many were secondary school students; • Patrol Driver – Private contractor personnel engaged to open and close and patrol unmanned stations; • Transport for Ireland (TFI) – Reported the incident to IÉ; • Lift Operators – Private contractor personnel located in the security room at Howth Junction Control Centre (HJCC) who operate the lifts.
Incident Synopsis	<p>During the opening of the Navan Road Parkway Station, the platform access gate onto/from Platform 2 to the concourse was closed and locked, preventing passengers leaving Platform 2.</p> <p>Five trains arrived at Navan Road Parkway Station, with numerous secondary school students, alighting, from trains, onto Platform 2.</p> <p>With no other means to leave or access Platform 2, at least thirty-three persons (nine separate instances) subsequently crossed the running lines t

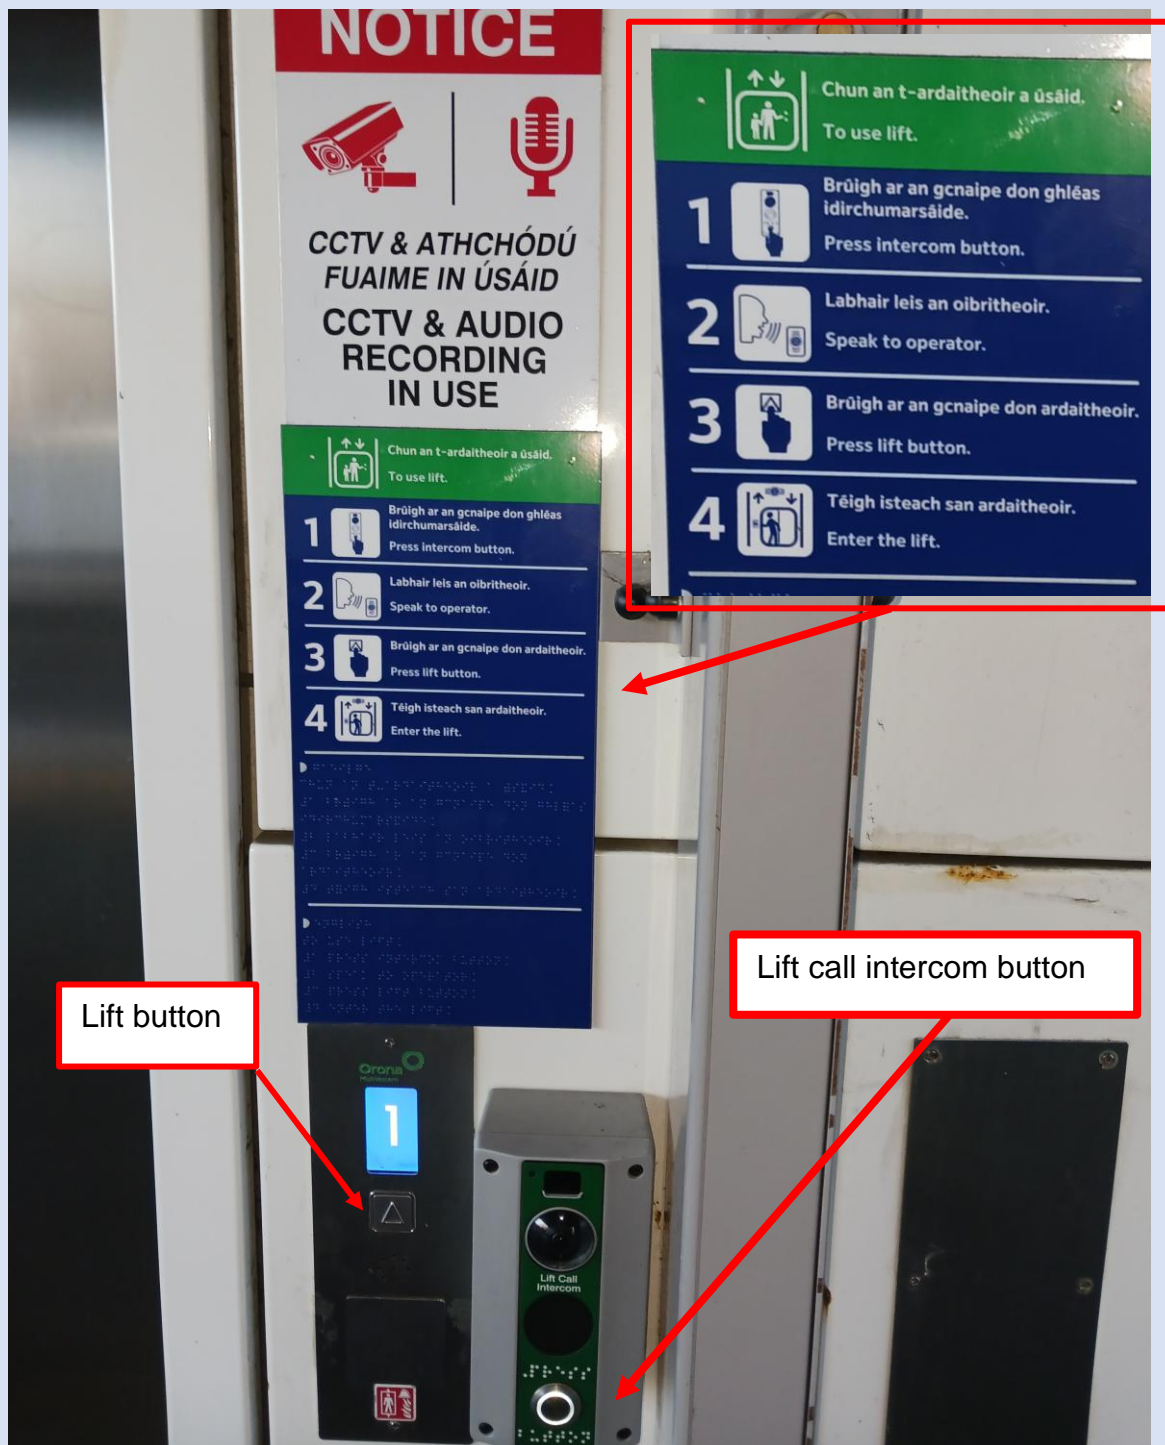
Figure 2 – Lift call intercom and signage

The lifts at Navan Road Parkway use the “Lift Call Operation” system and operate only after a Lift Operator has granted a request by a passenger through the intercom. The instructions on the panel read: To use the lift. 1. Press intercom button 2. Speak to operator 3. Press lift button 4. Enter lift (see Figure 2).

In terms of the two-step process, in that the user must first select the intercom button (first step) followed by the lift button (second step), once approval has been granted by the lift operator, the site visits found that some of the calls were long as a result of the user being unable to understand the second step of the process i.e. to press a separate button once again after speaking to the lift operator. Examples of this misunderstanding ranged from users being unable to find the lift button, re-pressing the intercom button, pressing the camera, pressing the speaker, or taking no further action after speaking to the lift operator.

The report found that, for users with hearing impairment and without hearing aids, the current two-step process impedes their use as they cannot receive any instruction by the lift operator.

The lifts on the IE Network require users to press an intercom and the lift button, making it a “two-step” process. The IE Human Factors Department, previously identified customer issues with this process, ranging from users being unable to locate the relevant buttons for the sequence, pressing the wrong buttons or camera instead of the intercom button or not taking any further actions after speaking with the lift operator. The RAIU also found similar issues while observing customers at lifts. The IE Human Factors Department identified that a transition to a one-step process would reduce the time taken to complete each call, reduce the workload of the lift operator, and improve usability for the end users.

IÉ-RU should review the current two-step process for lift call operation to determine whether it is feasible to move to a one-step lift call operation process, on all lifts. Where this is not possible, the Human Factors Department should carry out another review of the lift-call intercom system, with a view to making improvements in terms of the customer experience.

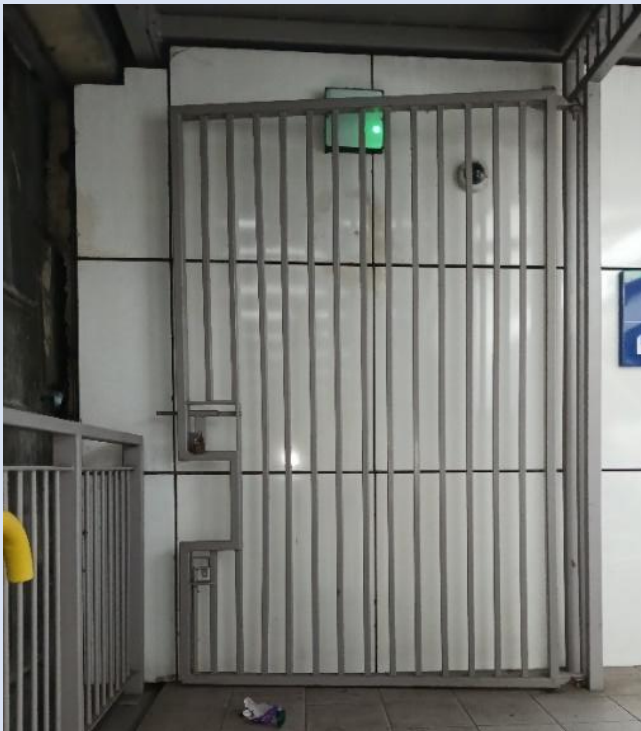
Figure 3 – Gate on stairway

A full height security gates preventing access to the concourse is located on each platform stairwell (see Figure 3). There is no signage on this gate.

05:36 hrs: During the unlocking of Navan Road Parkway Station, for start of service, the Patrol Driver locked the staircase security gate to Platform 2.

<p>SAN Safety Recommendation 8</p>	<p>The Patrol Driver locked the gates, leaving no instructions at the gate for the customers when they arrived at the gates, as a result, the RAIU make the following safety recommendation:</p> <p>IÉ-RU should consider whether instructional signage is warranted at locations where passengers may become trapped e.g. on gated stairwells, to include emergency numbers and/or details of alternative routes.</p>

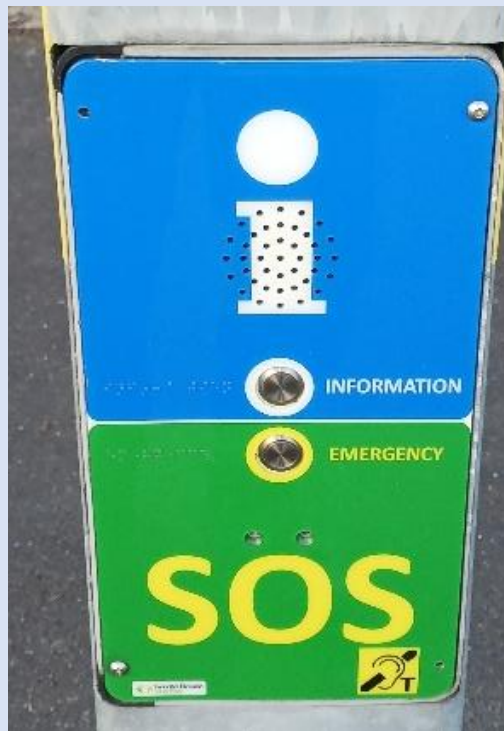
Figure 4 – Help point

There are two help points located on each of the platforms. The help points have both information and emergency buttons and associated signage (i and SOS (Figure 4)) fixed to a square pole and is facing towards the track, there is no signage on the sides of the pole.

The absence of additional signage on the sides makes the help points inconspicuous from the lift and stair locations i.e. the passengers need to be standing in front and close to the signage to see it.

The help points on the platforms are inconspicuous when passengers are at the location of the stairs and lifts (the location where passengers required assistance).

<p>SAN Safety Recommendation 6</p>	<p>It is noted that the Customer Experience (CX) Manager DART, IÉ-RU and the CCE Regional Manager DART, are currently carrying out risk assessment at stations with high history of trespass occurrences to identify and prioritise locations where anti-trespass mats should be installed†.</p> <p>However, while the <u>reported</u> occurrences of trespass at Navan Road Parkway is low, approximately thirty-three children accessed the railway line without IÉ detecting the incident. As a result, the RAIU make the following safety recommendation:</p> <p>IÉ-IM, in conjunction with IÉ-RU should expand its risk assessment process in terms of prioritising the locations where anti-trespass mats should be fitted, to also consider whether anti-trespass mats should be installed at stations that are in close proximity to schools.</p>
<p>SAN Safety Recommendation 7</p>	<p>The help points on the platforms are inconspicuous to some passengers as the signage was facing directly towards the railway. In relation to this incident, they were inconspicuous to the passengers needing assistance at the lifts and staircase. While noting, that new SOS signage is being trialled, the RAIU consider that a safety recommendation is warranted, to ensure the trialling is progress, as a result the RAIU make the following safety recommendation:</p> <p>IÉ-RU should review and improve its current signage for help points, with a view to improving the visibility of these help points at passenger locations along the platform.</p>

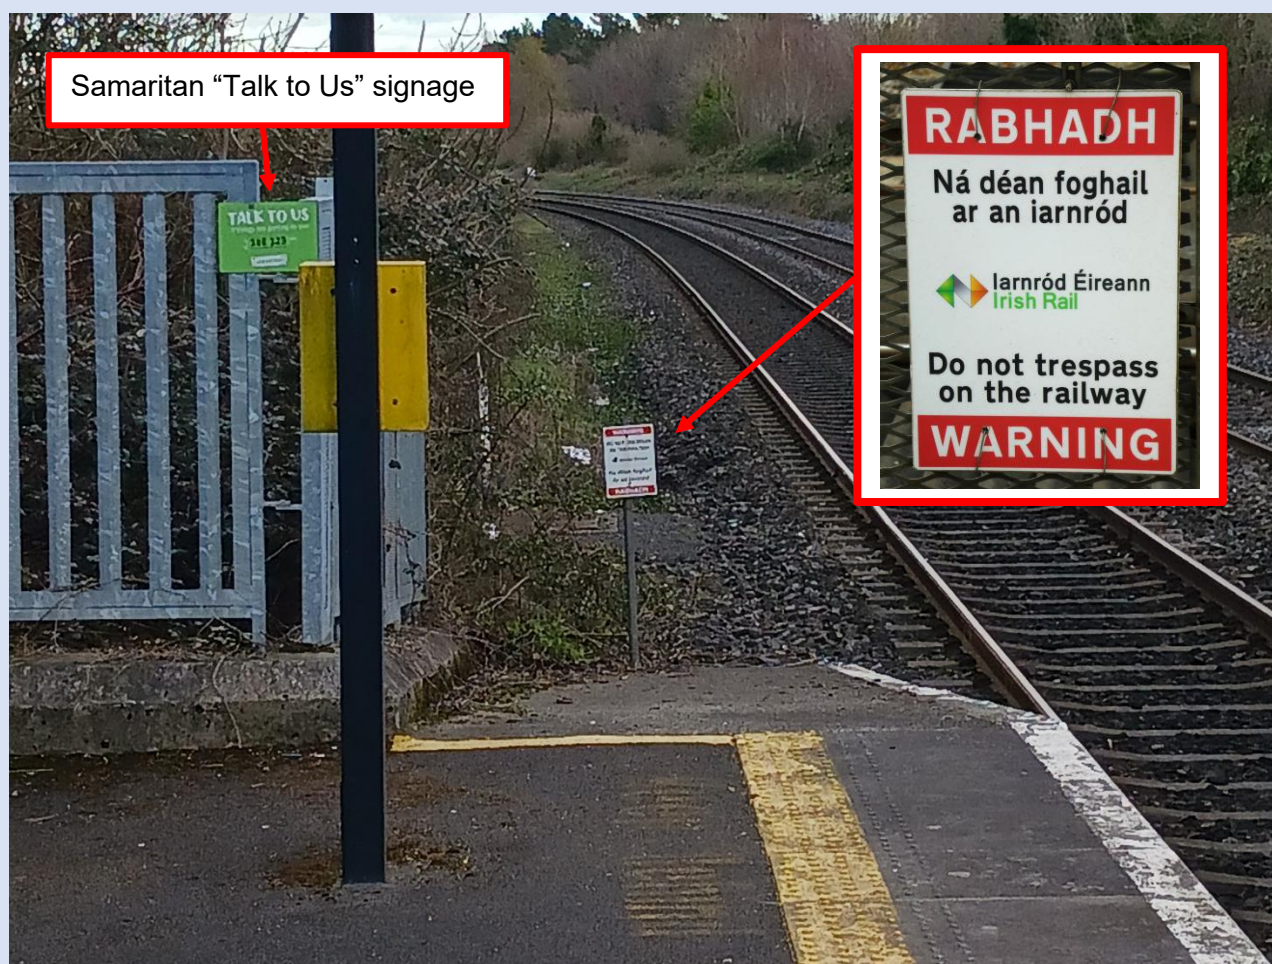
Figure 5 – Platform ramps and associated signage

There are platform ramps at the ends of each platform to facilitate access onto the railway for IÉ track workers. The ramps are not gated and there are no anti-trespass mats (also informally known as witches' hats) present.

The signage present at the ramps are the “rabhadh”, “warning” signs, which state “Do not trespass on the railway” (see Figure 5).

The signage and infrastructure at the platform ramps did not deter students alighting onto the railway lines.

The infrastructure at the end of the platforms was ineffective at deterring passengers from accessing the railway line, as a result, the RAIU make the following safety recommendation:

IE-IM Chief Civil Engineer (CCE) should review current signage located at the platform ramps, with a view to having the signage clearly portray the hazard (i.e. the passenger is accessing a live railway line) and indicates the severity of not adhering to the warning (i.e. possible collision with a train)*.

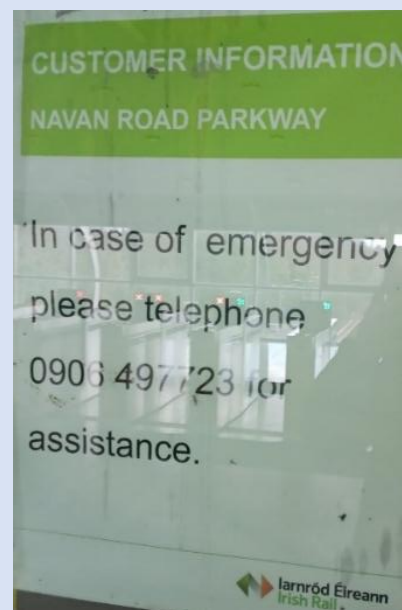
Figure 6 – Kiosk signage

In relation to other signage, at the time of the accident, there was a sign present in the window of the ticket kiosk which stated “Customer Information Navan Road Parkway In case of emergency please telephone 090 649 7723 for assistance”, see Figure 6.

The RAIU phoned this number several times, with no answer. IÉ could not determine, post incident, whether anyone phoned this number on the day of the incident. There are no other numbers displayed at the station.

There was no staff in the room where the emergency number at the ticket kiosk was diverted.

When the emergency phone number 090 649 7723 is dialled, it would bring the caller to the CCTV room at Athlone, however, this room is currently unstaffed.

On notification, by the RAIU of the number not being answered, IÉ removed the poster.

All help points are currently managed through the CCTV Room at Mallow. As an interim measure the Telecoms Department have forwarded all calls from the emergency number to the CCTV Control Room at Mallow. A test was carried out to test the diversion and it works as expected. The poster has since been re-installed.

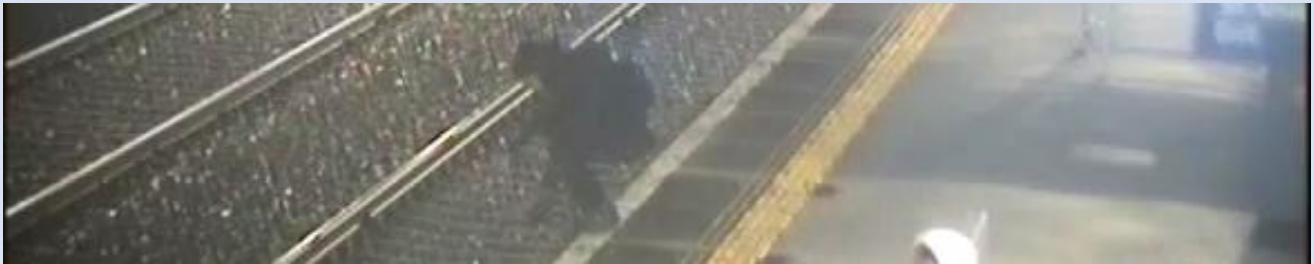
Figure 7 – Passenger alighting onto railway line

06:52 hrs: The adult dressed in black briefly returns to the staircase prior to the arrival of the 06:54 hrs service, before returning to the concourse, using the stairs to Platform 1 and crossing the lines between the platforms to board the service (see Figure 7). The second passenger uses the lift to access Platform 2.

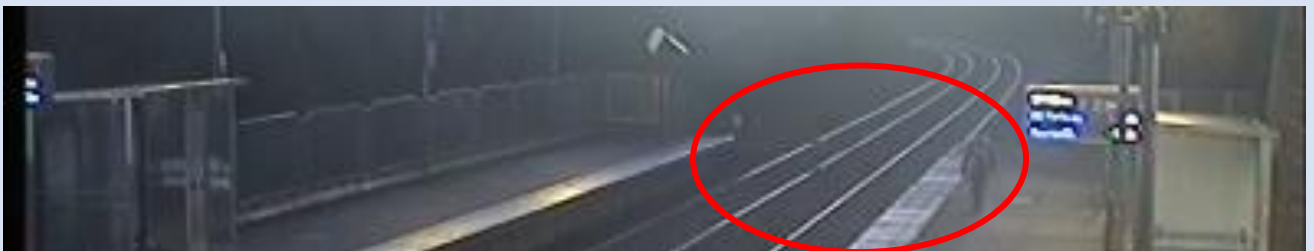
Figure 9 – Passengers walking across the tracks

07:49 hrs: When the next Down train arrives at the station at 07:45 hrs, two passengers alight from the train. They unsuccessfully attempt to leave via the stairs, then then access the railway line at the platform end without attempting to use the lift, see Figure 9.

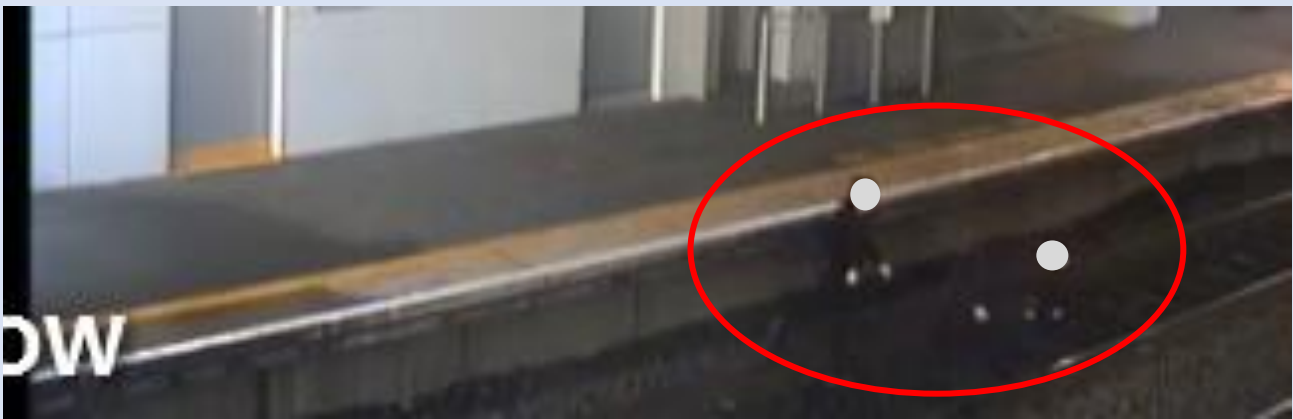
Figure 10 – Two students children cross the railway line

08:08 hrs: Two of the group cross the railway lines between the platforms behind the departing train, see Figure 10 .

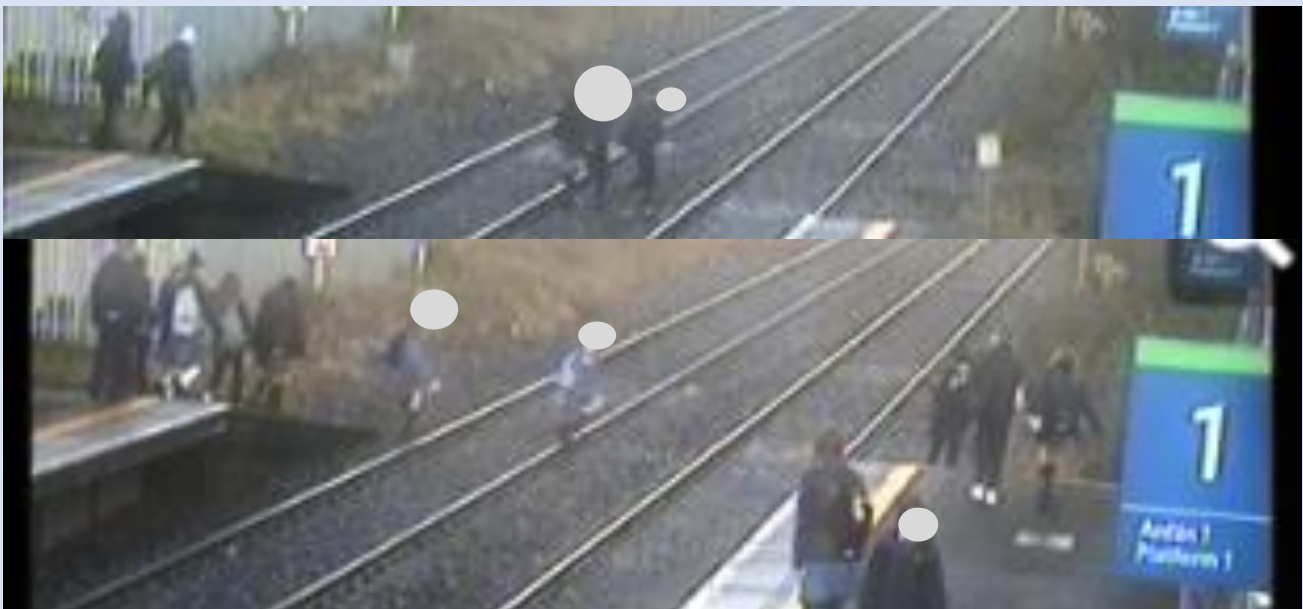
Figure 11 – Mass track access by students

08:13 hrs - 08:15 hrs: Nineteen students cross the running lines at the end of Platform 2 (see Figure 11). The last of this group cross thirty-four seconds before a non-stop Up train passes.

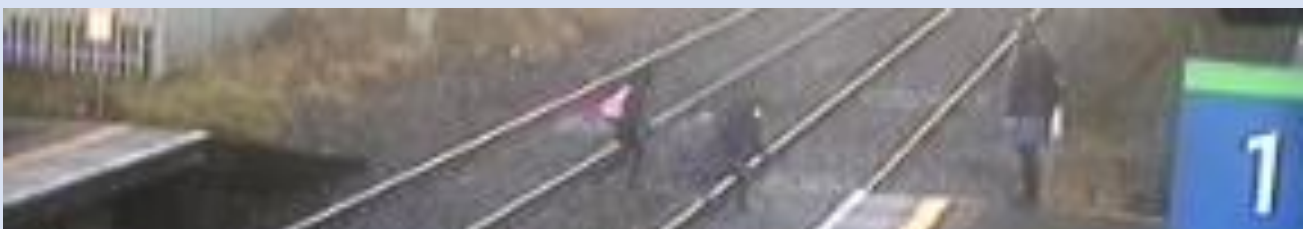
Figure 12 – Three students crossing the railway lines

08:16 hrs: After the passing of a through train a further three students cross the line, see Figure 12.

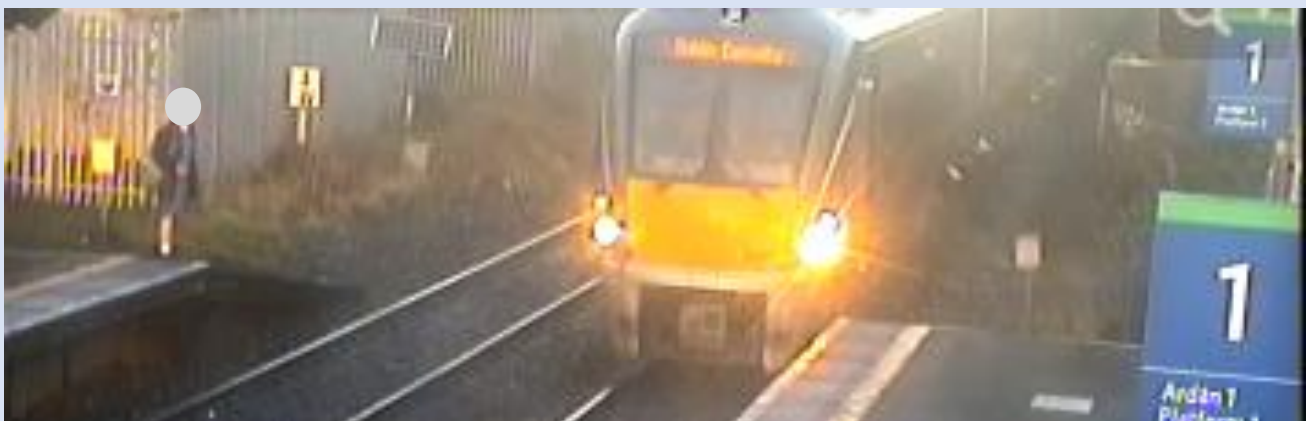
Figure 13 – Train stopped, and staff talk to student

08:32 hrs: A train approaches the station and stops at the platform end where a female student is stood, for approximately thirty seconds. A second person present in the cab speaks to the student (see Figure 13). After the train departs, the female student crosses the lines at the platform end.

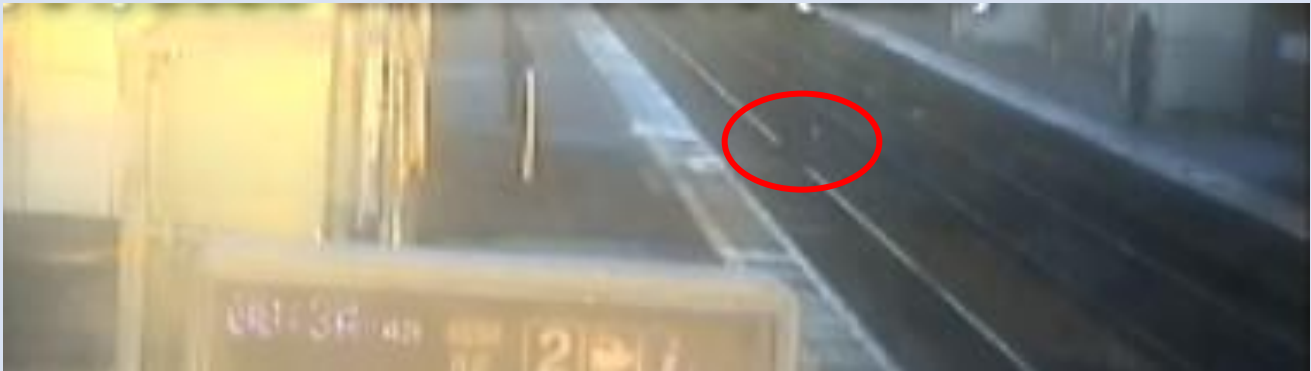
Figure 14 – Student crosses railway lines

08:34 hrs: A student crosses the line between the platforms as the train clears the platform.
