PART 1 – Occurrence Description

Time & Date	31/01/2025 between 06:45 hours (hrs) and 09:30 hrs
Organisation	Iarnród Éireann Railway Undertaking (IÉ-RU) & IÉ-Infrastructure Manager (IÉ-IM)
Location	Navan Road Parkway
Parties	<p>Other parties involved, directly and indirectly, were:</p> <ul style="list-style-type: none"> • Passengers alighting onto Platform 2, many were secondary school students; • Patrol Driver – Private contractor personnel engaged to open and close and patrol unmanned stations; • Transport for Ireland (TFI) – Reported the incident to IÉ; • Lift Operators – Private contractor personnel located in the security room at Howth Junction Control Centre (HJCC) who operate the lifts.
Incident Synopsis	<p>During the opening of the Navan Road Parkway Station, the platform access gate onto/from Platform 2 to the concourse was closed and locked, preventing passengers leaving Platform 2.</p> <p>Five trains arrived at Navan Road Parkway Station, with numerous secondary school students, alighting, from trains, onto Platform 2.</p> <p>With no other means to leave or access Platform 2, at least thirty-three persons (nine separate instances) subsequently crossed the running lines t

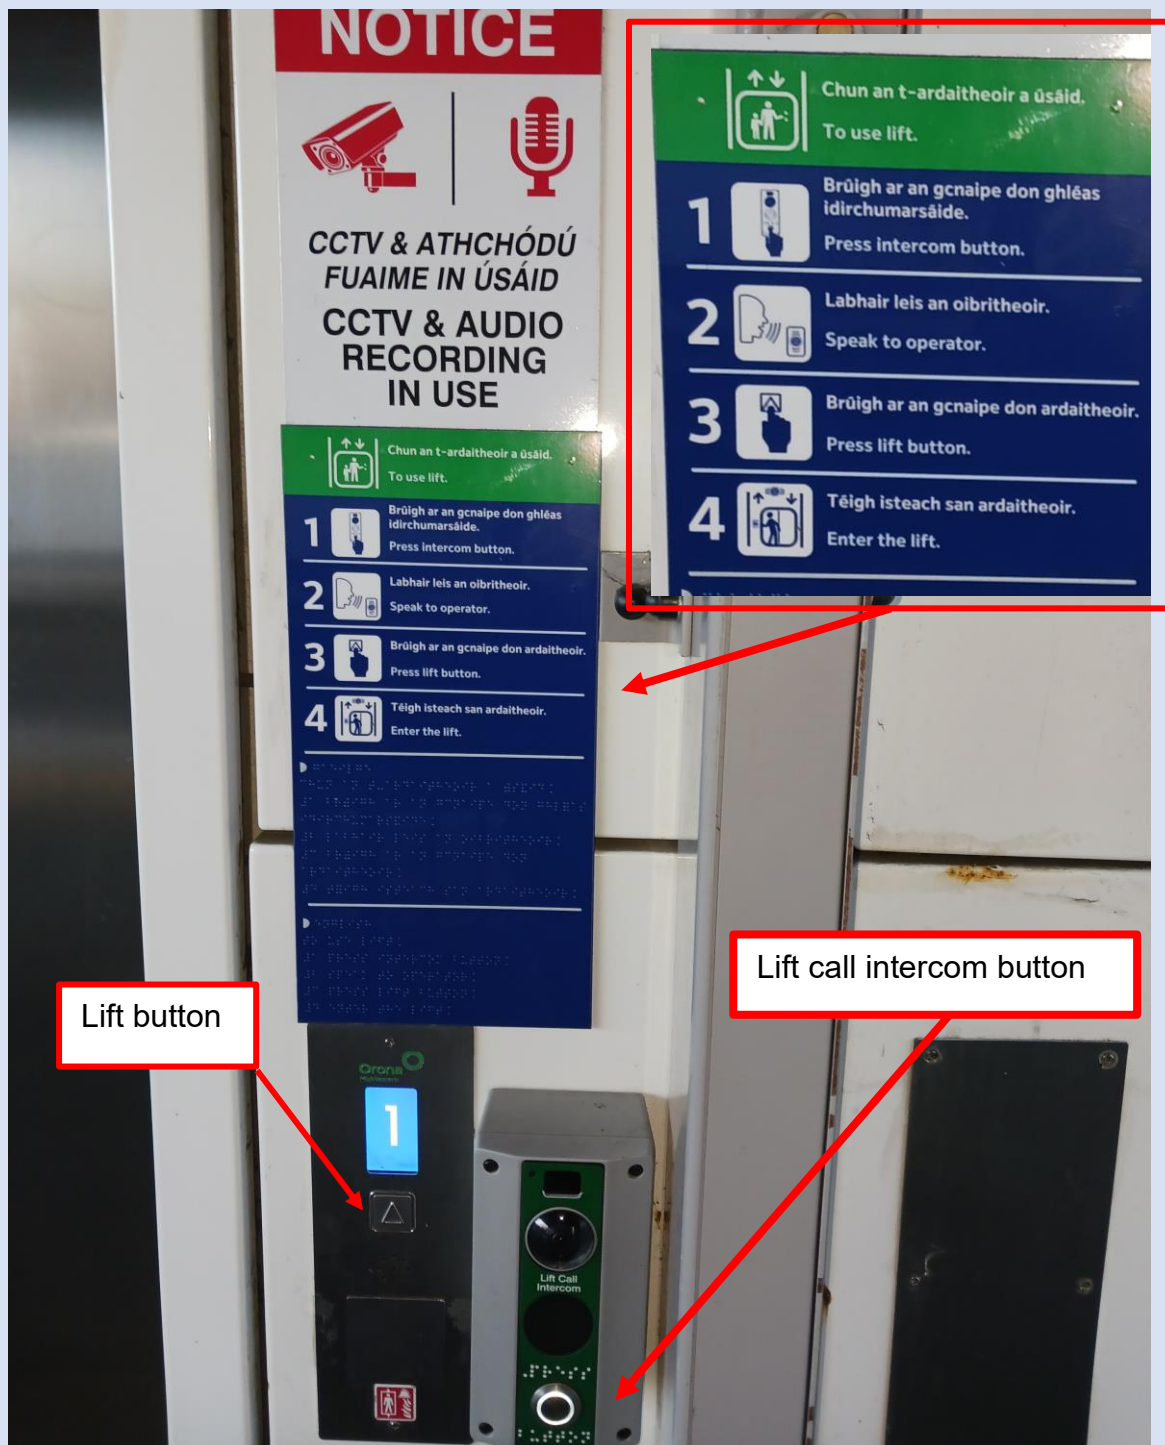
Figure 2 – Lift call intercom and signage

The lifts at Navan Road Parkway use the “Lift Call Operation” system and operate only after a Lift Operator has granted a request by a passenger through the intercom. The instructions on the panel read: To use the lift. 1. Press intercom button 2. Speak to operator 3. Press lift button 4. Enter lift (see Figure 2).

In terms of the two-step process, in that the user must first select the intercom button (first step) followed by the lift button (second step), once approval has been granted by the lift operator, the site visits found that some of the calls were long as a result of the user being unable to understand the second step of the process i.e. to press a separate button once again after speaking to the lift operator. Examples of this misunderstanding ranged from users being unable to find the lift button, re-pressing the intercom button, pressing the camera, pressing the speaker, or taking no further action after speaking to the lift operator.

The report found that, for users with hearing impairment and without hearing aids, the current two-step process impedes their use as they cannot receive any instruction by the lift operator.

IÉ-RU should review the current two-step process for lift call operation to determine whether it is feasible to move to a one-step lift call operation process, on all lifts. Where this is not possible, the Human Factors Department should carry out another review of the lift-call intercom system, with a view to making improvements in terms of the customer experience.

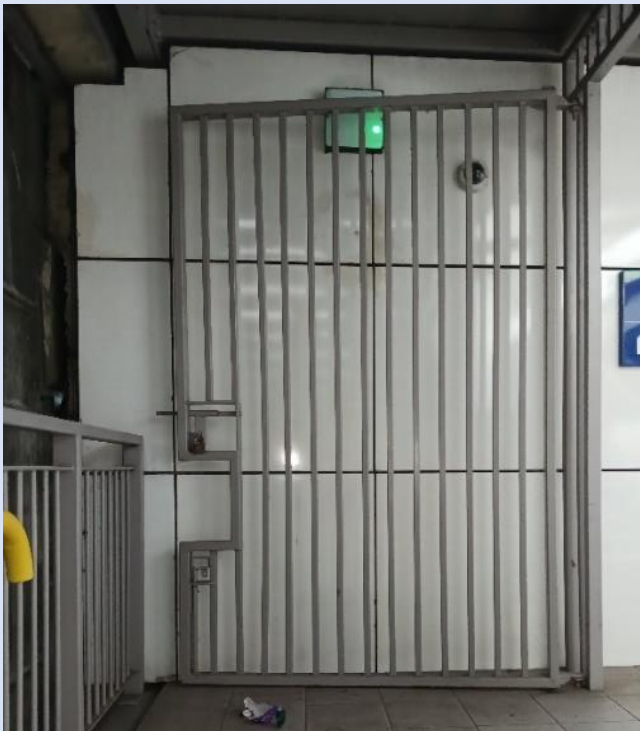
Figure 3 – Gate on stairway

A full height security gates preventing access to the concourse is located on each platform stairwell (see Figure 3). There is no signage on this gate.

SAN Safety Recommendation 8	<p>The Patrol Driver locked the gates, leaving no instructions at the gate for the customers when they arrived at the gates, as a result, the RAIU make the following safety recommendation:</p> <p>IÉ-RU should consider whether instructional signage is warranted at locations where passengers may become trapped e.g. on gated stairwells, to include emergency numbers and/or details of alternative routes.</p>

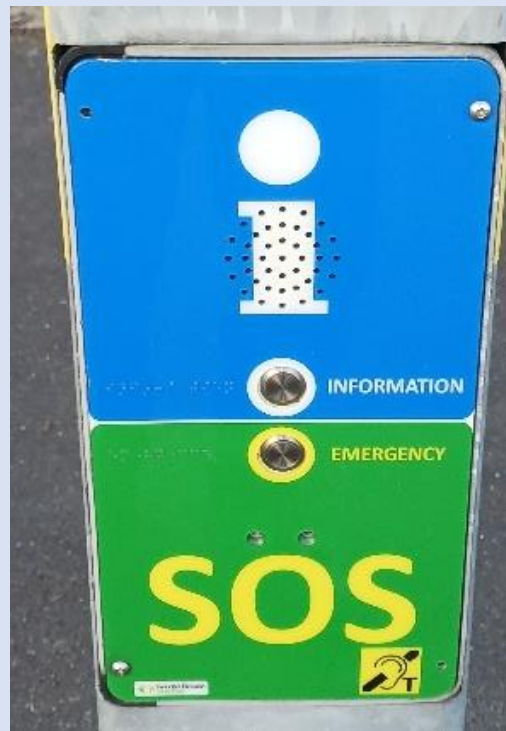
Figure 4 – Help point

There are two help points located on each of the platforms. The help points have both information and emergency buttons and associated signage (i and SOS (Figure 4)) fixed to a square pole and is facing towards the track, there is no signage on the sides of the pole.

The absence of additional signage on the sides makes the help points inconspicuous from the lift and stair locations i.e. the passengers need to be standing in front and close to the signage to see it.

The help points on the platforms are inconspicuous when passengers are at the location of the stairs and lifts (the location where passengers required assistance).

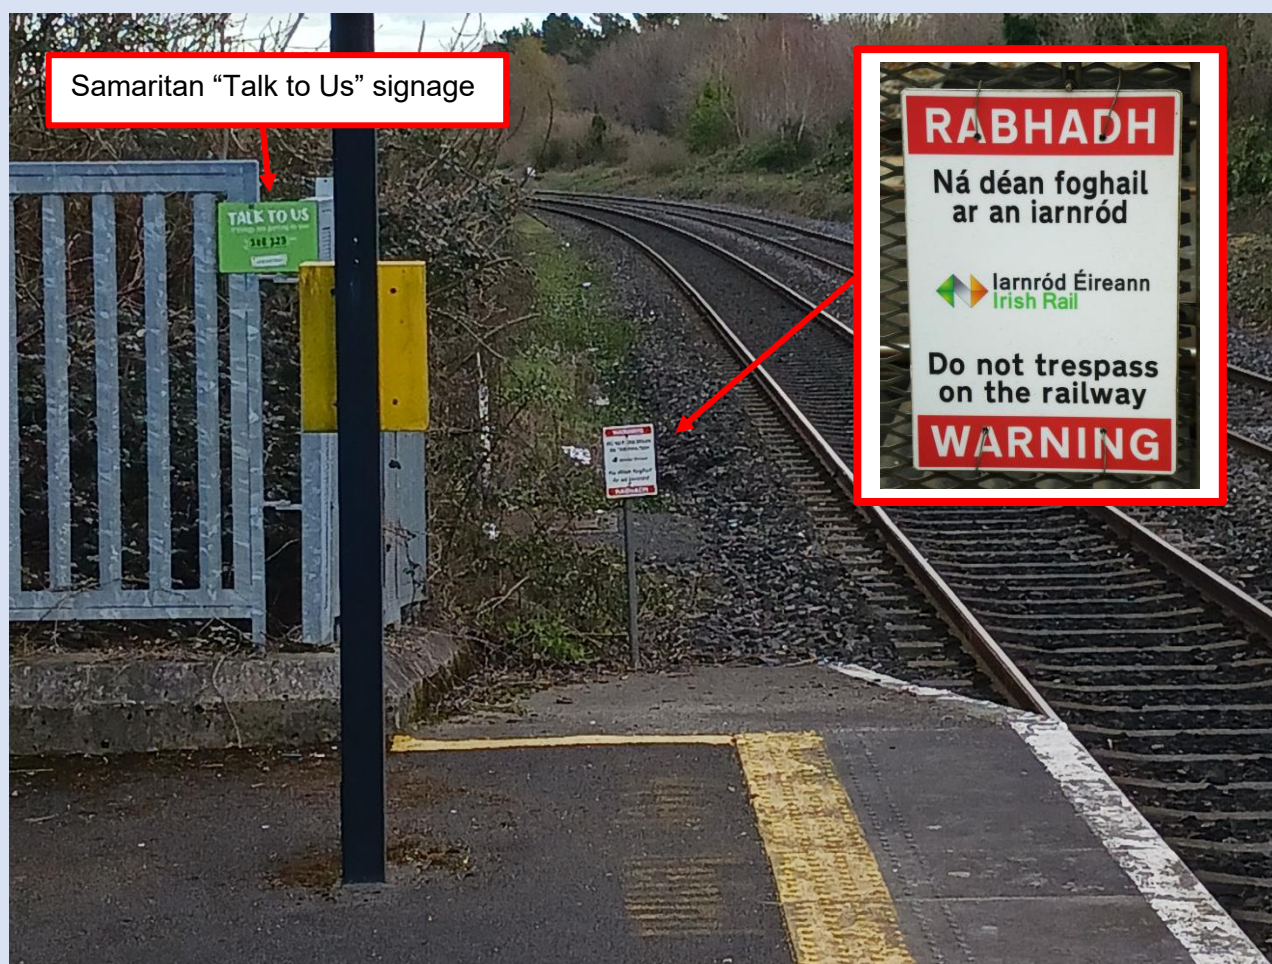
Figure 5 – Platform ramps and associated signage

There are platform ramps at the ends of each platform to facilitate access onto the railway for IÉ track workers. The ramps are not gated and there are no anti-trespass mats (also informally known as witches' hats) present.

The signage present at the ramps are the “rabhadh”, “warning” signs, which state “Do not trespass on the railway” (see Figure 5).

The signage and infrastructure at the platform ramps did not deter students alighting onto the railway lines.

IE-IM Chief Civil Engineer (CCE) should review current signage located at the platform ramps, with a view to having the signage clearly portray the hazard (i.e. the passenger is accessing a live railway line) and indicates the severity of not adhering to the warning (i.e. possible collision with a train)*.

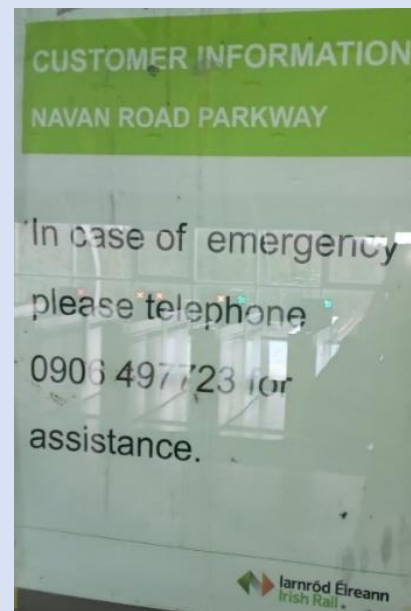
Figure 6 – Kiosk signage

In relation to other signage, at the time of the accident, there was a sign present in the window of the ticket kiosk which stated “Customer Information Navan Road Parkway In case of emergency please telephone 090 649 7723 for assistance”, see Figure 6.

The RAIU phoned this number several times, with no answer. IÉ could not determine, post incident, whether anyone phoned this number on the day of the incident. There are no other numbers displayed at the station.

There was no staff in the room where the emergency number at the ticket kiosk was diverted.

On notification, by the RAIU of the number not being answered, IÉ removed the poster.

All help points are currently managed through the CCTV Room at Mallow. As an interim measure the Telecoms Department have forwarded all calls from the emergency number to the CCTV Control Room at Mallow. A test was carried out to test the diversion and it works as expected. The poster has since been re-installed.

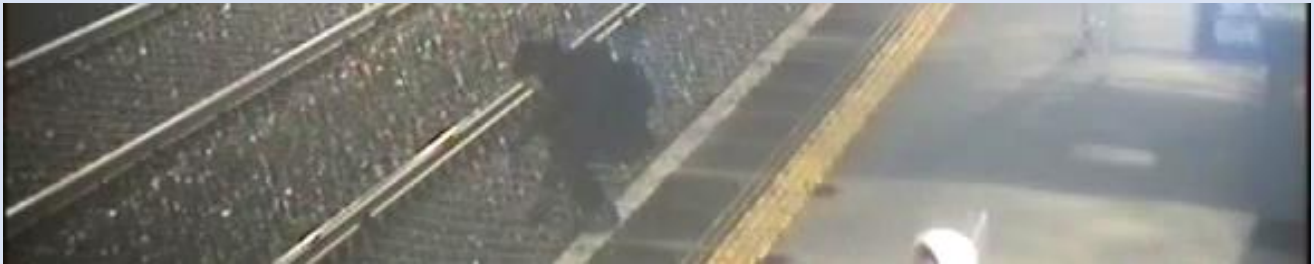
Figure 7 – Passenger alighting onto railway line

06:52 hrs: The adult dressed in black briefly returns to the staircase prior to the arrival of the 06:54 hrs service, before returning to the concourse, using the stairs to Platform 1 and crossing the lines between the platforms to board the service (see Figure 7). The second passenger uses the lift to access Platform 2.

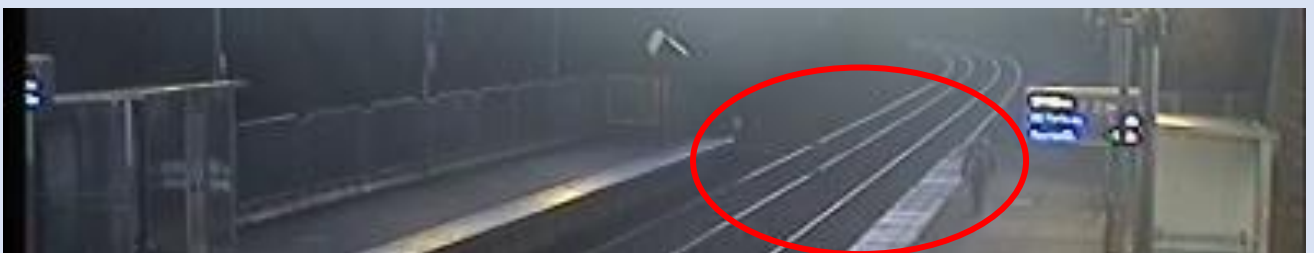
Figure 9 – Passengers walking across the tracks

07:49 hrs: When the next Down train arrives at the station at 07:45 hrs, two passengers alight from the train. They unsuccessfully attempt to leave via the stairs, then then access the railway line at the platform end without attempting to use the lift, see Figure 9.

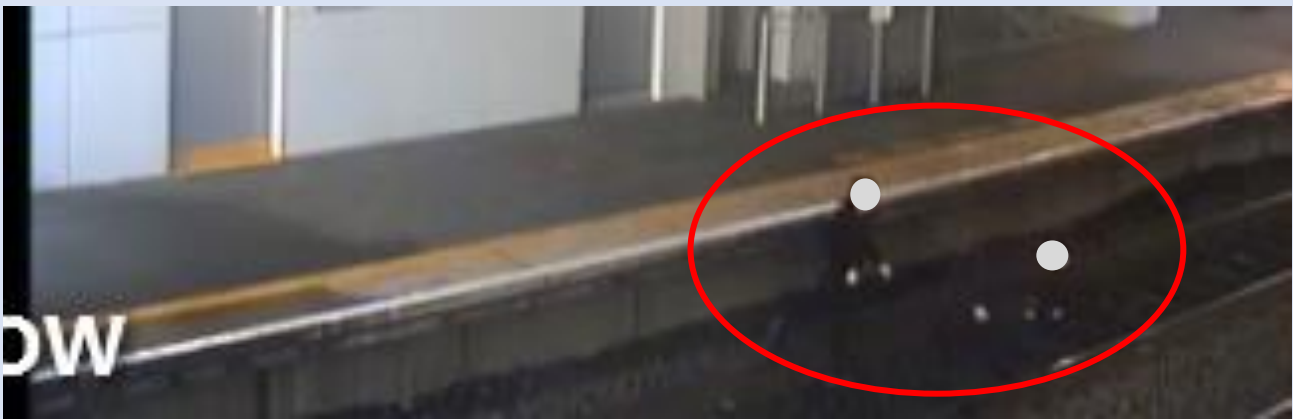
Figure 10 – Two students children cross the railway line

08:08 hrs: Two of the group cross the railway lines between the platforms behind the departing train, see Figure 10 .

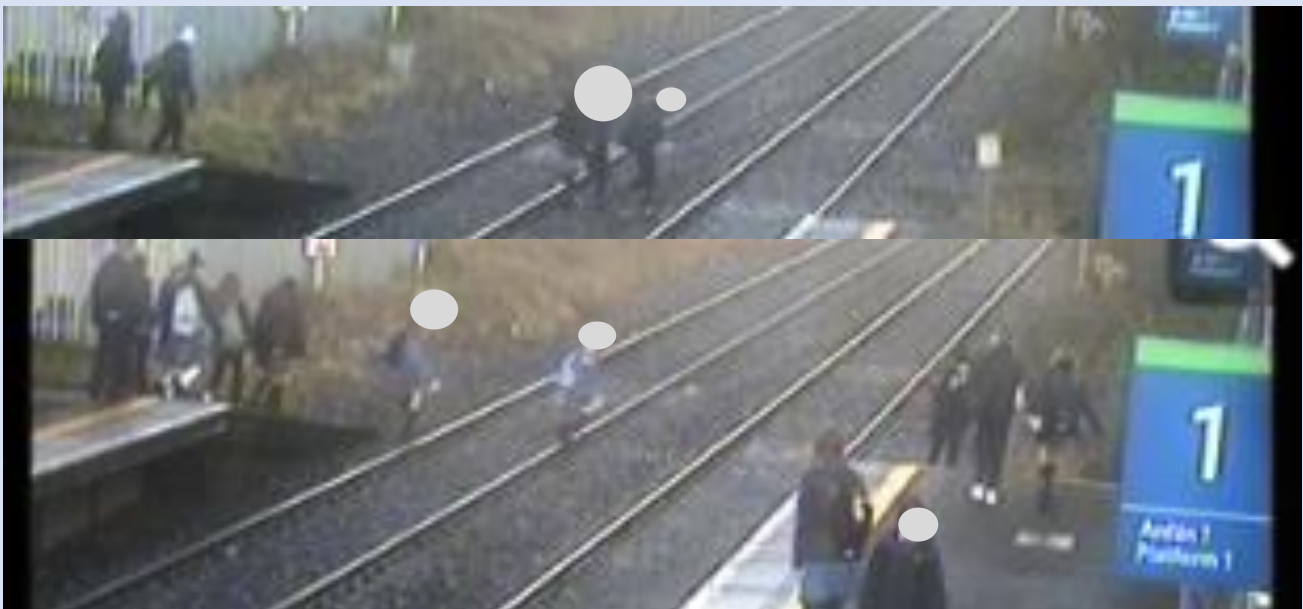
Figure 11 – Mass track access by students

08:13 hrs - 08:15 hrs: Nineteen students cross the running lines at the end of Platform 2 (see Figure 11). The last of this group cross thirty-four seconds before a non-stop Up train passes.

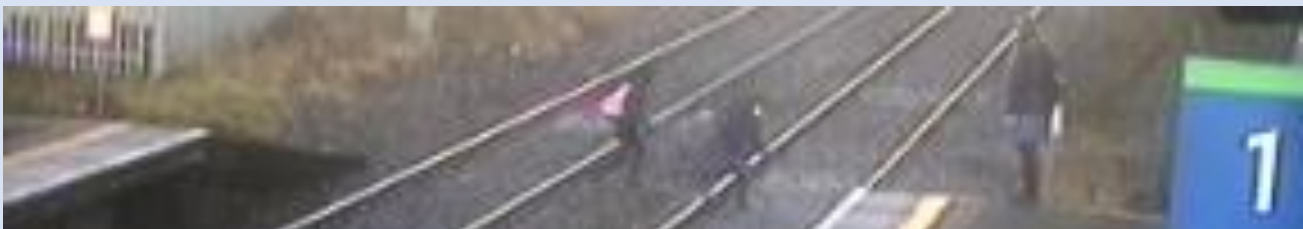
Figure 12 – Three students crossing the railway lines

08:16 hrs: After the passing of a through train a further three students cross the line, see Figure 12.

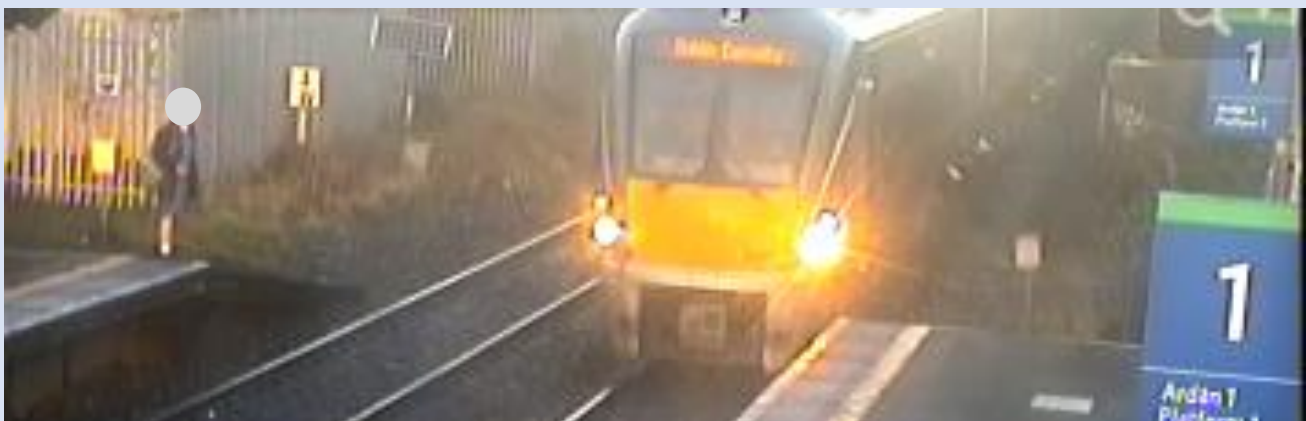
Figure 13 – Train stopped, and staff talk to student

08:32 hrs: A train approaches the station and stops at the platform end where a female student is stood, for approximately thirty seconds. A second person present in the cab speaks to the student (see Figure 13). After the train departs, the female student crosses the lines at the platform end.

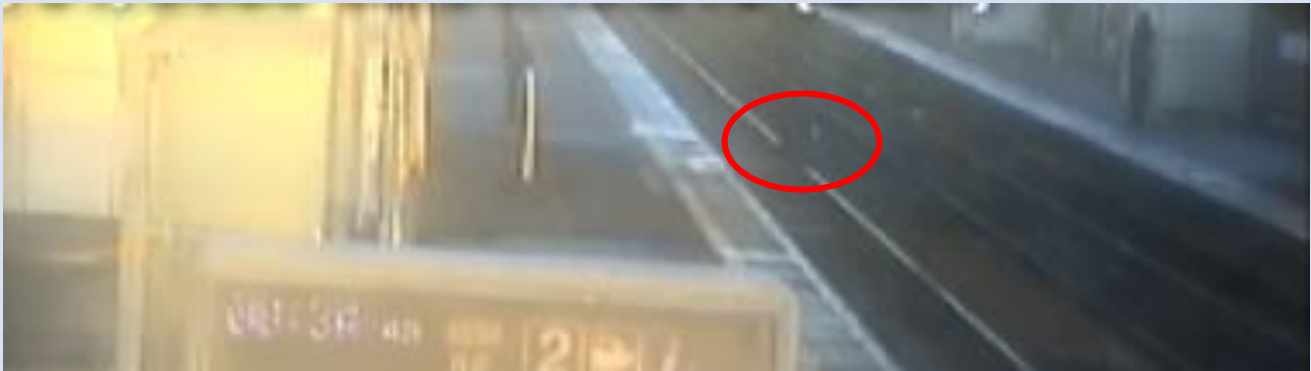
Figure 14 – Student crosses railway lines

08:34 hrs: A student crosses the line between the platforms as the train clears the platform.
