| <b>Synopsis of incidents</b> | <p>The incidents involved in this SAN are related to trap-and-drag incidents where persons or their belongings, were trapped in the tram doors which resulted in them being dragged along the platform, with the trams, when the trams departed.</p> |

| PART 5 – SAN Safety Recommendations | |
|---|---|
| SAN Title | Prevention of trap-and-drag incidents on the Luas network. |
| SAN Number | SAN 003 |

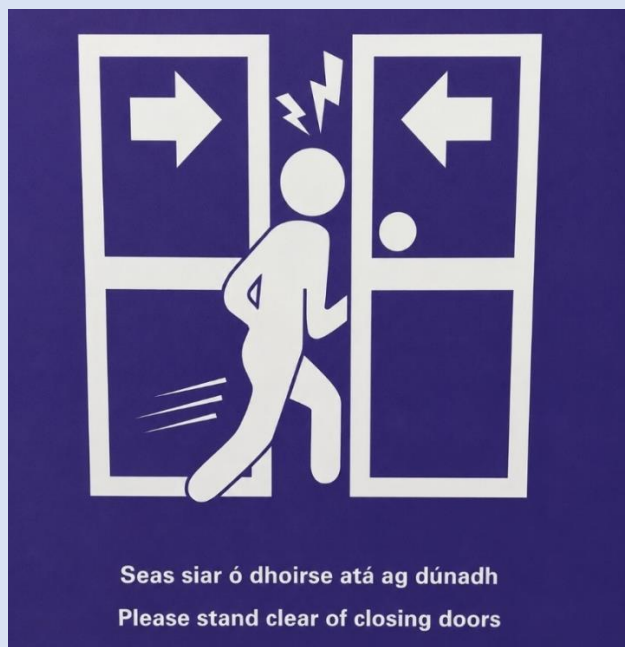
Figure 1 – Information sticker

A study indicated that there is a widespread misunderstanding of how train doors function and that passengers' mental models are incomplete. The information stickers (Figure 1) on trams are not sufficiently effective in clarifying the operation of the doors and informing passengers of the risk associated with the closing doors.

| <b>SAN Safety<br/>Recommendation 2</b> | <p>The intent of this safety recommendation is to change passenger behaviours in terms of late boarding of trams. As a result, the RAIU make the following safety recommendation:</p> <p><b>The Tram Operator, in conjunction with TII, should add warning stickers (such as “shark’s teeth” decalcomania) to the tram doors, to make the risks associated with closing train doors more visible to passengers.</b></p> |
| <b>SAN Safety<br/>Recommendation 3</b> | <p>The intent of this safety recommendation is to change passenger behaviours in relation to late boarding of trams and improve passengers’ understanding of how the doors operate. As a result, the RAIU make the following safety recommendation:</p> <p><b>The Tram Operator, in conjunction with TII, should develop a safety education campaign, to educate passengers on the operation of the doors and illustrate the risks associated with closing doors.</b></p> |

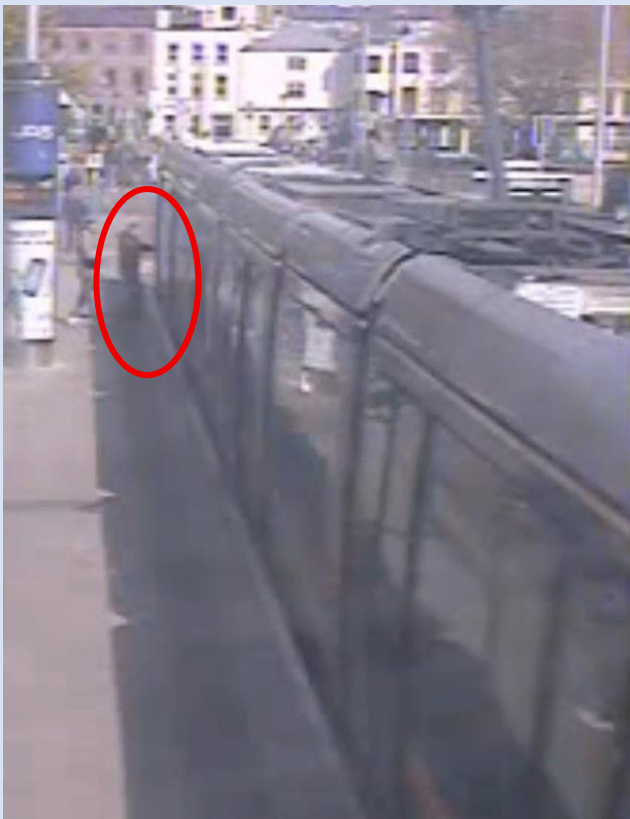
Tram 3026 was at Heuston Stop, awaiting departure. As the driver (Driver 3026) initiated the door closing sequence, the doors began to close, and a passenger put his finger between the doors, with the tram doors closing on his fingertip, trapping it, see Figure 2. The fingertip would have been less than the 10 mm and therefore not detected.

Figure 2 – Passenger placing finger in between doors

TDLR fleet maintenance inspected the tram door following the incident and confirmed the door failed the obstacle detection test; this has now been corrected with a full door setup.

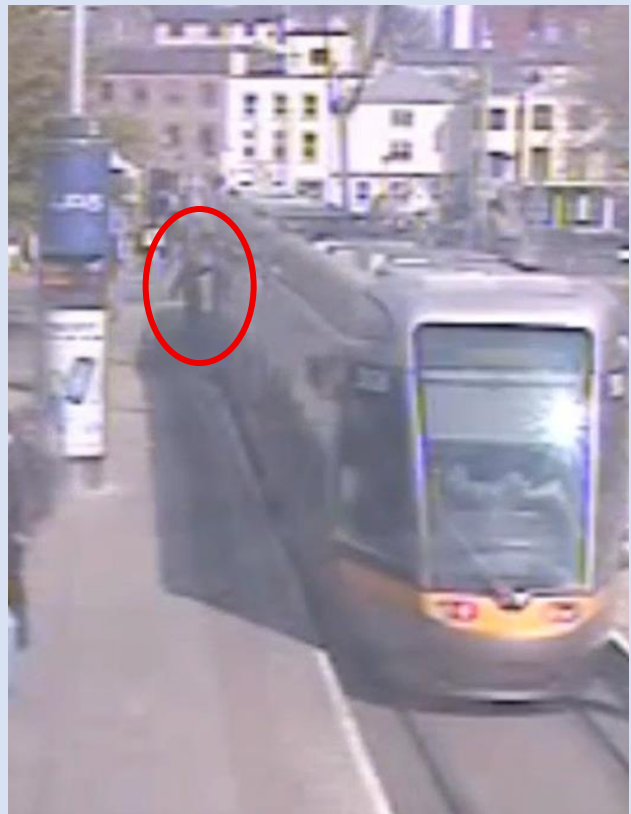
Figure 3 – Passenger running with the tram

Tram 3026 departed, with Driver 3026 unaware of the passenger being trapped. The person ran alongside the tram before Driver 3026 became aware of the commotion on the tram and stopped the tram. A passenger onboard pushed the trapped passenger's finger out from inside the tram.

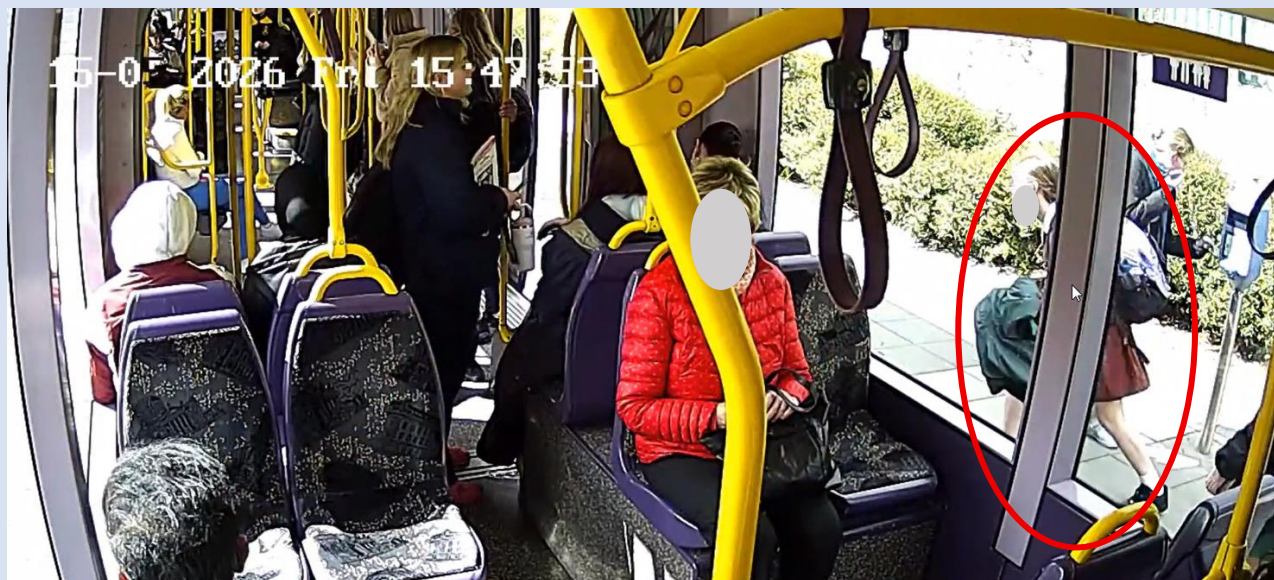
Tram 5011 was at Stillorgan Stop, awaiting departure. As the driver (Driver 5011) initiated the door closing sequence, the doors began to close, and a passenger ran towards the doors, see Figure 4.

Figure 4 – Teenager approaching tram doors

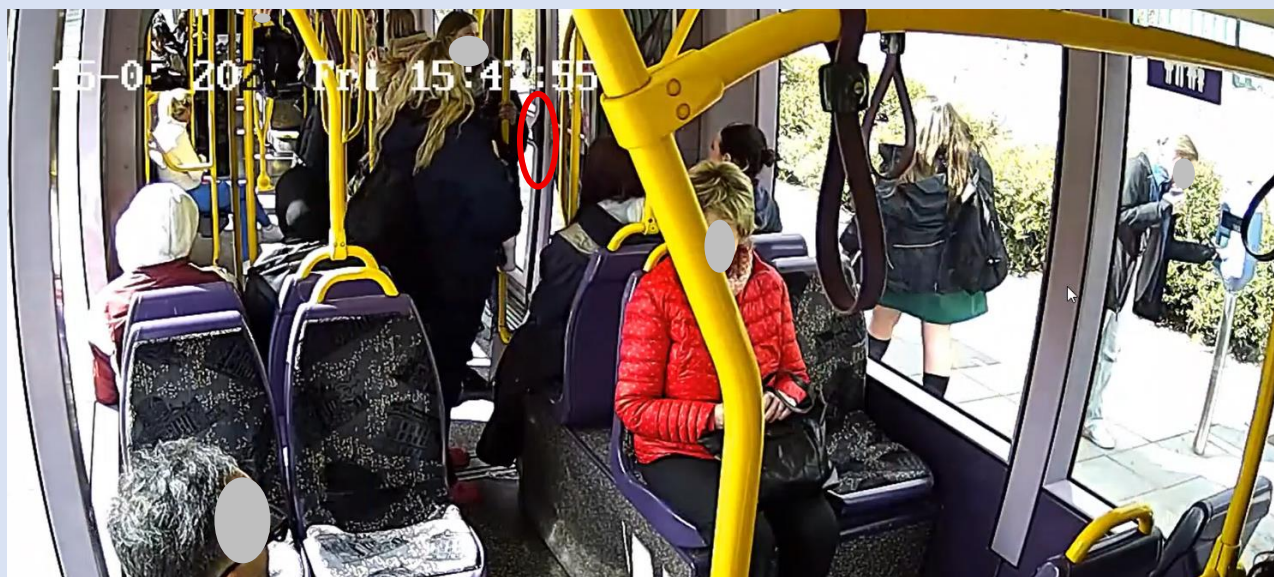
The passenger put their coat in between the doors. The tram doors closed as normal trapping the coat, see Figure 5, the coat would have been less than the 10 mm and therefore not detected.

Figure 5 – Coat trapped in doors

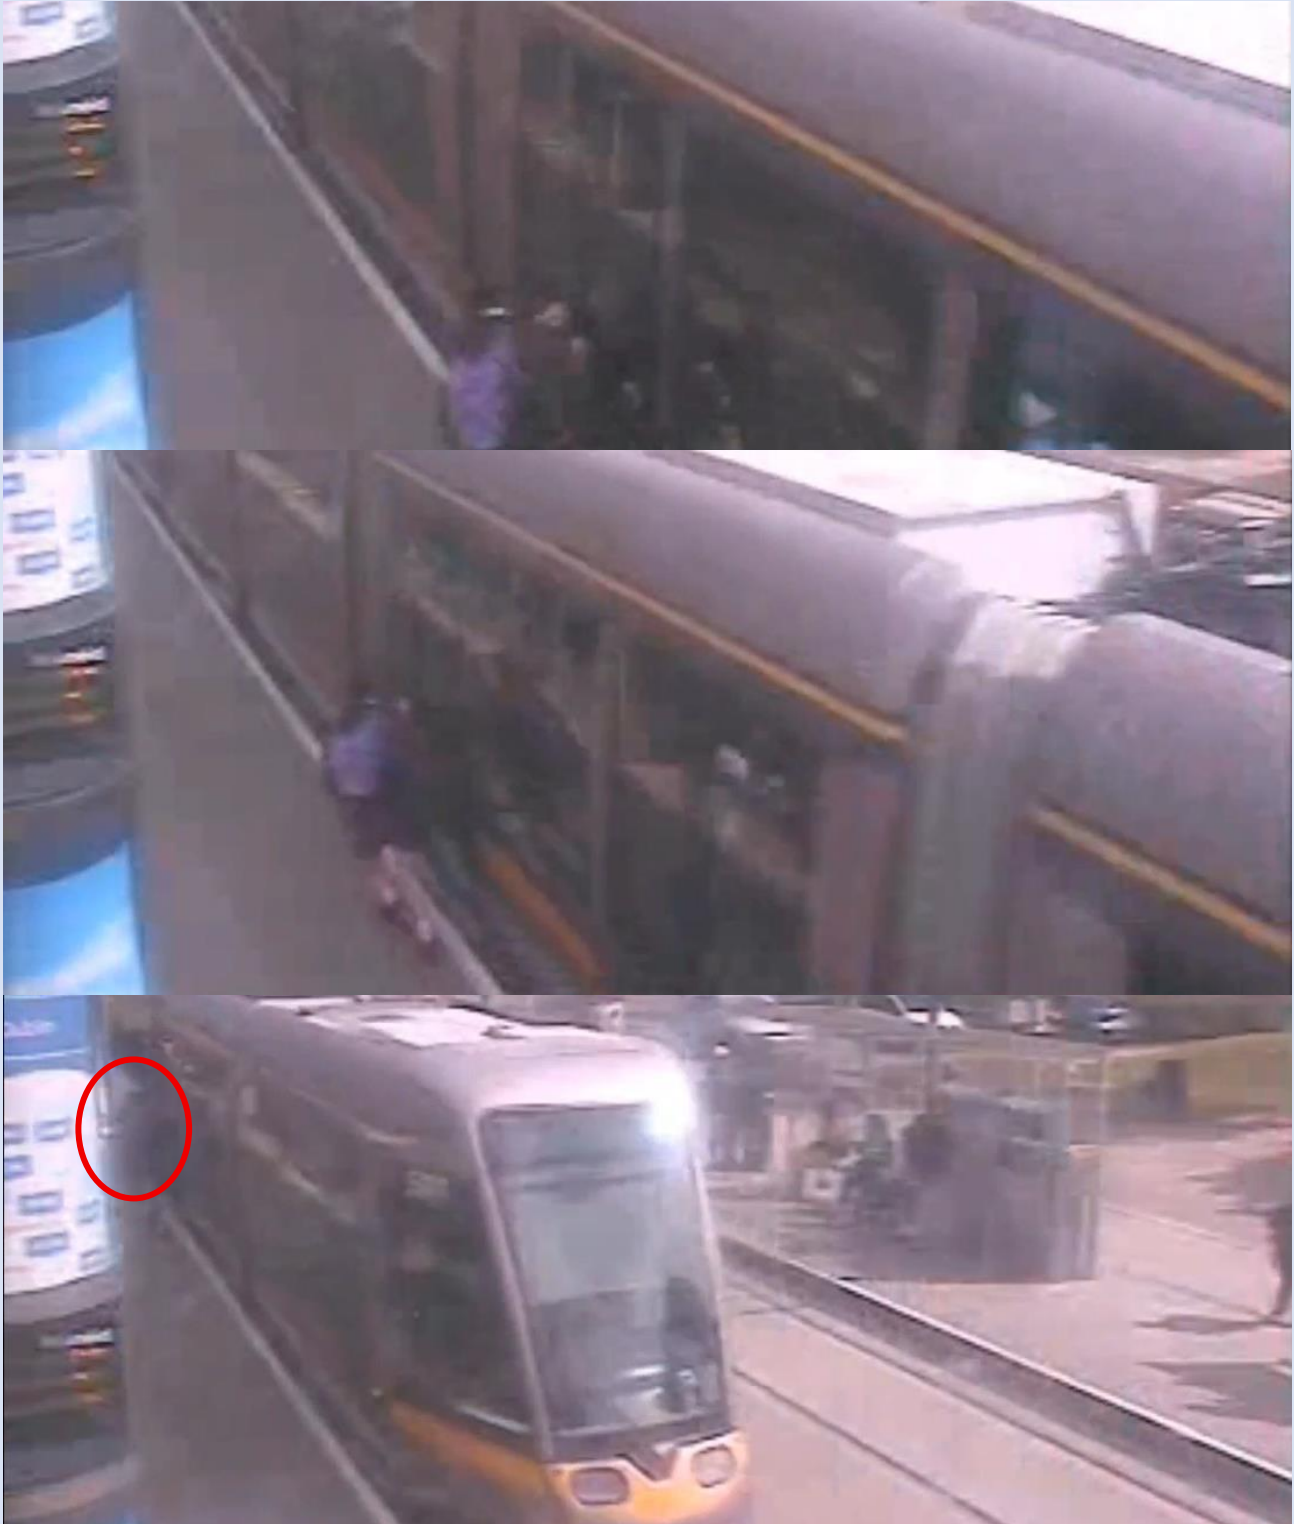
Driver 5011 departed, unaware of the coat being trapped. The passenger attempted to dislodge their coat from the door and ran parallel to the departing tram, see Figure 6, before releasing the coat at the end of the platform and falling (out of view of the CCTV). Driver 5011 remained unaware of the incident.

Figure 6 – Teenager running along the platform

Customers on the platform assisted the teenager and contacted the emergency services and the teenager was removed to hospital by ambulance. The teenager's parents reported the incident to TDLR, stating that she sustained deep lacerations to her face as well as grazing to her knee and hands.

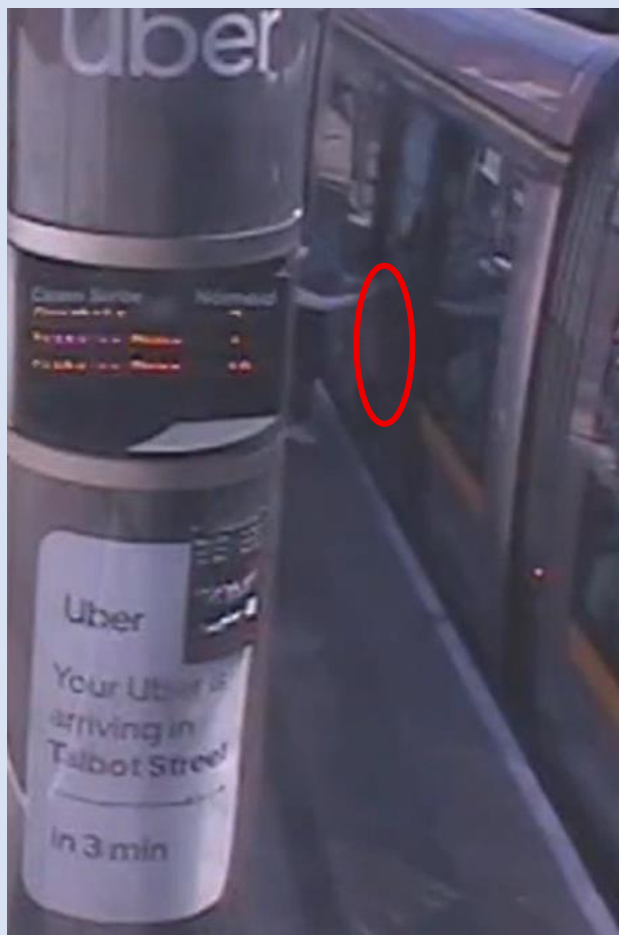
Tram 3014 was at Bus Áras Stop, awaiting departure. As the driver (Driver 3014) initiated the door closing sequence, the doors began to close, and two passengers ran to the doors and put a bag between the doors, with the tram doors closing on the bag, trapping it, see Figure 7. The bag would have been less than the 10 mm and therefore not detected.

Figure 7 – Bag put in between closing doors

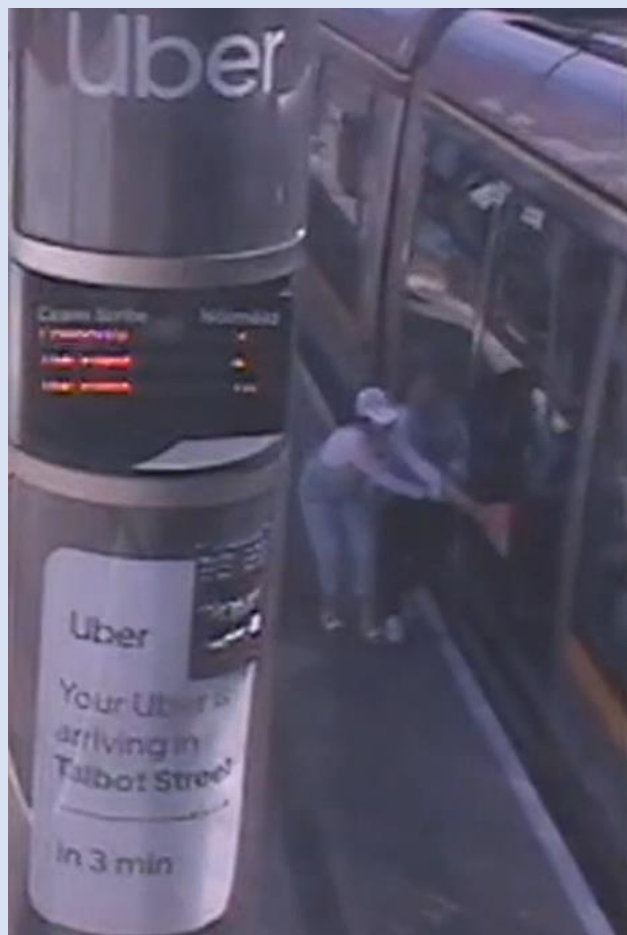
Figure 8 – Females running with the bag

The passengers held onto the bag and ran alongside the tram, see Figure 8.

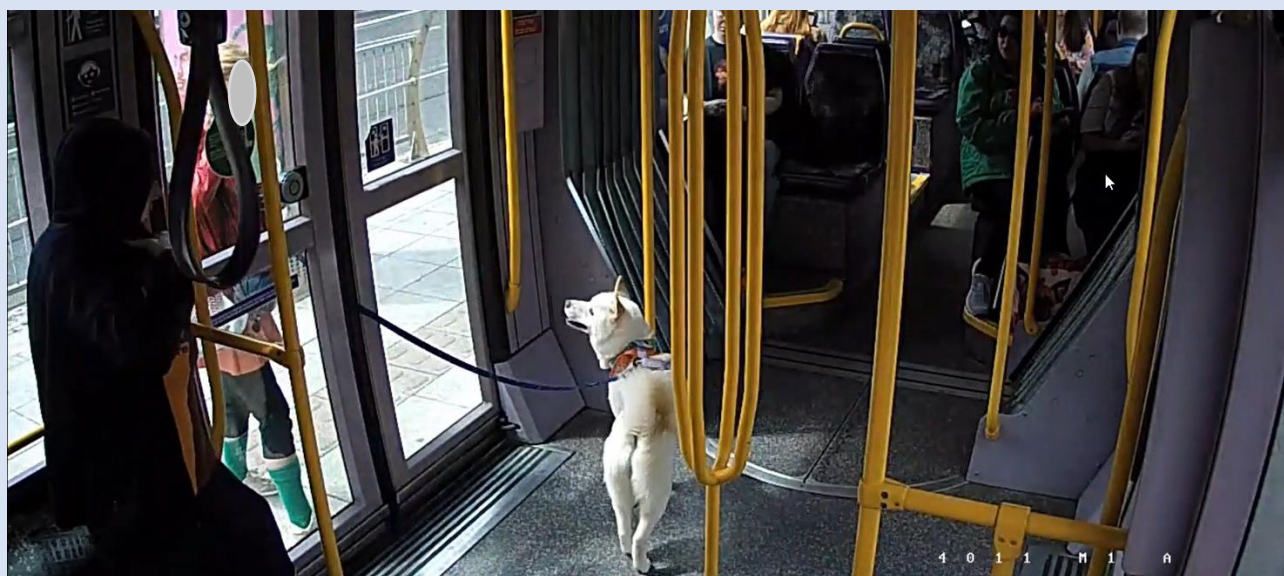
Tram 4011 was at Hospital Stop, awaiting departure. As the driver (Driver 4011) initiated the door closing sequence, the doors began to close, and a dog on a lead boarded the tram without the owner. The tram doors closed as normal trapping the lead, see Figure 9, the lead would have been less than the 10 mm and therefore not detected.

Figure 9 – Dog onboard tram with lead trapped in the door

Driver 4011 departed, unaware of the lead being trapped. The dog owner had the lead around her wrist and was dragged alongside the tram, eventually freeing herself from the lead and falling onto the platform.
