### PART 1 – Introduction

## PART 2 – Near miss, between Ballyhaunis and Castlerea, on the 13<sup>th</sup> July 2026

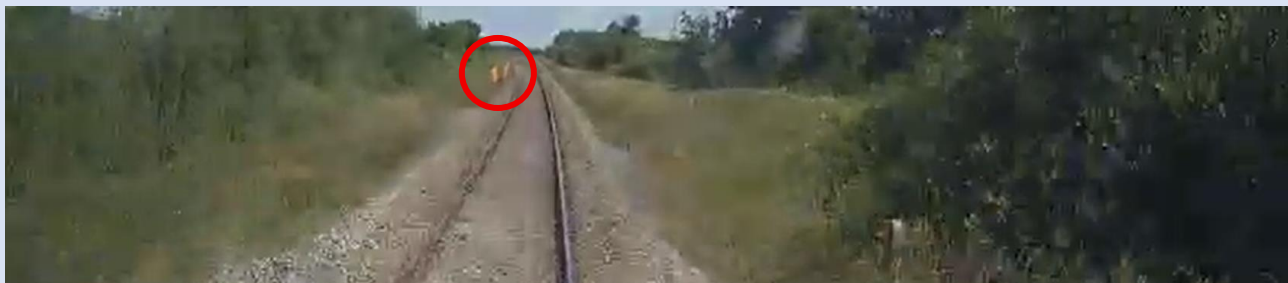
On the 13<sup>th</sup> July 2026, two staff members accessed the line under Red Zone Working conditions. At 14:05 hrs, the 13:10 hrs passenger service from Westport to Dublin Heuston approached the two members of staff, near the 118 ½ MP between Ballyhaunis and Castlerea, at 67 mph (108 km/h), see Figure 1 (staff members circled).

Figure 1 – Members of staff on the line (taken from the train's forward-facing CCTV)

On seeing the staff members, the train driver sounded the horn; on seeing the train, the staff members moved to a position of safety, reaching it approximately four to five seconds before the train passed. The driver of the train applied the emergency brake, and the train came to a stop. There were no injuries to the staff member. The available sighting distance was insufficient to allow the two staff members to reach a position of safety with an adequate margin before the train arrived. The TAI identifies the location as an Orange Section (Medium Risk).
