Railway Accident Investigation Unit

INVESTIGATION REPORT

Structural failure of a platform canopy at Kent Station, Cork

18th December 2013
RAIU Report No: R2014 – 005
Published: 7/11/2014

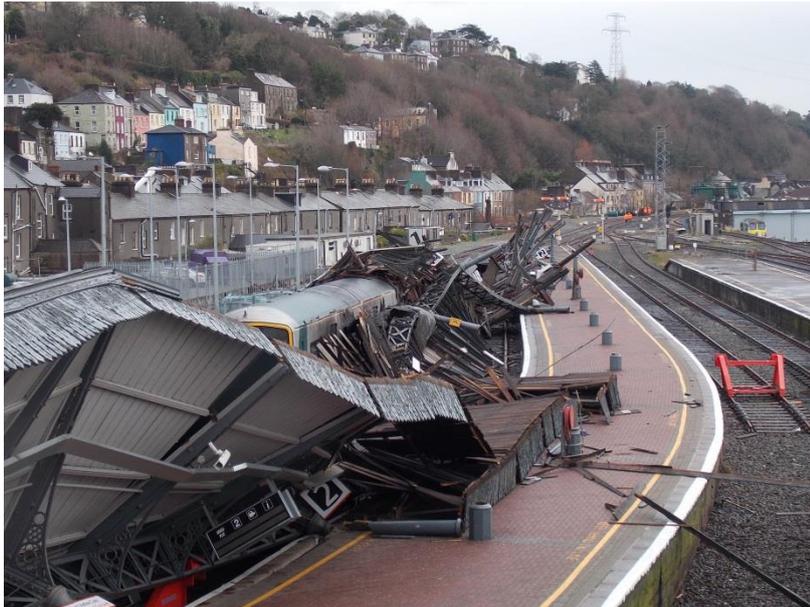
Figure 2 - Collapsed canopy and resultant debris

- 2 Three people were on Platforms 1 and 2 waiting for the 14:45 hrs service from Midleton which was due to arrive into the station at 15:08 hrs.
- 3 The wind and the rain increased in intensity and a section of roof felt was carried by the wind from the canopy over Platform 4 onto the ground beside Platform 2. At 15:02 hrs the canopy above Platforms 1 and 2 started to sway and the supporting columns began to fall at the end of the platform furthest from the concourse. Sequentially the columns fell and this resulted in the canopy collapsing.
- 4 The canopy sections and debris fell onto the platform, the unoccupied track at Platform 1 and onto an empty stationary train stabled on the adjacent 'engine road'. Additionally debris from the roof structure was blown into the car park damaging some vehicles (see Figure 2).

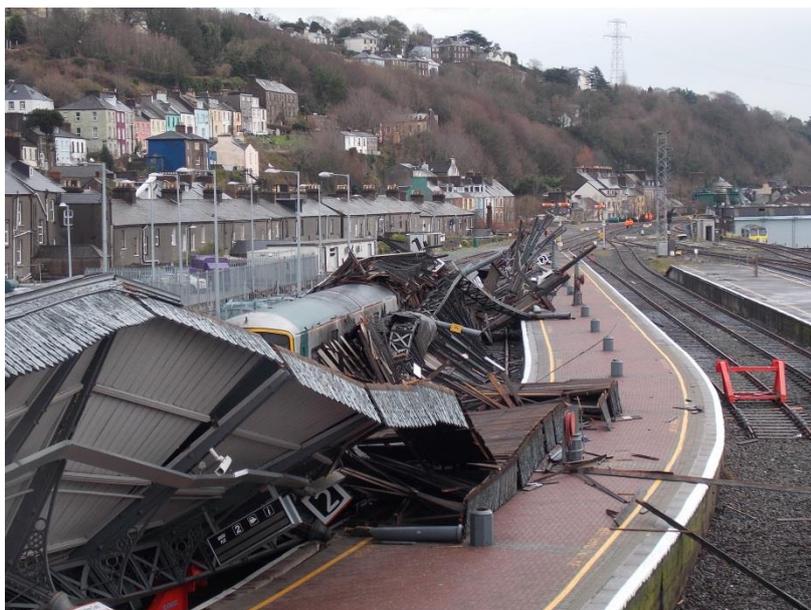
Figure 6 – Collapsed canopy and resultant debris

20 Every supporting column of the canopy over Platforms 1 and 2 fractured leading to the collapse of the structure and subsequently it sustained extensive damage throughout. The following damage was caused by the falling canopy and resultant debris:

- Two sets of railcars were damaged. One of the sets had minor damage when the unit was struck by debris and the engine fire extinguishing system was triggered on the underside;
- There was also damage to the drivers drop light window. This unit was stabled on Platform 3 at the time of the accident;
- The second railcar was the unit stabled in the siding adjacent to Platform 1 and 2 and was struck and mostly covered with debris from the canopy;
- There was damage to a number of road vehicles in the car park adjacent to the accident.

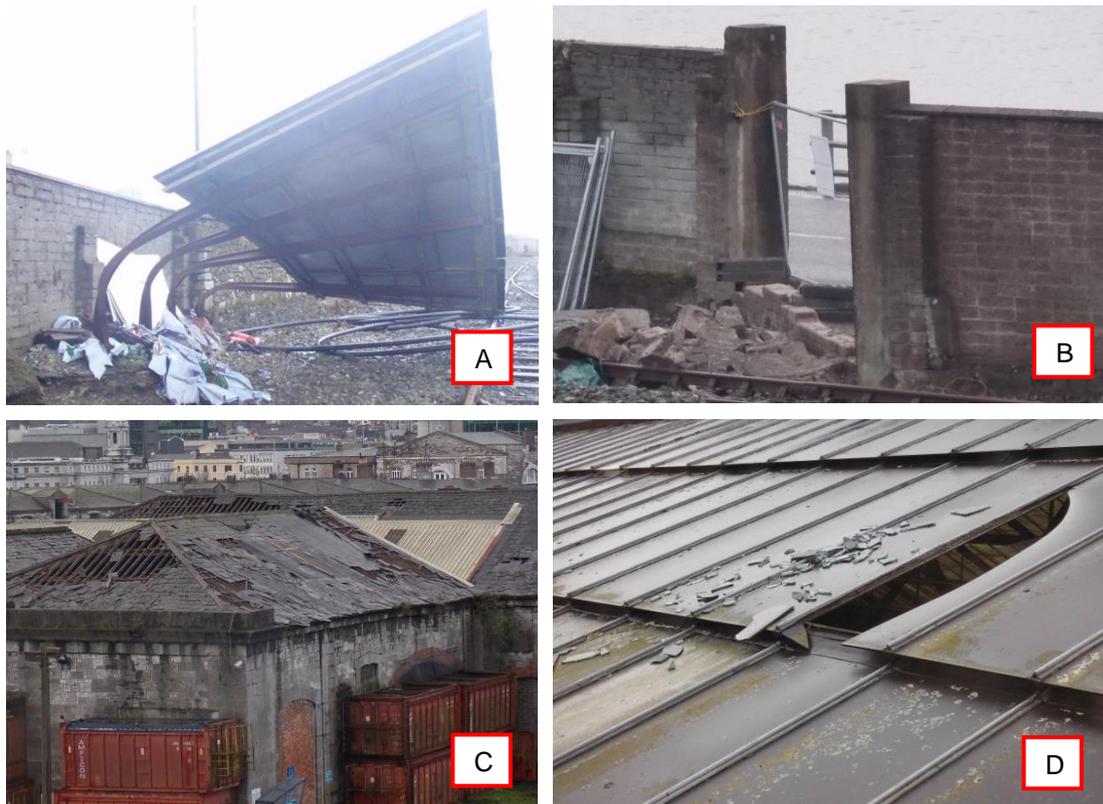
Figure 7 – Additional damage in vicinity of Kent Station

- Cork cabin is a two storey timber framed building. The building did not suffer any structural damage. However, some superficial damage was identified including a broken window on the first floor, a dislodged internal Perspex panel and a broken door bracket;

- An advertising hoarding near the perimeter wall on the south side of the station was damaged as shown in Figure 7A. The structure was supported by steel columns which bent over due to the force of the wind;

- Both the goods store and the locomotive shed are large buildings with tiled roofs. A number of tiles were removed from both structures by the wind. It was also observed that a number of houses on Lower Glanmire road adjacent to the station also had tiles removed from their roofs Figure 7C;

- A large section of roof felt was removed from the main canopy and landed on the ground next to Platform 2. In addition to this glass panes failed near the centre of the structure with the glass being blown out through the top of the roof Figure 7D.

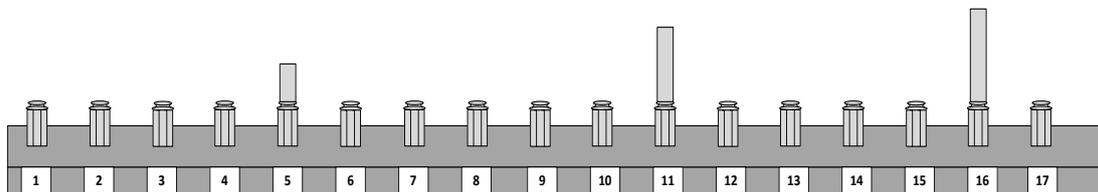
Figure 15 – Schematic of supporting columns post-accident

55 The initial site inspection identified that all of the seventeen supporting columns of the canopy over Platforms 1 and 2 had failed.

57 For the purpose of this report the columns of the canopy are numbered from one to seventeen starting at the station building end of the platform, see Figure 15.

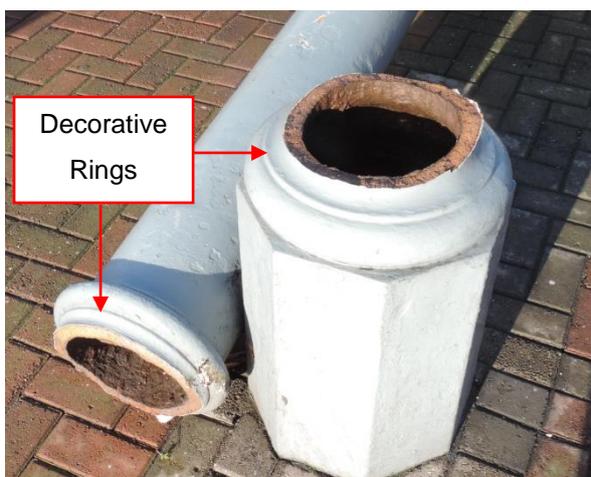
Figure 16 – Point of failure at decorative feature

58 Fourteen out of seventeen of the columns failed at a circular feature in the lower part of each column also shown in Figures 15, 16 and 17. This feature acted as a decorative transition between the octagonal base section and the narrow tubular section.

- 59 The decorative feature was comprised of an upper and lower ring structure with an intervening concave groove. A sharp radius marked the transition between the rings and the concave section (Figure 16). Sharp radii such as these are known as stress raisers.

- 60 Examination of the fracture faces showed that they exhibited brittle fracture patterns with no apparent *plastic deformation*. The fracture faces for the columns that failed in this area were essentially flat, which is indicative of *brittle overload* consistent with the application of the maximum tensile stress. With a brittle fracture, crack propagation is very fast with the crack propagating almost perpendicular to the direction of applied stress. In addition to this no evidence of pre-existing cracks was observed in any of the columns.

110 Fourteen out of seventeen of the columns failed at a circular feature in the lower part of each column which acted as a stress raiser (paragraphs 58 and 59).

111 The fracture faces for the columns that failed in this area were essentially flat, which is indicative of brittle overload consistent with the application of the maximum tensile stress. The fracture patterns are also indicative of a rapid failure in the direction of the applied stress (paragraph 60)

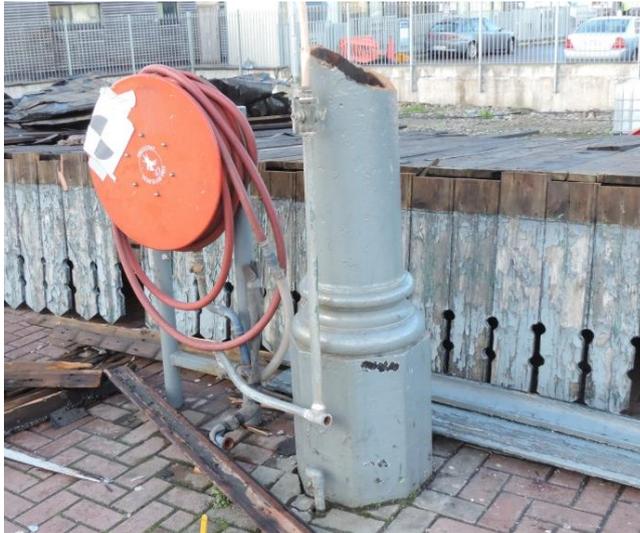
Figure 18 – Column five

- 64 Measured values for the column thickness were also affected by the width of the internal layer of corrosion within each column.
- 65 Columns five, eleven and sixteen did not fail at the decorative feature at the base of the column. All three failed at different heights. Column eleven failed a similar decorative feature near the top of the column. Whereas columns five (Figure 18) and sixteen failed nearer the middle of the columns. Both of these columns demonstrated *porosity* in the fracture surface which may have weakened the columns at these points (Figure 19). Porosity in the column would again be due to inconsistencies within the original manufacturing techniques.

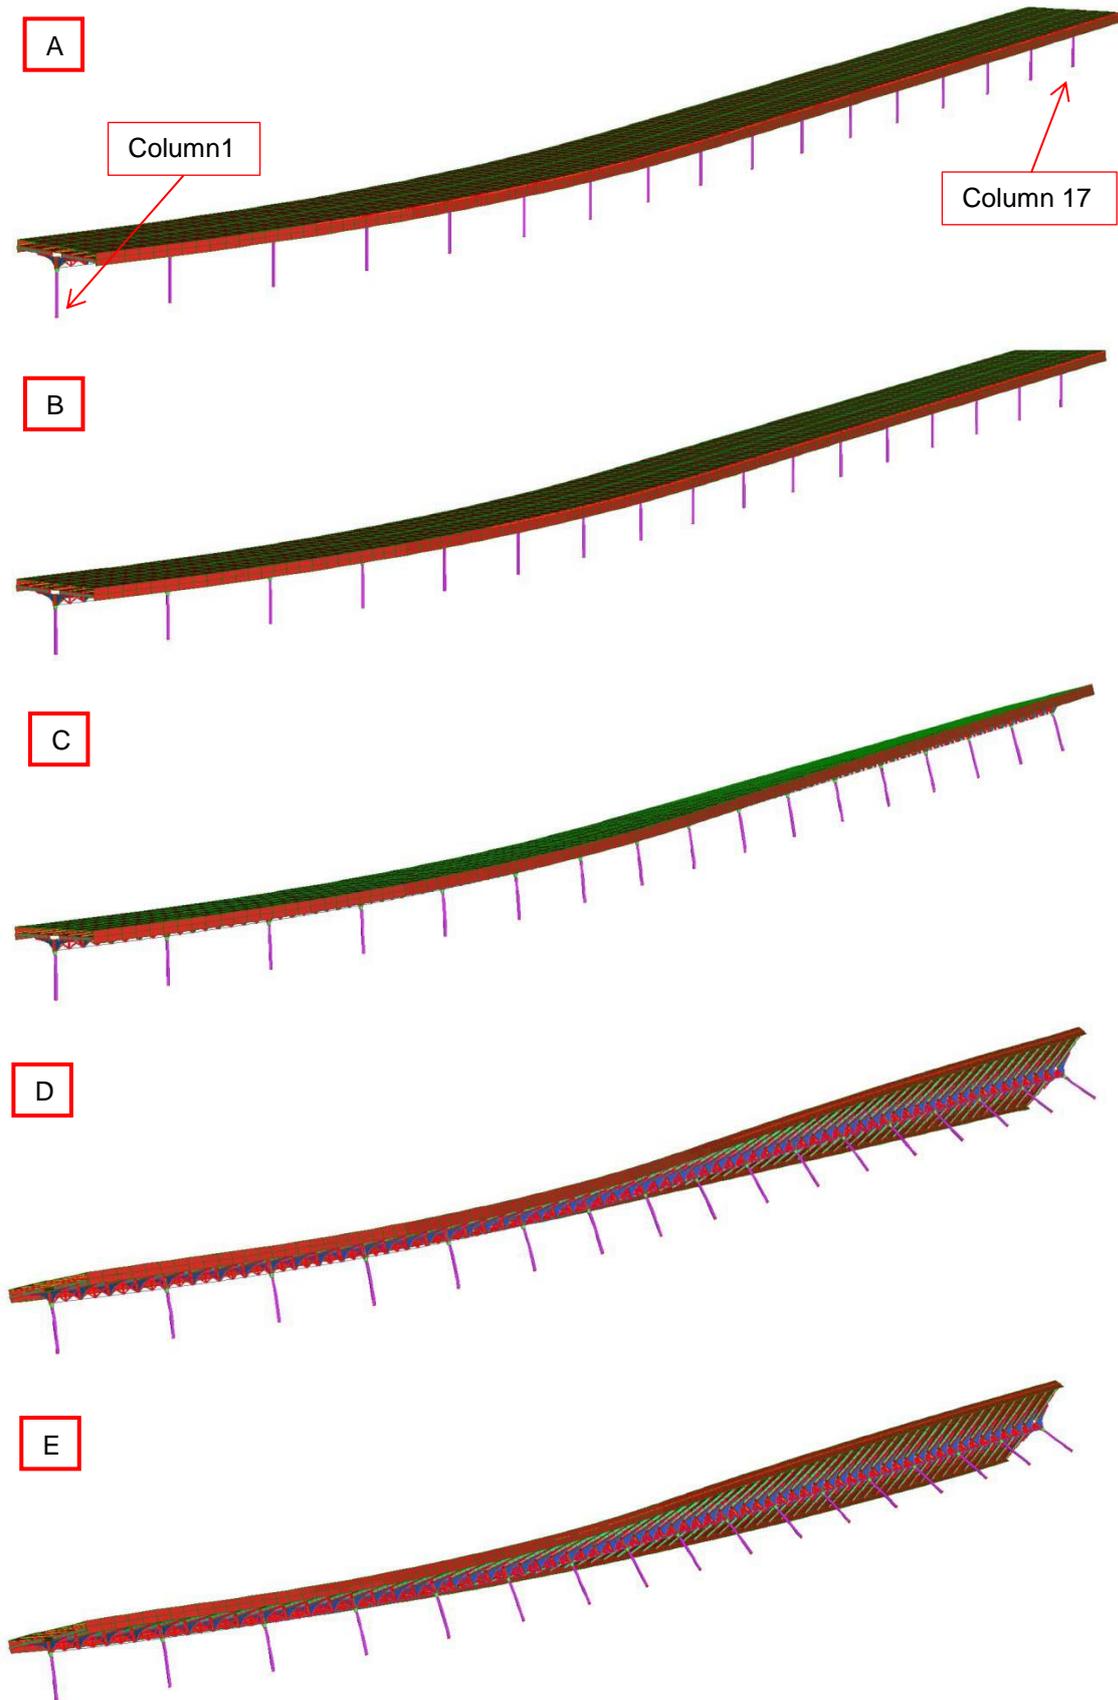
Figure 24 – Selected moments from simulation of canopy collapse, Fluvio (2014)

73 Figure 24 shows five images which best represent the displacement response of the canopy (Figure 24 has the columns numbered 1 – 17, from left to right, as illustrated in Figure 24A).

- At 0.02 s the canopy is in its equilibrium state (Figure 24 A);
- At 1.84 s the first column fails (Figure 24 B);
- At 2.64 s the last column fails (Figure 24 C);
- At 3.48 s the north-eastern corner of the canopy impacts the ground (Figure 24 D);
- At 3.80s more of the structure impacts the ground as the time progresses (Figure 24 E).

- 76 At the time of the last column failing, the most eastern column, i.e. the first column to fail, had displaced over 1m. At this stage progressive collapse had been initiated. This result ties in with the eye-witness accounts that indicated that the canopy collapsed progressively from the far end of the platform.
