**Railway Accident
Investigation Unit
Ireland**

INVESTIGATION REPORT

**Passenger trap-and-drag occurrence on Luas tram
at Heuston Stop,**

RAIU Report No: 2020 – R001

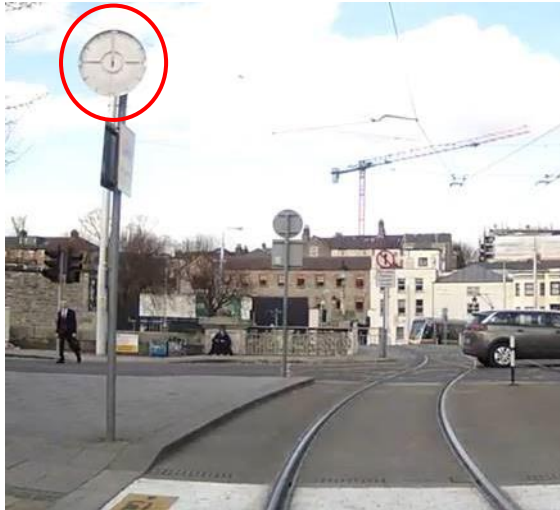
- 53 On the day of the incident, the mounted inbound platform mirror was missing. It cannot be determined how long it had been missing as it was not reported by drivers, see Figure 6 for missing mirror (circled in red); see Figure 7 for replacement mirror.

Figure 6 – Missing mirror

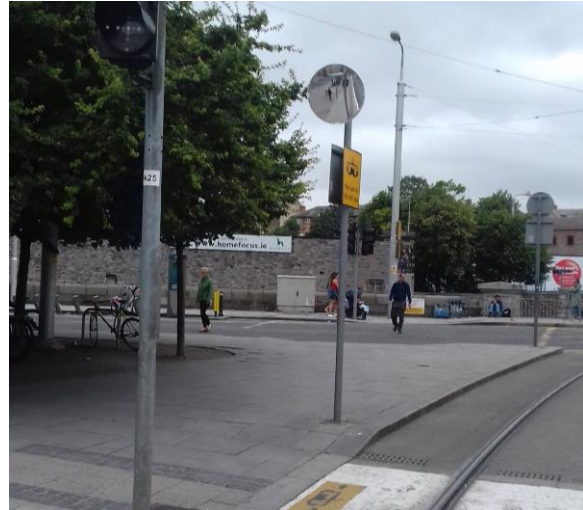
Figure 7 – Replacement mirror

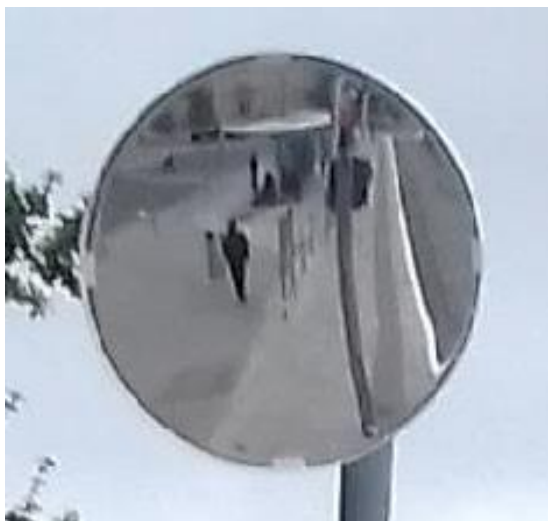
- 54 A close up of the mirror at Heuston Stop (Figure 8) shows that the signal pole is obstructing some of the driver's view. By way of comparison in relation to platform viewing, the inbound platform at Charlemont Stop on the Green Line is fitted with a colour CCTV monitor to assist tram drivers looking at the platform and doors (Figure 9); it should be noted however, this has been installed primarily as a result of the curvature of the line.

Figure 8 – Mirror Close-Up

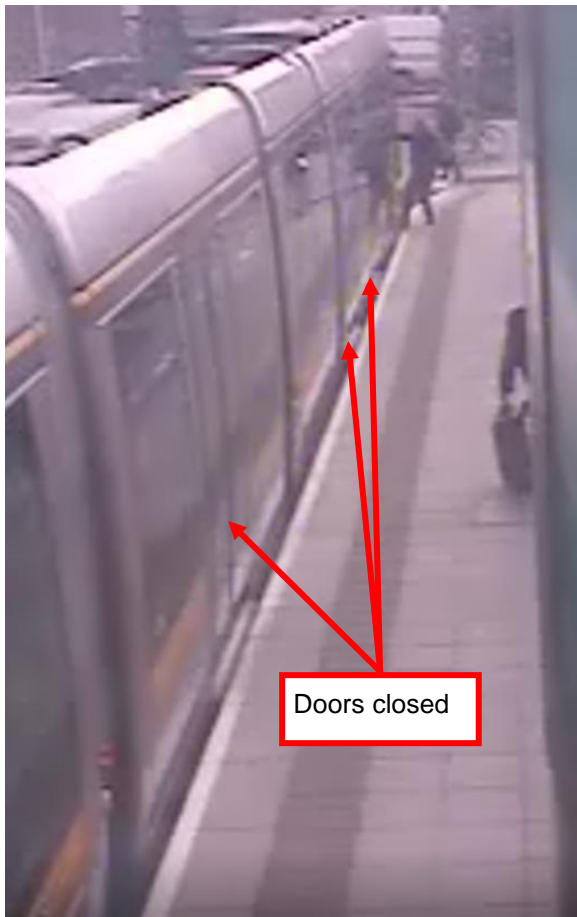
- 78 At 14:21:26 an intending passenger ran towards the rear most door on Tram 3011 and placed his hand between the door seal and the door pillar. All the doors closed, and the passenger's fingers became trapped in the rear door (see Figure 13).
- 79 The door adjacent to the passengers door re-opens, likely due to an obstruction greater than 10 mm being detected, however, on the rear most door, the passenger's hand remains trapped as the passenger's hand was less than 10 mm (Figure 14).

Figure 13 – Passenger's hand trapped in door

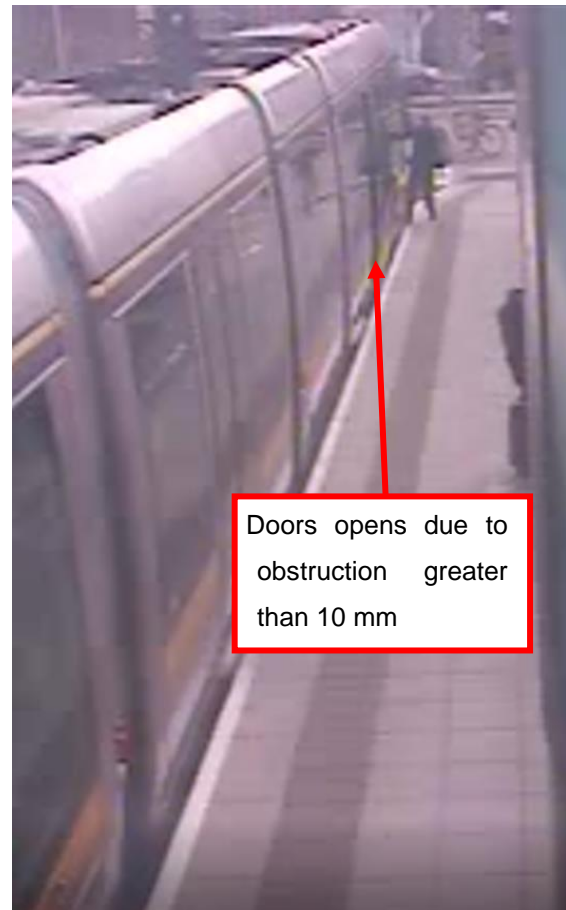
Figure 14 – Door, in front of trapped passenger's door, opens

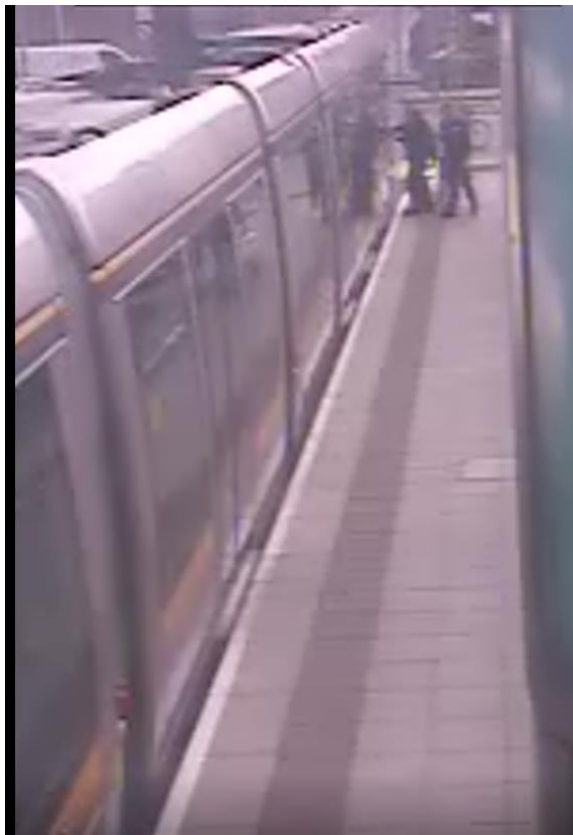
- 82 During the conversation, the Driver checks his TCMS console which shows that the doors were closed and locked; as a result of this and as he had already sent the an RTS command, the Driver did not open the doors.

Figure 15 – STT staff assisting passenger

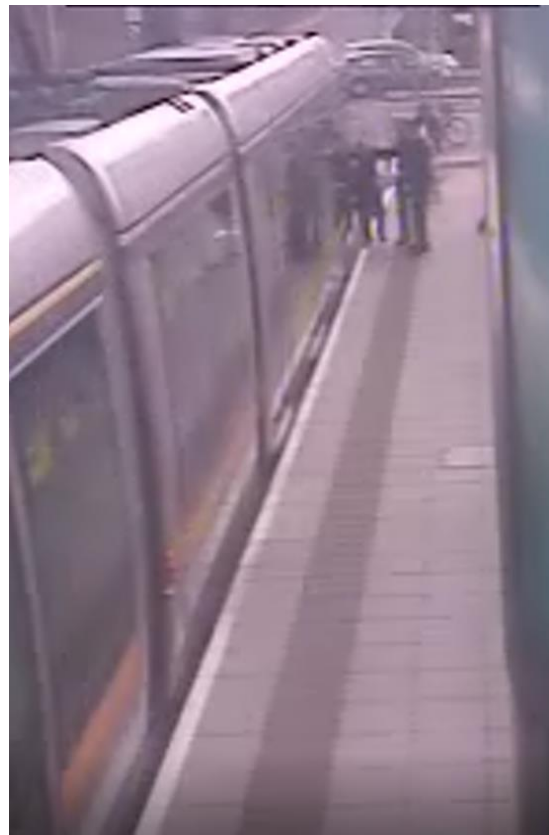
Figure 16 – Passenger & STT staff moving with the tram

- 83 At 14:21:46 the Driver starts to move the tram off the platform. The intending passenger walks along the platform with his hand trapped in the door as the STT staff attempt to free the passenger's fingers (see Figure 16).
- 84 At 14:21:51 the STT staff are successful in freeing the passengers trapped fingers.

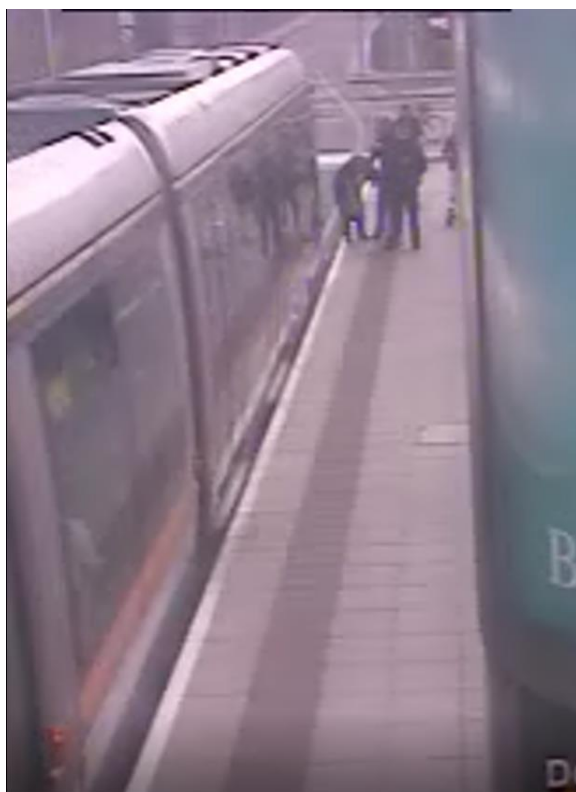
Figure 17 – Passenger's hand is freed

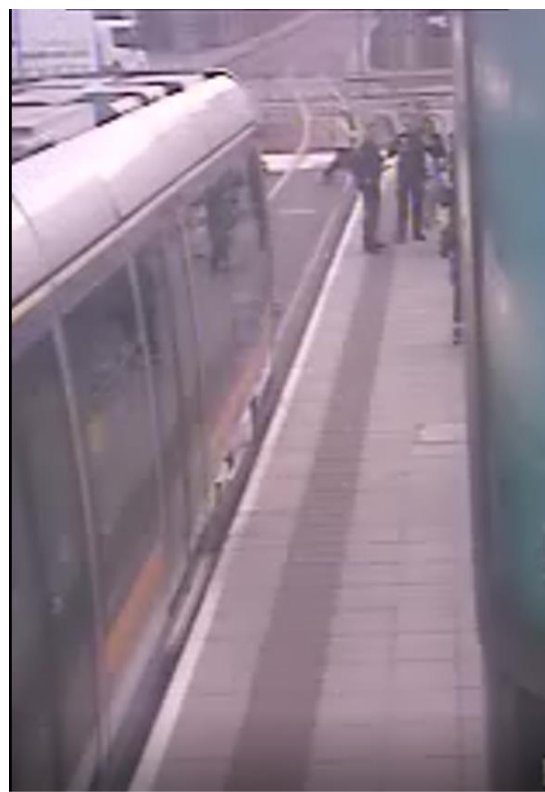
Figure 18 – Tram stops

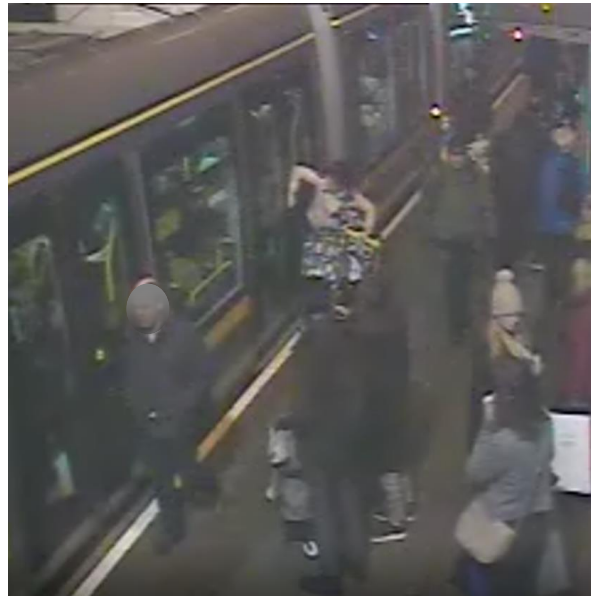
Figure 20 – Woman's hand trapped in doors

105 Approximately two seconds later, the passenger puts her hand between the doors as they are about to fully close resulting in her hand being trapped in the doors (see Figure 20); she began trying to pull her arm free after the initial trapping.

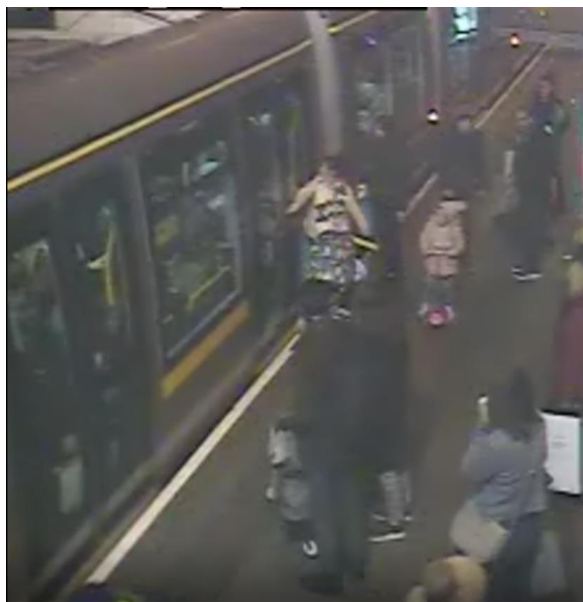
106 At the same time the driver viewed the door open indicator lamp had extinguished on the driver's console and the TCMS Console showed all passenger doors were closed and locked. The driver sent an RTS command. The driver checked his rear-view monitors (he did not see the passenger with her hand trapped) and checked the pedestrian crossing in front of the tram; before he commenced his departure from Jervis Stop (five seconds after the passenger first got her hand trapped) with the passenger's hand remaining trapped in the door (Figure 21). The driver was unaware that the passenger's hand is trapped.

Figure 21 – Tram begins to depart with hand trapped in doors

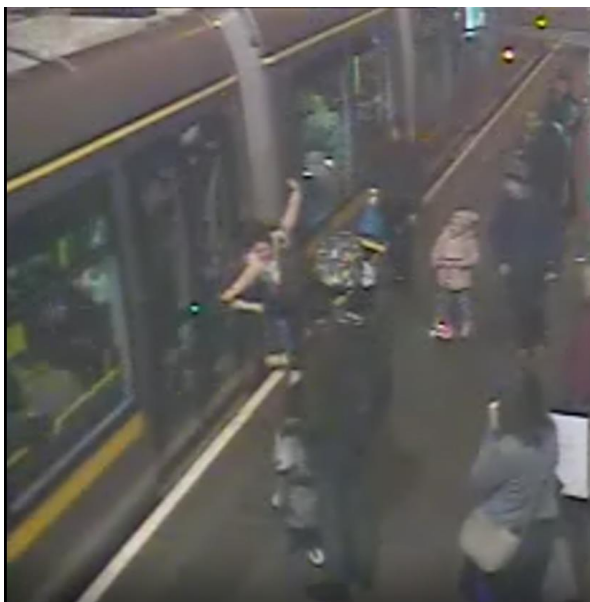
Figure 22 – Passenger being dragged along the platform

107 The woman is dragged along the platform (see Figure 22), begins to fall (see Figure 23), frees her hand and fall onto the platform (still Figure 24, which is a still of the CCTV taken three seconds after the tram begins its departure for Jervis Stop).

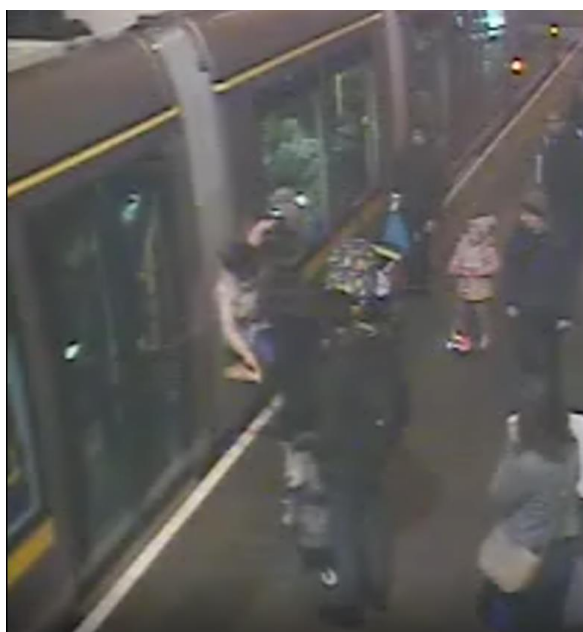
Figure 23 – Passenger frees hand and begins to fall onto the platform

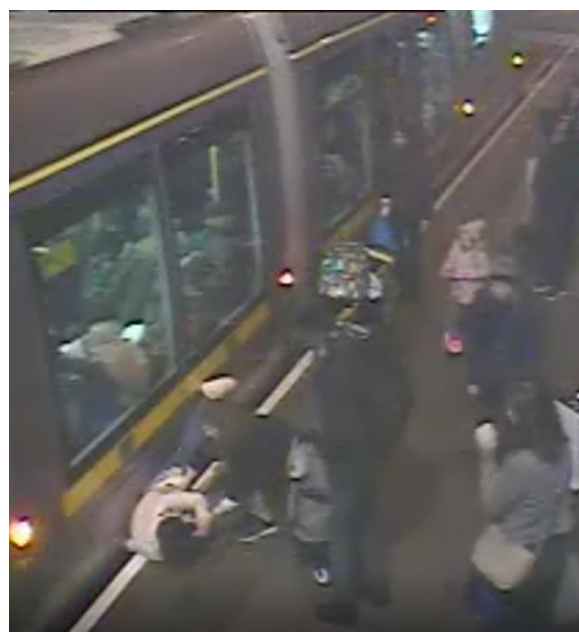
Figure 24 – Passenger falls onto the platform
