Railway Accident Investigation Unit Ireland

INVESTIGATION REPORT

Person entrapped in lowered CCTV level crossing, Ashfield, Offaly, 24th May 2020

RAIU Investigation Report No: 2021 - R003

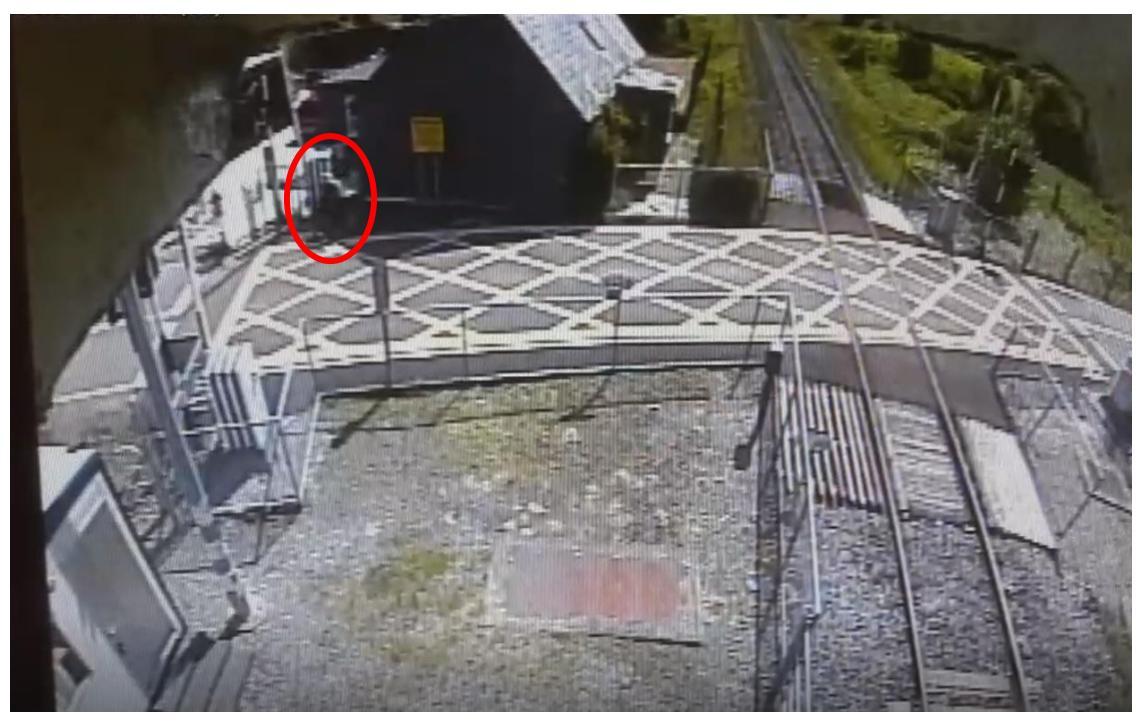
Figure 17 – Two MOPs (circled red) within the confines of LC XA068

88 At 12:14:13 hrs, the entrance barriers begin to lower; two MOPs (MOP1 and Child) remain within the confines of LC XA068, circled together in Figure 17.

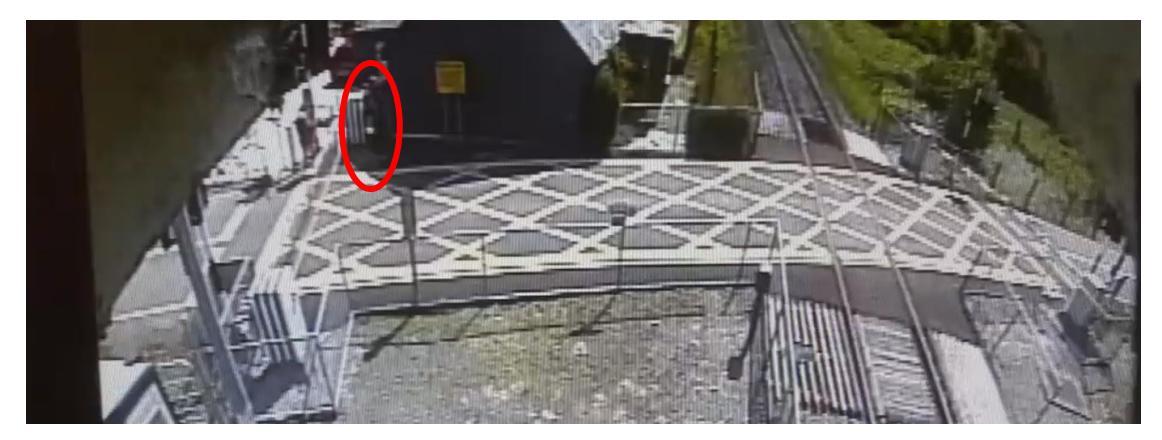
Figure 18 - Moment LC XA068 cleared within two MOPs inside the barriers

91 At 12:14:27 hrs, at ALCC, LCCO1 presses the "Crossing Clear" buttons (two seconds after the four barriers have been fully lowered); one second later, at 12:14:28 hrs, LCCO1 presses the "Signal Controls – Request", to clear the rail signals to proceed, as set out in paragraph 74. LCCO1 stated that they did not see any MOPs in the confines of the level crossing. It should be noted that in the still image taken at the moment the crossing was cleared, shown in Figure 18, that the MOPs are in the shadows cast from the house and with the house painted a dark colour they are difficult to distinguish in the still; however, when the live CCTV footages is viewed the MOPs movements are clearly visible.

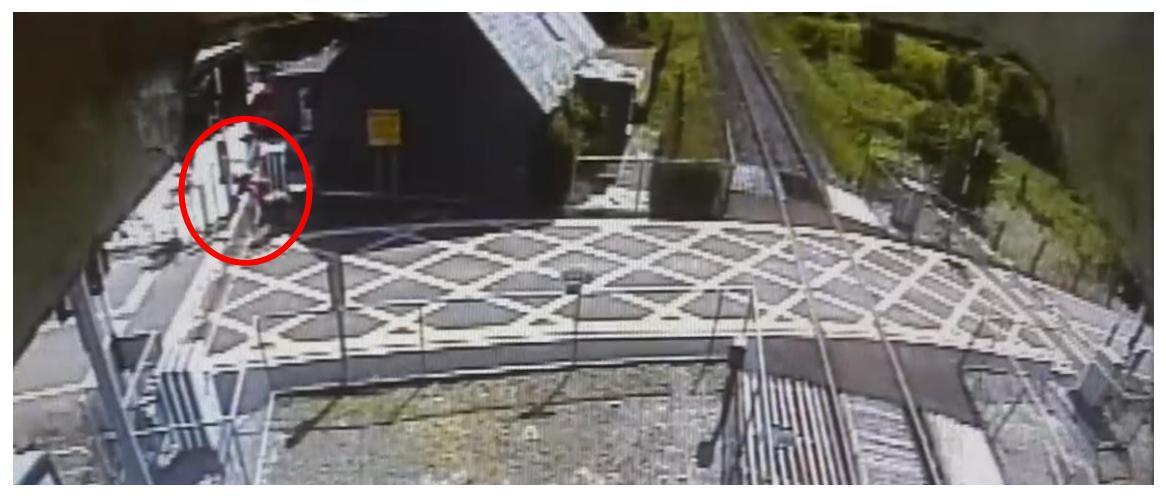
Figure 19 – MOP1 lifts child over the barriers to MOP2 (circled red)

- 92 At 12:14:31 hrs the distant signals (Up Distant and Down Distant) and stop signals (Up Stop and Down Stop) are all displaying proceed aspects.
- 93 At 12:14:34 hrs, MOP1 lifts the Child over the barriers to MOP2 (see Figure 19) and moves the bicycle clear of the road and railway; MOP1 remains trapped within the barriers.

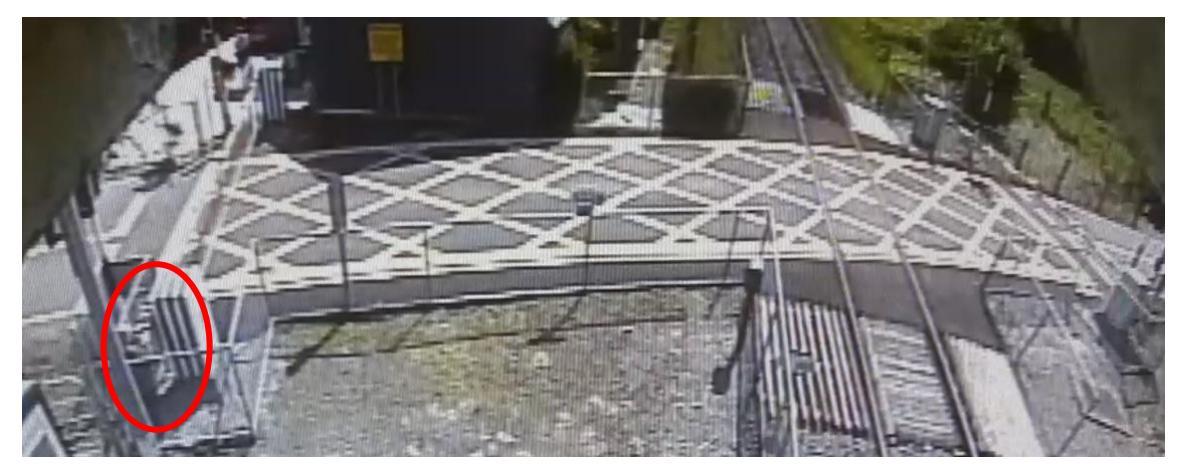
Figure 21 – MOP1 behind the housing for the level crossing

- Places the initiation switch to "Local" at 12:15:21 hrs. LCCO1 does not press the "Emergency Alert" button on the touchscreen as per paragraphs 80;
- Presses the "Barriers Raise" button at 12:15:29 hrs; the barriers do not raise (the barriers would not raise in this situation as the level crossing signals had been cleared); and seventeen seconds later LCCO1 releases the "Barrier Raise" button;
- Presses the "Signals Cancel" button at 12:15:46 hrs. The distant signals (Up Distant and Down Distant) now display "Caution" aspects and the stop signals (Up Stop and Down Stop) now display "Danger" aspects.
- 97 At 12:16:14 hrs, after finishing the conversation with LCCO1 and hanging up the telephone, MOP1 walks away from the telephone and stands behind the barrier machine on the Up side of the track, see Figure 21 (circled red).

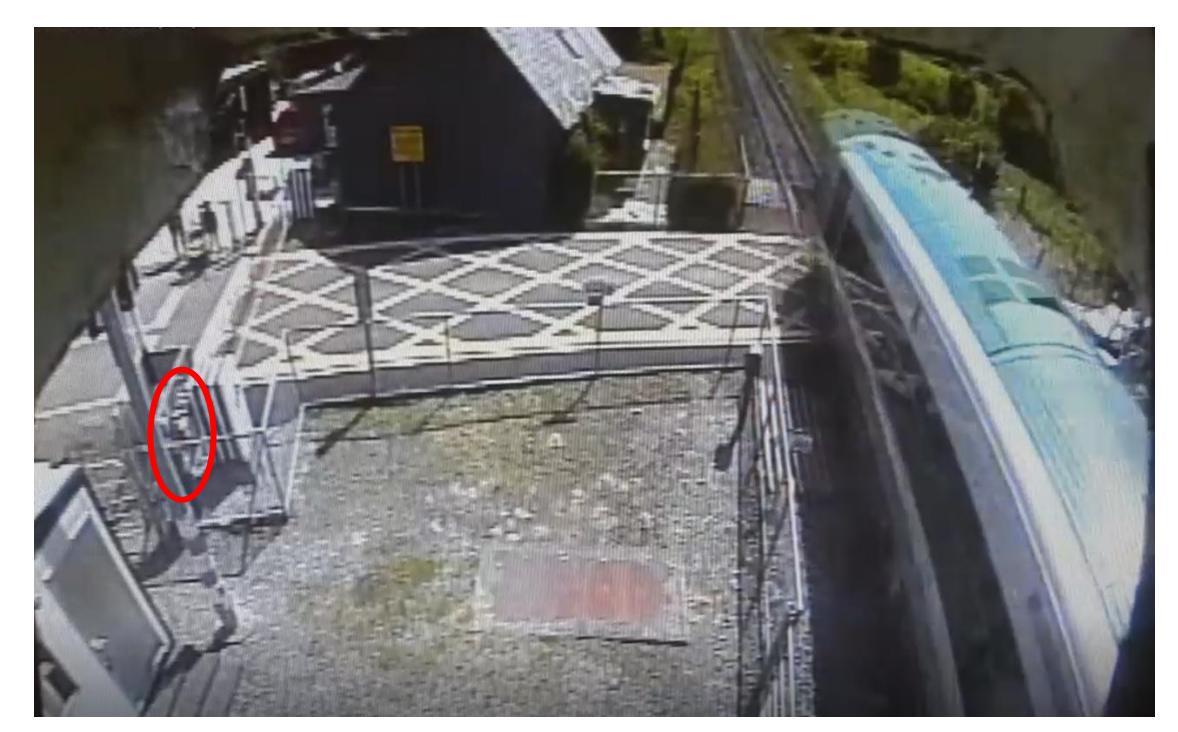
Figure 23 – MOP inside barriers as Train A703 passes through LC XA068

- 102 LCCO2 assumed that LCCO1 would not have cleared the signals for a train with a MOP still inside the barriers.
- 103 However, at 12:18:12 hrs, LCCO1 again selects the "Signals Control Request" button; this action results in the Up Stop, Down Stop, Down Distant signals all displaying proceed aspects again at 12:18:13 hrs. Up Distant remains at caution (paragraph 100) as Train A703 is likely to have travelled past this signal.
- 104 After the incident, when asked why the continuous used of the "Signal Controls" buttons, the LCCO1 could not explain while acknowledging that they understood what actions should have been taken.
- 105 At 12:18:50 hrs, Train A703 arrives at and passes over LC XA068 with MOP1 still within the confines of the level crossing behind the barrier machine, see Figure 23.

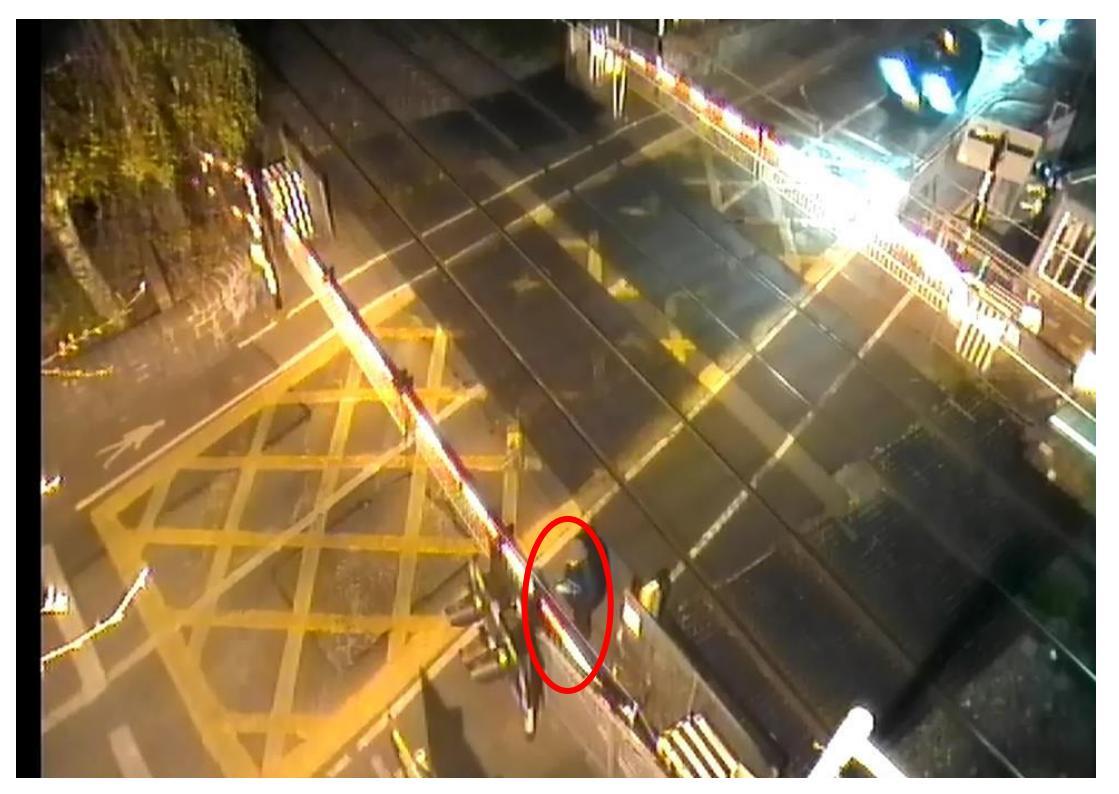
Figure 24 – MOP inside the barriers of LC XR004

- 116 At 22:07 hrs on Monday the 24th April 2017 the initiation for LC XR004 was triggered by the 21:30 hrs passenger service from Malahide to Greystones (Train E131). The warning lights and bells for the crossing flashed and sounded, respectively. At the same time, two MOPs entered LC XR004 (see Figure 24) with one MOP becoming trapped in the confines of the level crossing when the barriers were fully lowered.

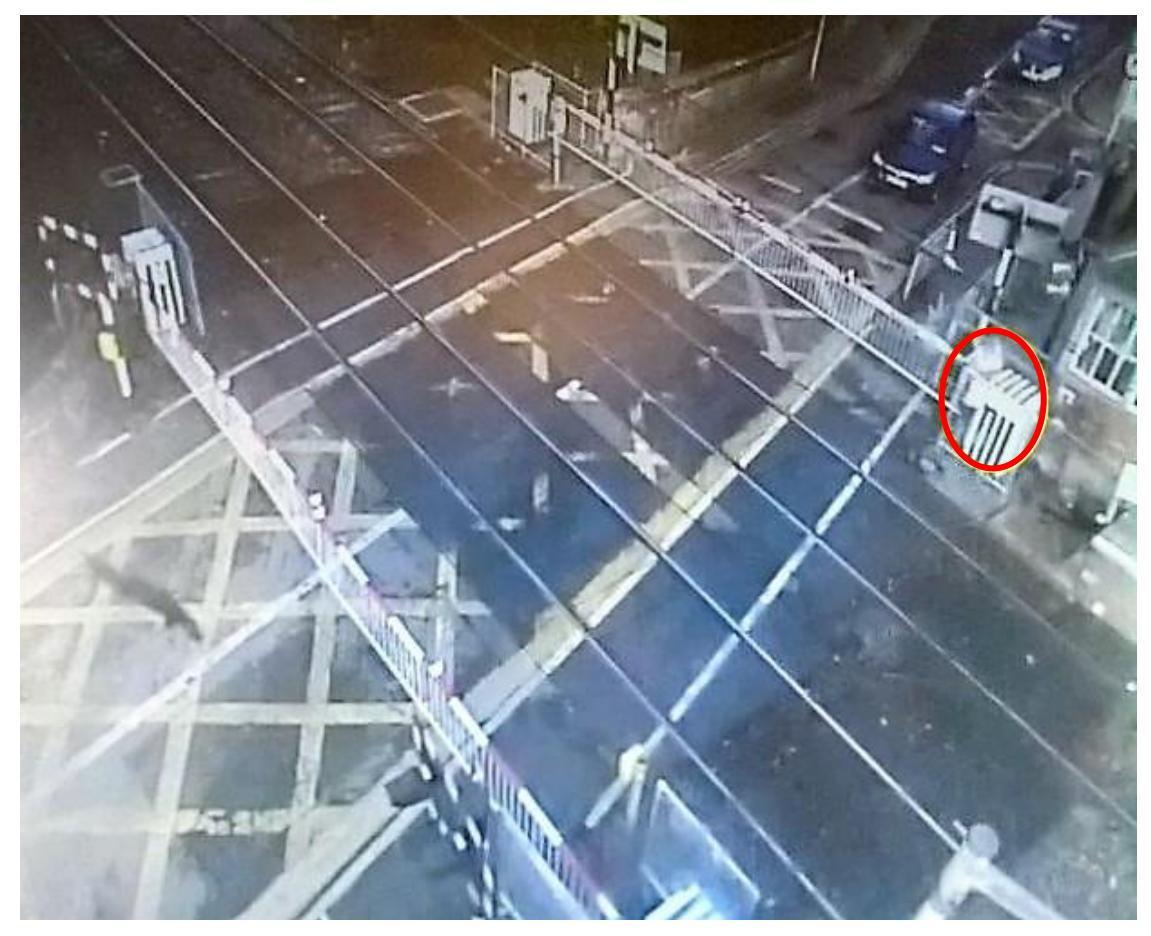
Figure 25 – MOP (circled red) inside the barriers of LC XR004

- 119 At 12:50:32 hrs on the 1st February 2018 the initiation for LC XR004 (a description of LC XR004 is provided in paragraph 115) was triggered by the 12:15 hrs passenger service from Howth to Bray (Train E213).
- 120 The warning lights and bells for the crossing flashed and sounded, respectively. A MOP entered LC XR004, while the warnings were active, and had insufficient time to clear LC XR004. The MOP took refuge between the barrier boom and the protecting mesh fence between the boom and the Down line (Figure 25).

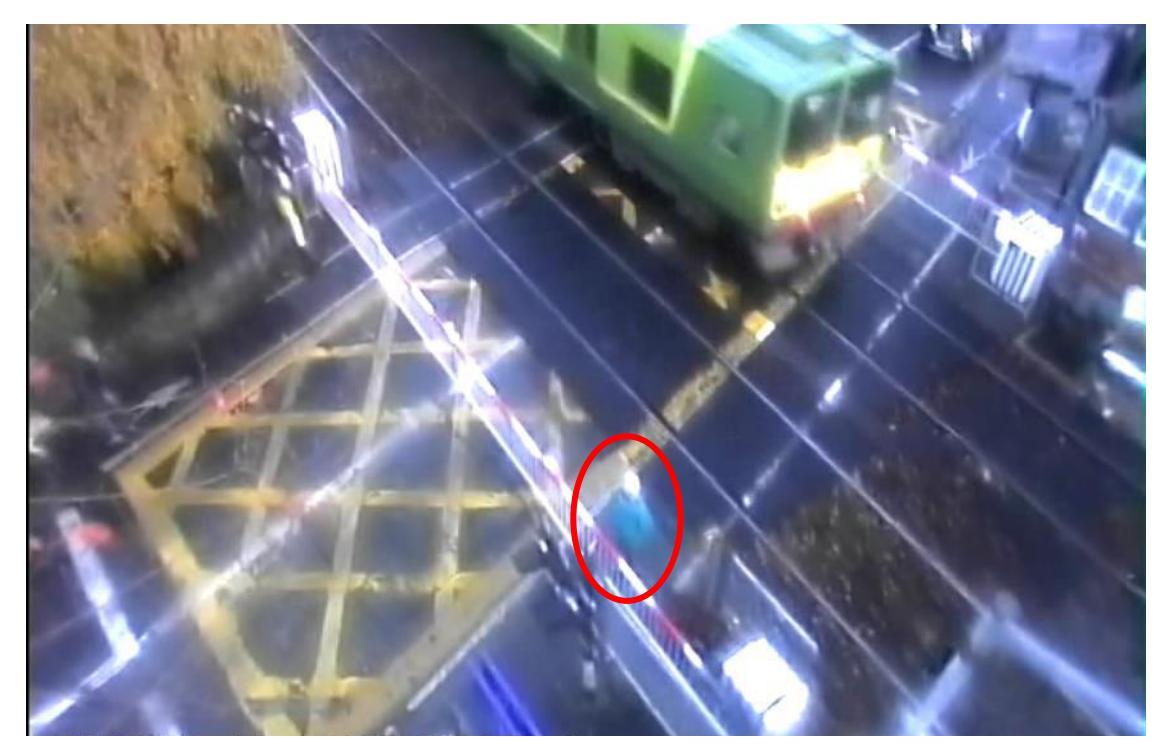
Figure 26 – MOP (circled red) inside the barriers of LC XR004 with Train E212

- 123 On Monday the 3rd December 2018, at 09:24 hrs, the initiation for LC XR004 (a description of LC XR004 is provided in paragraph 115) was triggered by the 08:41 hrs passenger service from Howth to Bray (Train E212).
- 124 The warning lights and bells for the crossing flashed and sounded, respectively. Approximately twelve seconds after the barrier lowering sequence had commenced a MOP entered the LC XR004 and was unable to exit as the barriers had lowered.
- 125 The LCCO pressed the "Crossing Clear" buttons at 09:24:18 hrs with the MOP inside the barriers, with Train E212 passing through LC XR004 at 09:25:19 hrs, see Figure 26.

- 126 The LCCO was unaware of the incident and the driver of Train E212 did not see the MOP when passing. The incident was discovered as a result of another MOP incident at LC XR004 two minutes later; whereby four MOPs disembarked from Train E212, ran from the platform onto LC XR004, the level crossing barriers were in the process of lowering again for another train, with the last MOP falling on the level crossing. In the instance, the LCCO stopped the lowering sequence enabling the MOP to exit LC XR004.
- 127 There was one recommendation as a result of this incident: The CCE should examine the feasibility of installing signage at CCTV Level Crossings warning pedestrians not to enter the crossing once the warning lights and bells for the crossing flash and sound.

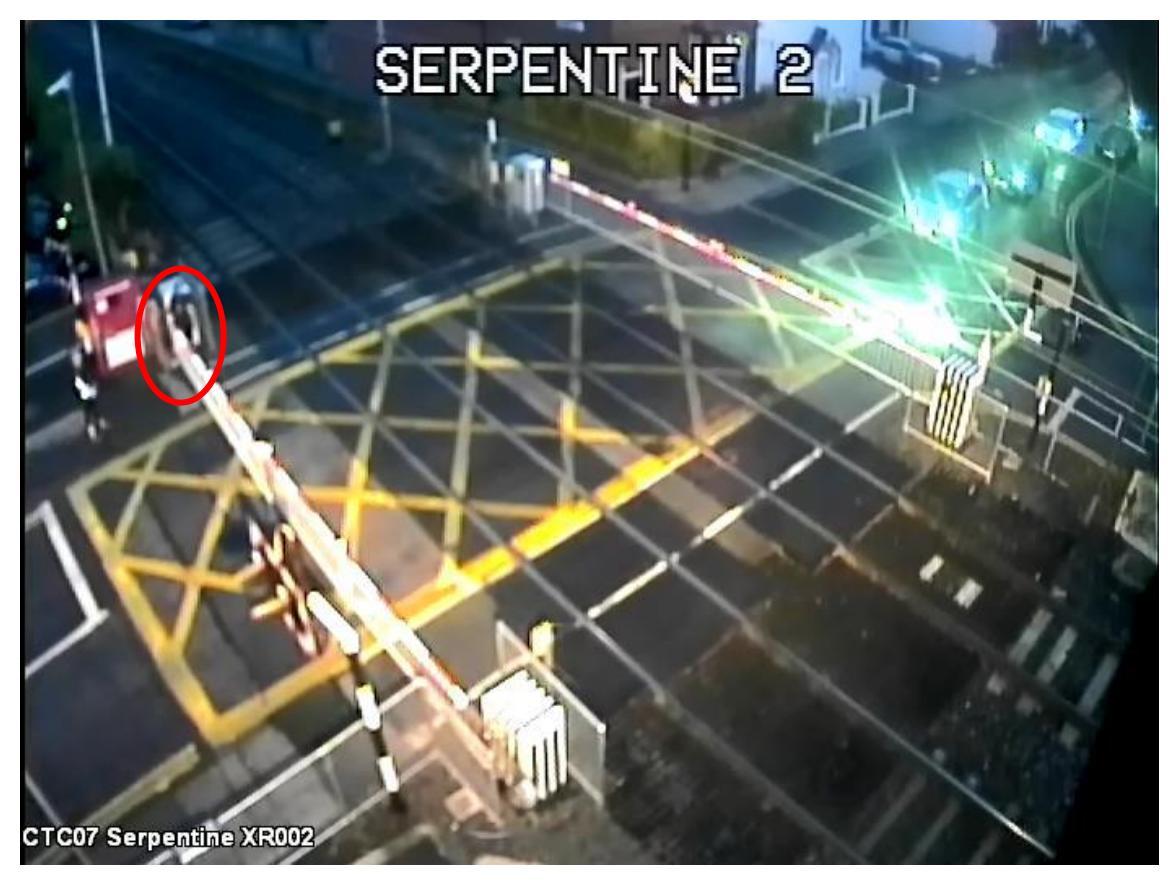
Figure 27 – MOP (circled red) inside the barriers of XR002

- 128 Serpentine Level Crossing, identified as XR002, is a four barrier Station CCTV Crossing monitored from the CTC Suburban Level Crossing Workstation at CTC Connolly.
- 129 On Tuesday the 11th December 2018, the initiation for LC XR002 was triggered by the 07:24 hrs passenger service from Greystones to Howth (Train E906). The warning lights and bells for the crossing flashed and sounded, respectively. Approximately twelve seconds after the initiation sequence commenced a MOP entered XR002 and was unable to exit as the barriers had fully lowered. The MOP stood in front of a barrier machine, with a mesh fence separating the MOP from the running line, see Figure 27.

- 130 At 08:07:04 hrs the LCCO cleared XR002 and at 08:10:02 hrs Train E906 passed through the crossing with the MOP inside the barriers. The driver of Train E906 reported the incident to the CTC Central Signalman, who in turn applied the correct post-incident procedures.
- 131 There was one recommendation as a result of the incident, namely, the CCE should examine the feasibility of installing signage at CCTV Level Crossings warning pedestrians not to enter the crossing once the warning lights and bells for the crossing flash and sound.

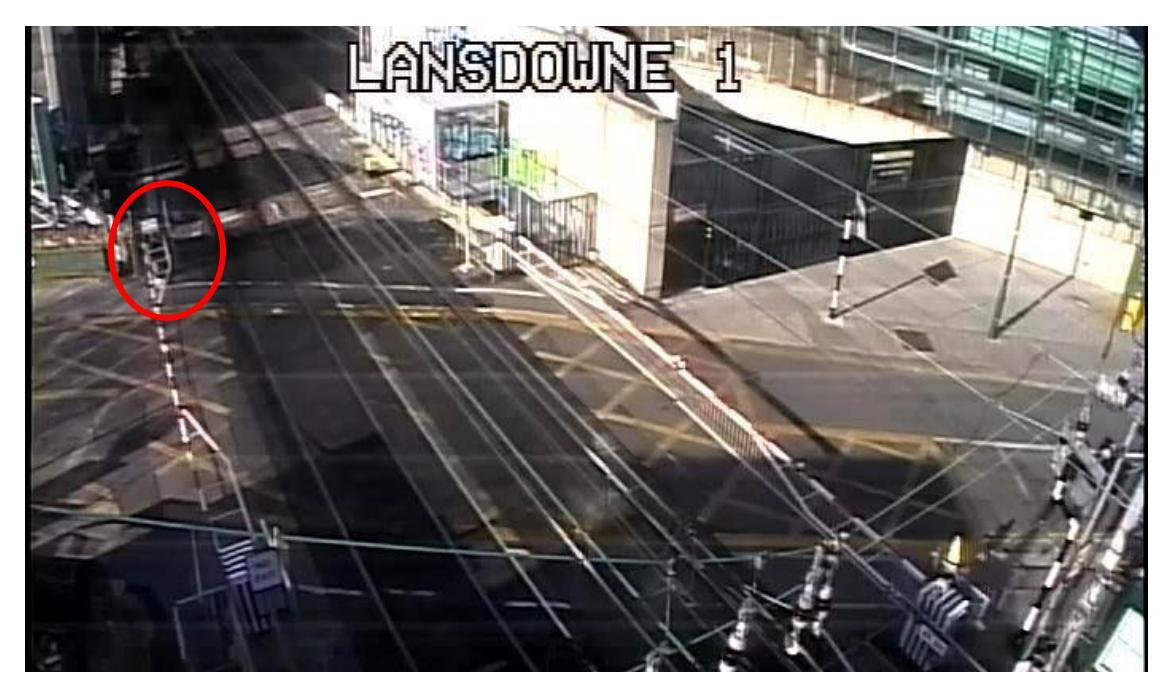
Figure 28 - MOP (circled red) inside the barriers of LC XR001

- 132 LC XR001 is a four barrier Station CCTV Crossing operated public road crossing, located on the Pearse to Rosslare Europort line between Grand Canal Dock and Lansdowne Road Stations.
- 133 On Tuesday, the 12th March 2019 at 15:09 hrs, the initiation for LC XR001 was triggered by the 14:35 hrs passenger service from Bray to Howth (Train E927). The warning lights and bells for the crossing flashed and sounded, respectively.
- 134 A MOP, with a dog, entered LC XR001 after the lowering sequence had commenced and had insufficient time to exit LC XR001 as the barriers had fully lowered. The MOP climbed under the barrier supporting frame and stood between the main barrier boom and the supporting frame, see Figure 28.

- 135 At 15:10:23 hrs, the LCCO pressed the "Crossing Clear" buttons, with the MOP inside the barriers.
- 136 When Train E927 was stopped at Lansdowne Road Station, the driver saw the MOP inside the barriers and contacted the Signalman, who in turn applied the correct post-incident procedures.
- 137 There was one recommendation as a result of this incident, namely that the CCE should examine the feasibility of installing signage at CCTV Level Crossings warning pedestrians not to enter the crossing once the warning lights and bells for the crossing flash and sound.

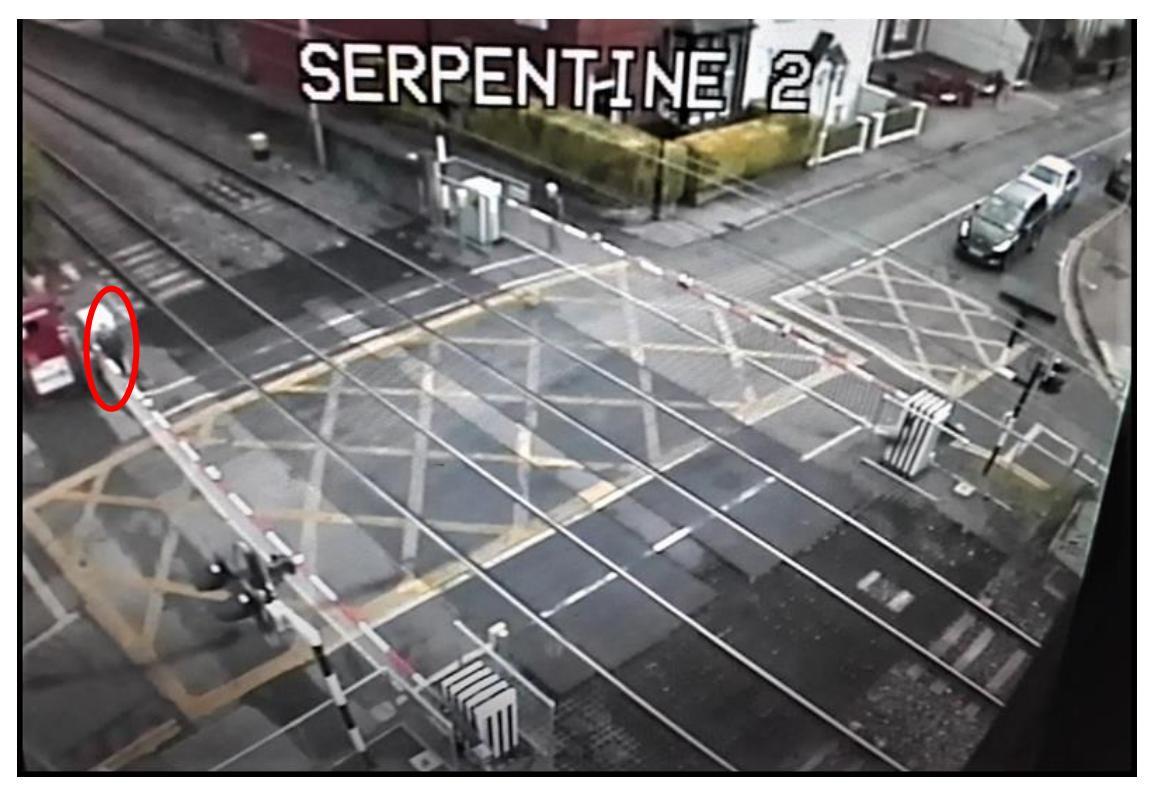
Figure 29 – MOP (circled red) inside the barriers of LC XR002

- 138 On Thursday the 13th of June 2019, LC XR002 (a description of LC XR002 is provided in paragraph 115) was initiated for both the 12:35 hrs passenger service from Bray to Howth (Train E921) and the 12:33 hrs passenger service from Malahide to Greystones (Train E114).
- 139 The warning lights and bells for the crossing flashed and sounded, respectively. A MOP entered LC XR002 after the warning sequence had begun and did not have sufficient time to exit the level crossing as the barriers had fully lowered.
- 140 At 13:06 hrs the LCCO cleared LC XR002 for the passage of trains with the MOP inside the barriers, Figure 29.

- 141 On passing through LC XR001, the driver of Train E921 noticed the MOP inside the barriers and immediately reported it to the Controlling Signalman, who in turn followed all post-incident procedures correctly.
- 142 There was one recommendation as a result of the incident, namely, that the CCE should examine the feasibility of installing signage at CCTV Level Crossings warning pedestrians not to enter the crossing once the warning lights and bells for the crossing flash and sound.

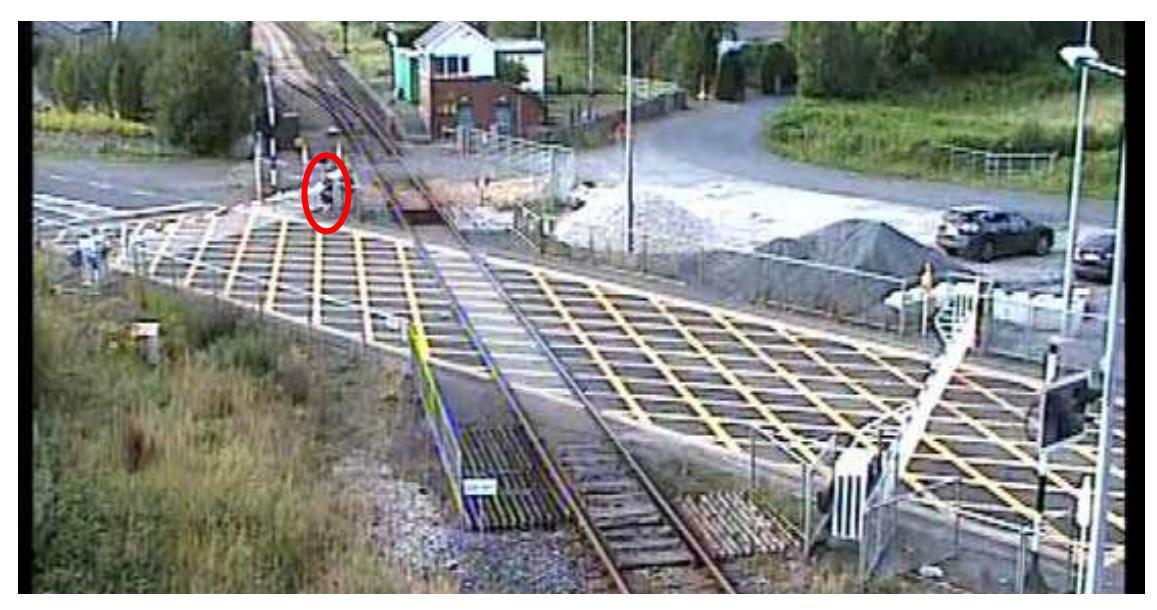
Figure 30 – MOP (circled red) inside the barriers of LC XM065

- 143 LC XM065 is a four barrier CCTV level crossing monitored from Area 2 in Athlone Local Control Centre. XM065 is designated as a Station CCTV Crossing.
- 144 On Tuesday the 21st July 2020, LC XM065 was initiated for the 18:15 hrs passenger service from Heuston to Westport (Train A808). The warning lights and bells for the crossing flashed and sounded, respectively.
- 145 After the warning sequence was initiated, a MOP, jogged onto the level crossing but was unable to clear as the barriers had fully lowered. The MOP then stood in front of the level crossing barrier, see Figure 30

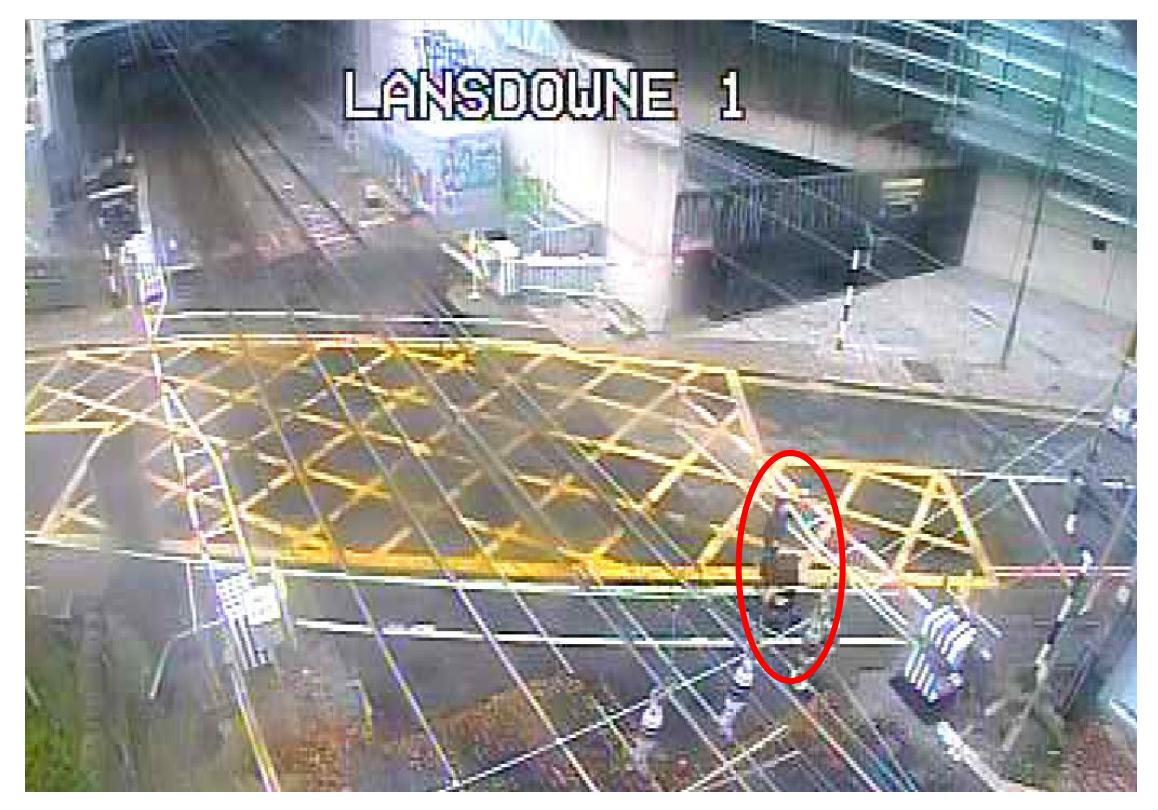
Figure 31 – MOP with buggy (circled in red) inside the barriers of LC XR001

- 150 At 11:01 hrs on Tuesday 31st October 2017 the initiation for LC XR001 (paragraph 132) was triggered by the 10:30 hrs passenger service from Malahide to Greystones (Train E131).
- 151 The warning lights and bells for the crossing flashed and sounded, respectively. However, at 11:01:58 hrs a MOP pushing a buggy entered the confines of LC XR001 during the warning sequence and was trapped when the barriers fully lowered, Figure 31.

- 152 At 11:03:00 hrs the LCCO pressed the "Crossing Clear" buttons. The LCCO then proceeded to attend to another crossing when a slight movement at LC XR001 caught his attention. The LCCO then noticed the buggy and placed LC XR001 into "Emergency Alert".
- 153 At 11:03:10 hrs another MOP walked down from Lansdowne Station platform ramp and assisted MOP with the buggy. The LCCO waited the required four-minute time out before the LCCO raised the barriers, freeing the MOP.
- 154 There was one recommendation made as a result of the incident: The CCE should examine the feasibility of installing signage at CCTV Level Crossings warning pedestrians not to enter the crossing once the warning lights and bells for the crossing flash and sound.

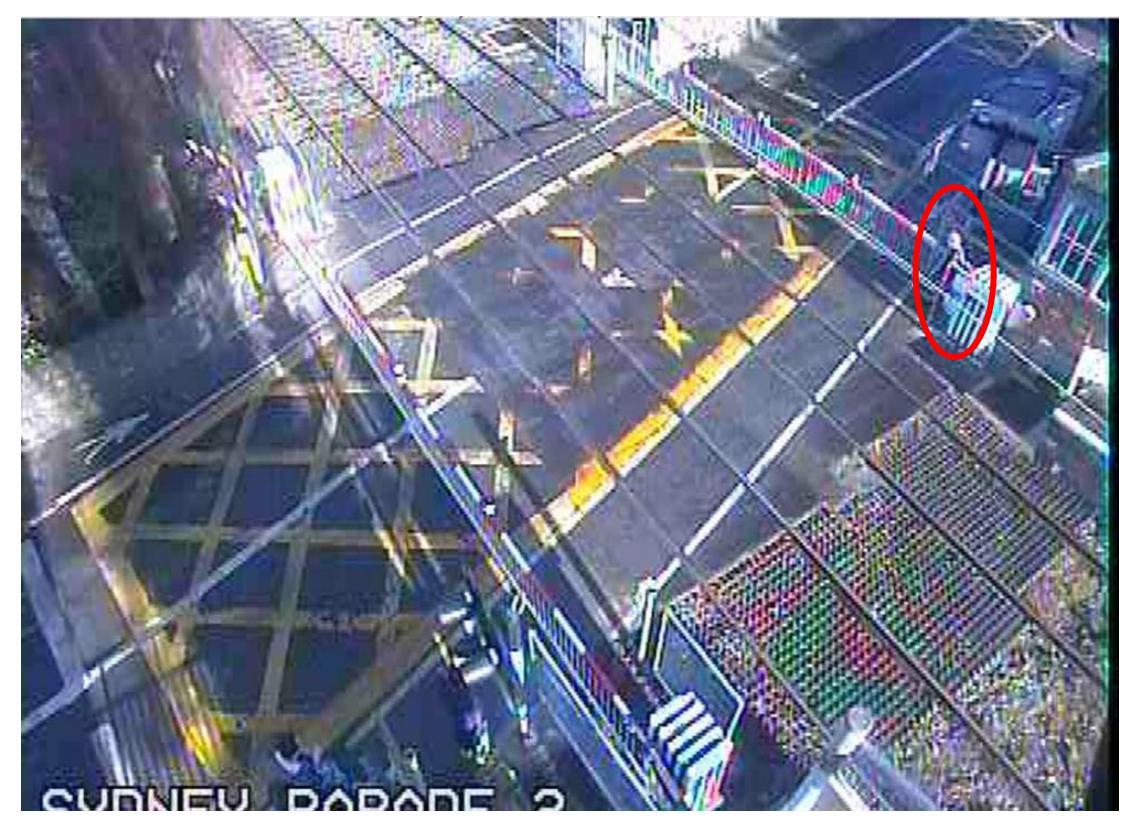
Figure 32 – MOP inside at the barriers (circled red) at LC XR004

- 155 On the 17th February 2015, the initiation for LC XR004 was triggered by the 09:30 hrs passenger service from Greystones to Howth (Train E944).
- 156 The warning lights and bells for the crossing flashed and sounded, respectively. However, a MOP entered LC XR004 and had insufficient time to clear LC XR004. The MOP took refuge between the barrier boom and the protecting mesh fence between the boom and the Down line (Figure 32).

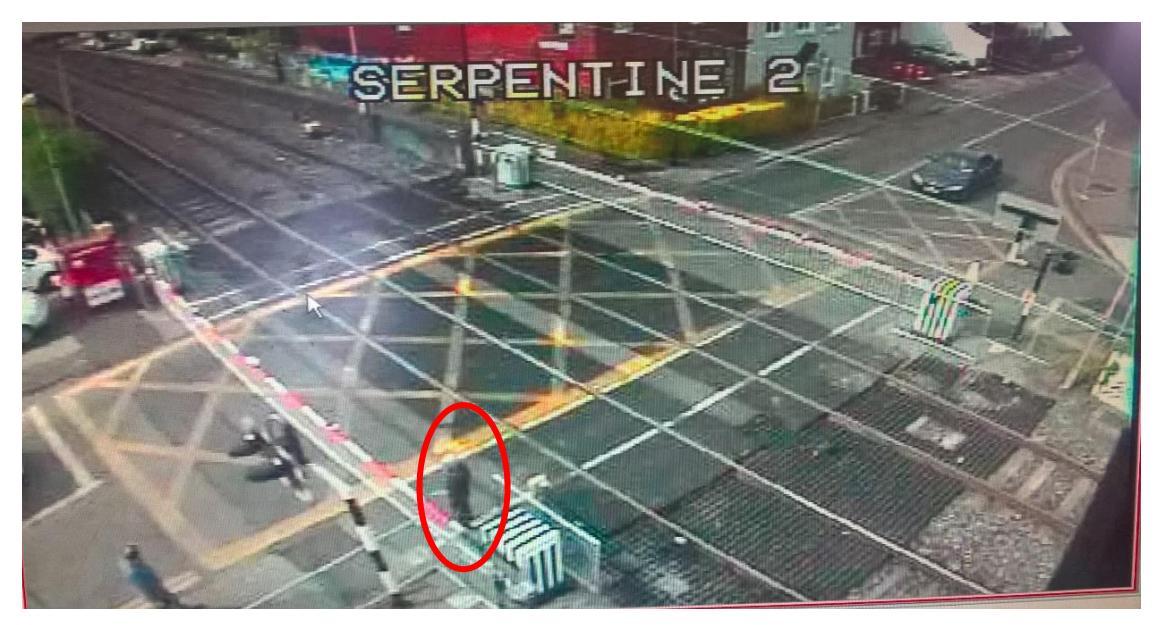
Figure 33 – MOP (circled red) inside the barriers of LC XR002

- 162 A MOP entered LC XR002 despite the visible and audible alarms and had insufficient time to clear LC XR002, and took refuge stand beside a mesh fence at the level crossing boom, see Figure 33.

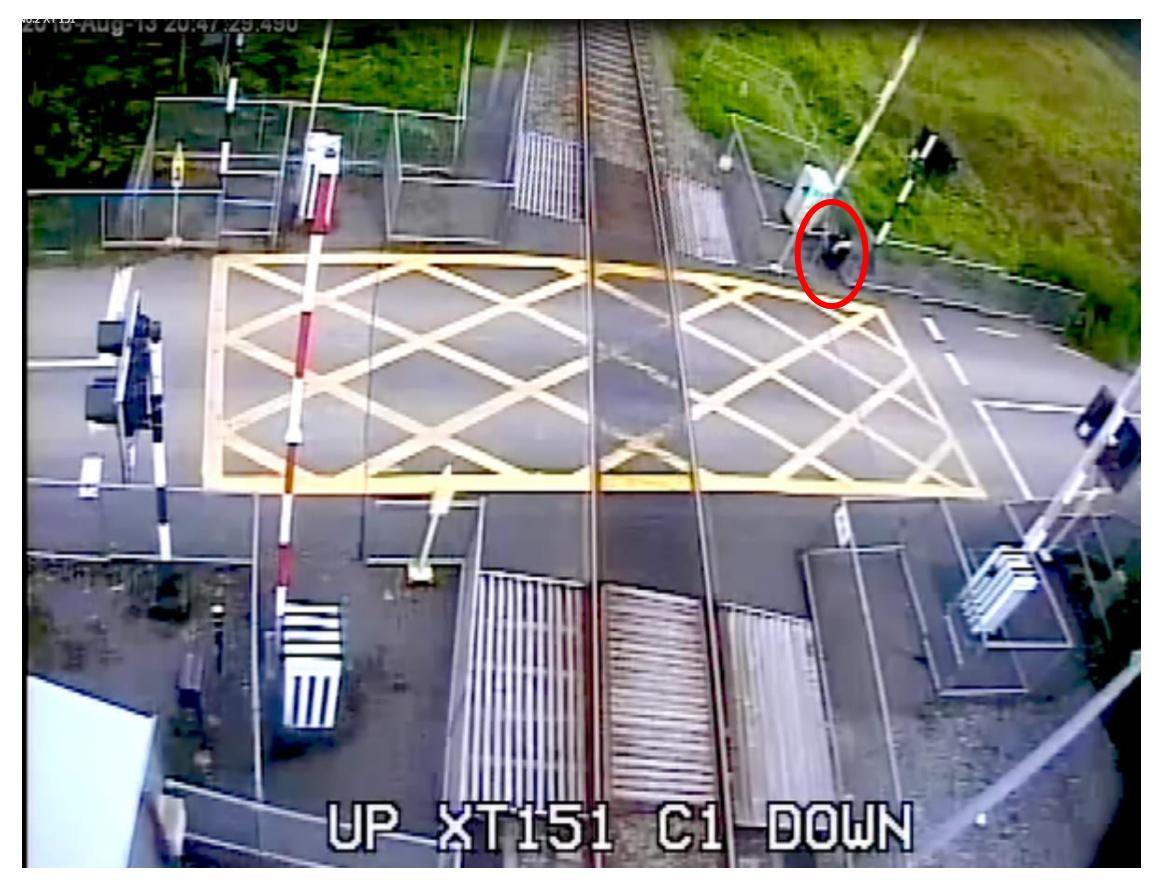
Figure 34 – Two MOPs (circled red) inside the barriers of XT151

- 165 Ahane No. 2 Level Crossing, is identified as XT15, is a four barrier Mid-Section CCTV Crossing is located on the Mallow to Tralee line, between Farranfore and Tralee stations, County Kerry. It is monitored from Mallow Local Control Centre and signalling controlled by the Signalman at the Waterford /Tralee Line signal console in CTC, Connolly.
- 166 On the 13th August 2018, two MOP entered LC XT151 and sat under the exit barrier, see MOPs circled red in Figure 34.

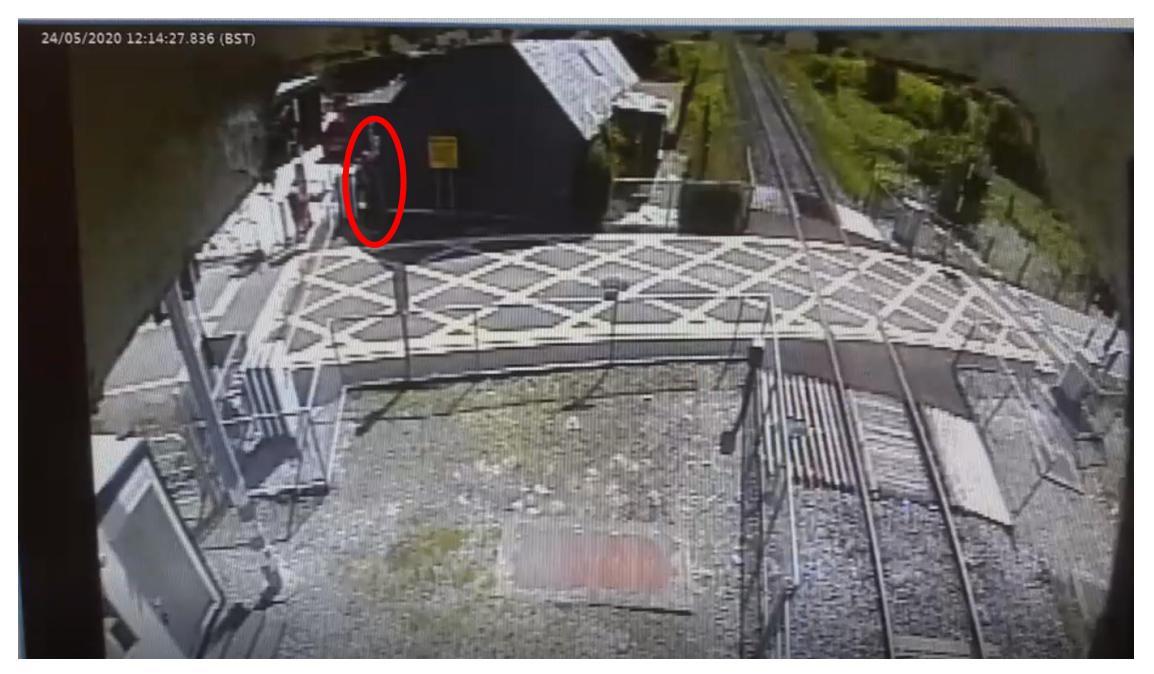
Figure 35 – Moment LC XA068 cleared within two MOPs inside the barriers

- 180 The requirements set out in IÉ-IM's SET's I-TEL-3516, are also met; in particular in relation to the minimum viewable area at LC XA068, whereby all the required aspects are visible in ALCC (paragraphs 47 51). It is noted, that the MOPs are not clearly visible in the still image from the CCTV at the moment the crossing was cleared, shown in Figure 35, as the MOPs are in the shadows cast from the house and with the house painted a dark colour they are difficult to distinguish in the still; however, when the live CCTV footage is viewed the MOP movements are clearly visible.

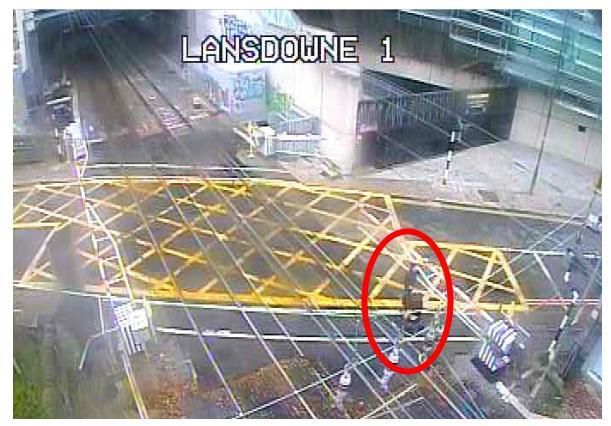
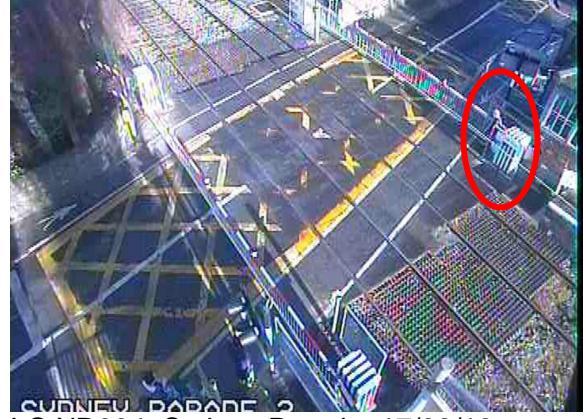
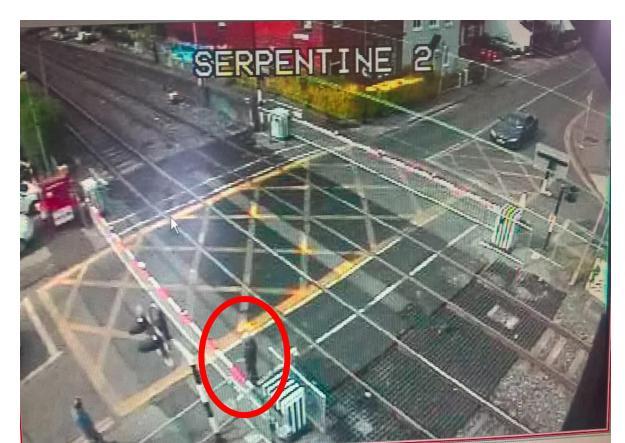
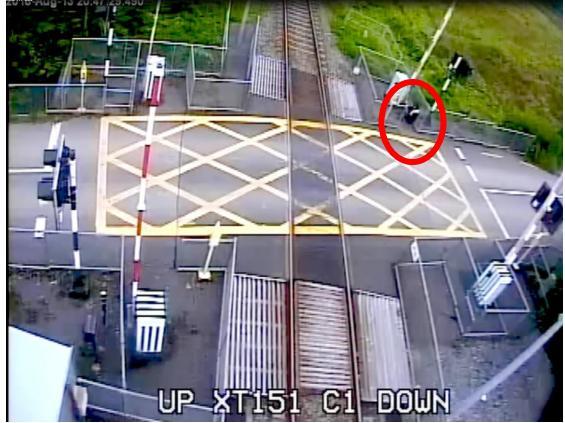
195 Of the eleven similar occurrences highlighted in this report, where MOPs were trapped inside the barriers, it was noted that in four of these incidents (paragraphs 113, 150 - 173) the LCCOs saw movement at the last moments and pressed the "Emergency Alert" function or cancelled the signals (in the case of Ahane No. 2, paragraph 194). The still CCTV images of these occurrences are presented in Figure 36.

LC XR002, Serpentine Avenue, 30/05/18 Figure 36 – Stills from CCTV footage

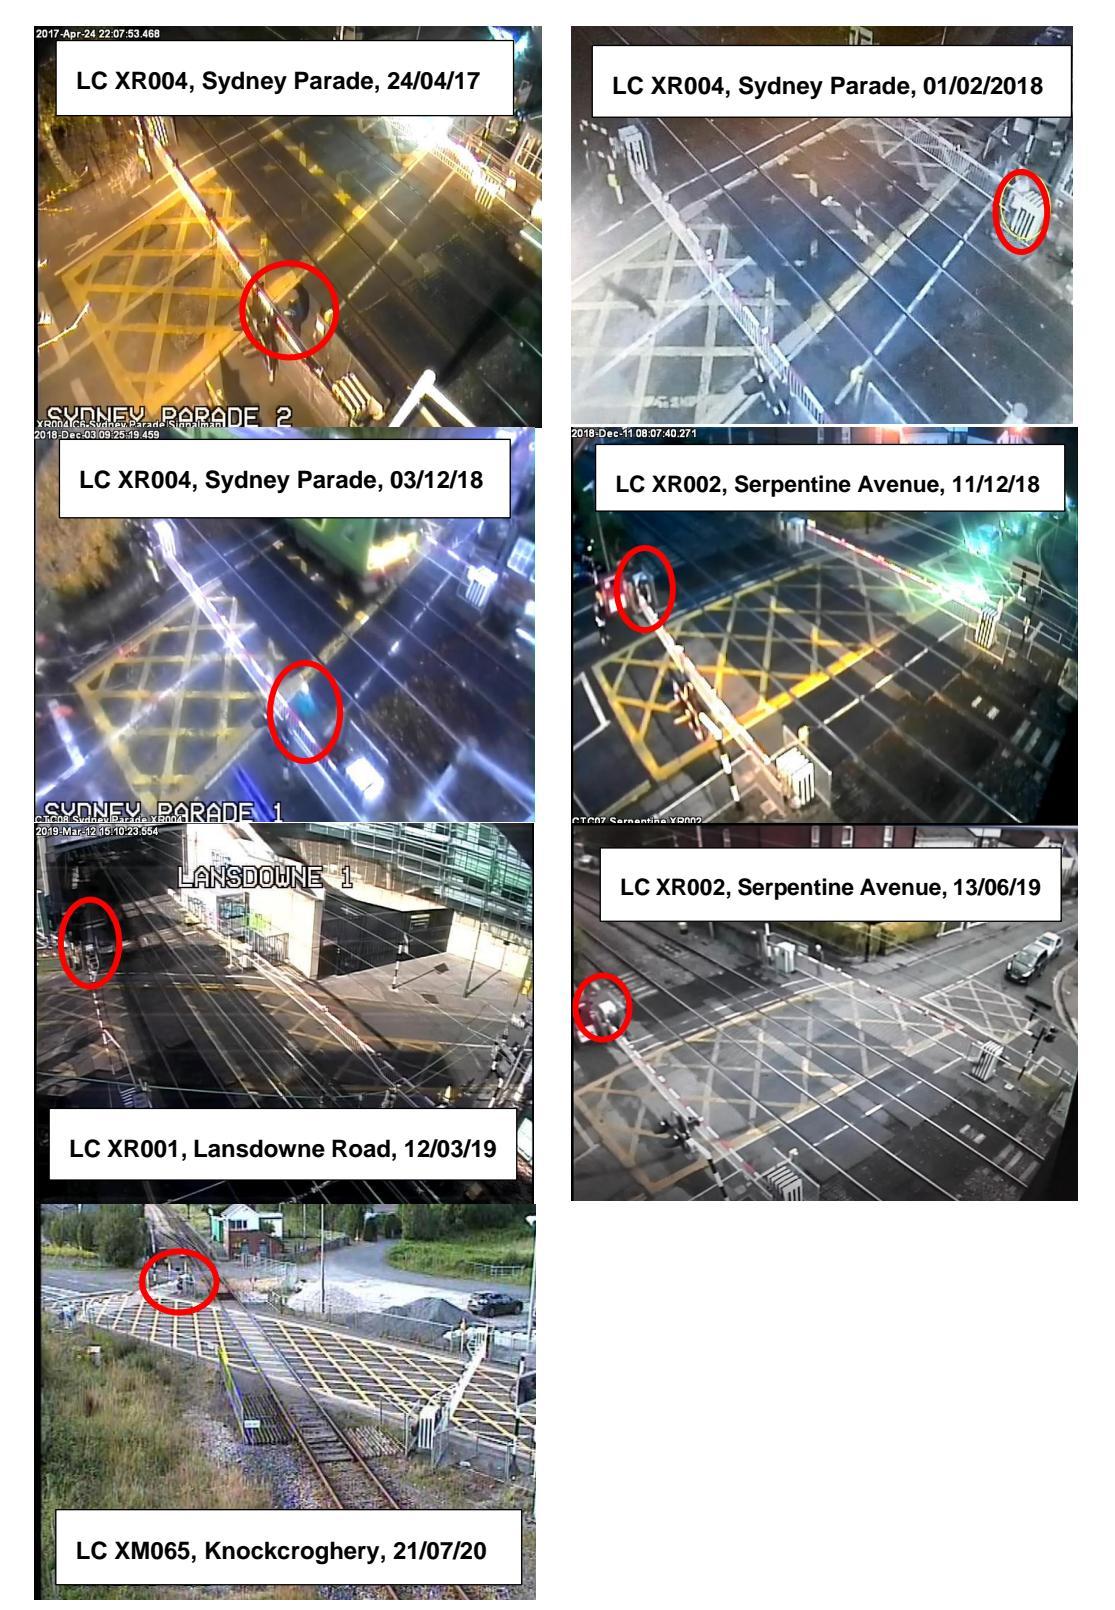
Figure 37 - Still CCTV footage of MOPs inside the barriers

196 In the seven other incidents of similar occurrences identified in this report (paragraphs 115 - 149) the LCCOs did not see the MOPs; and, the trains travelled through the level crossings and were subsequently reported by the train drivers (except in one instance where the driver also did not see the MOP). The images are presented in Figure 37.

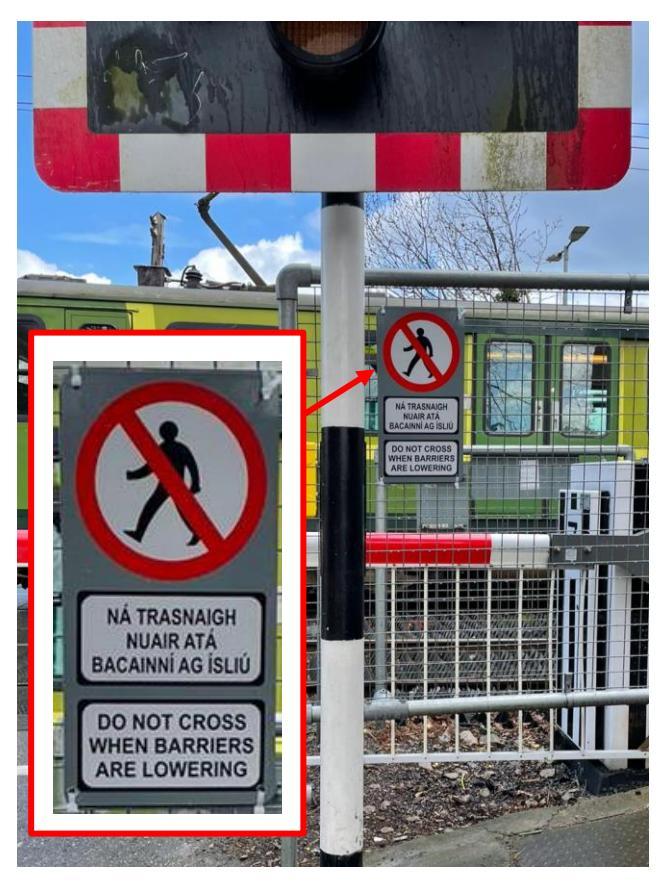
Figure 38 – Signage at CCTV level crossings

- 217 One internal safety recommendation made by IÉ-IM in relation as a result of investigations into similar occurrences, was made/re-iterated seven times from 2017 to 2020 (paragraphs 127, 131, 137, 142, 149, 154, 173), is as follows: "the CCE should examine the feasibility of installing signage at CCTV Level Crossings warning pedestrians not to enter the crossing once the warning lights and bells for the crossing flash and sound"
- 218 As of the time of publication of this report, signage is being erected at CCTV level crossings, see Figure 38.

- Safety Recommendation 202103-03 IÉ-IM Chief Civil Engineer (CCE) should examine the feasibility of installing signage inside the barriers of CCTV level crossings warning MOPs what actions to take in the event of becoming trapped.
