Railway Accident Investigation Unit Ireland

INVESTIGATION REPORT

Overhead Line detachment, Pearse Station,

RAIU Investigation Report No: 2021 - R005

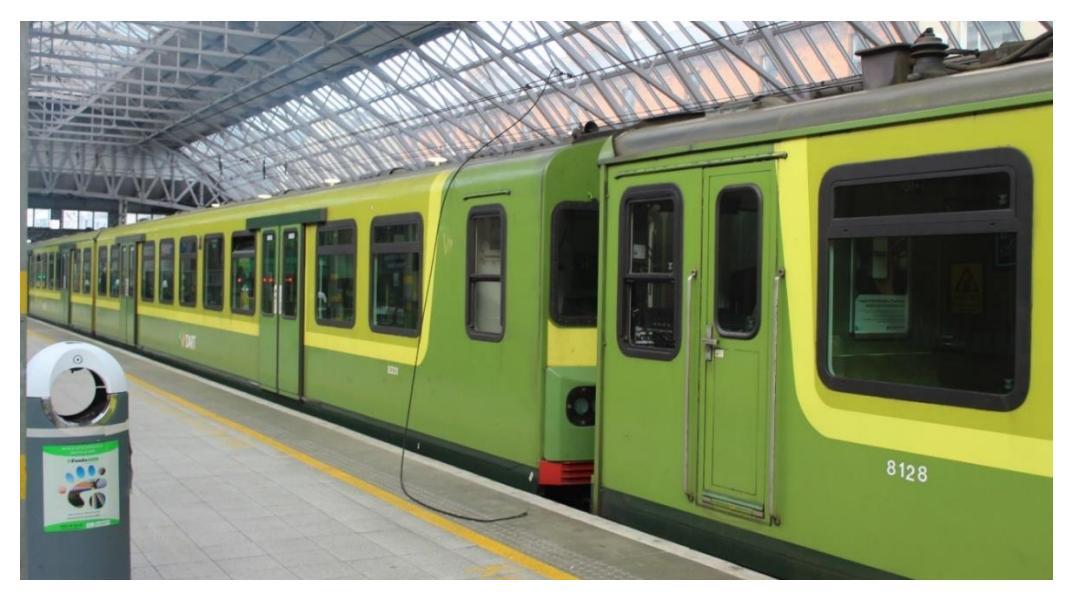
Figure 7 – OHLE wire on Platform 1, Pearse Station

55 After the second flashover, the OHLE wire separated and fell onto Platform 1, Figure 7.

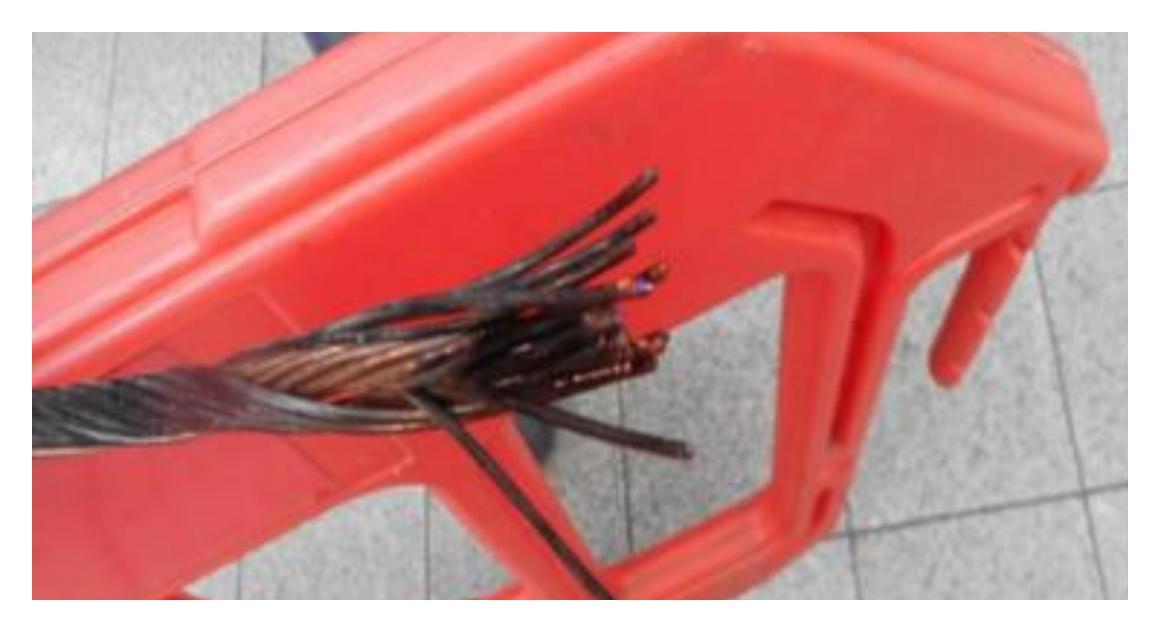
Figure 8 – Broken Catenary Wire

56 The wire that separated was identified as a Catenary Wire. Post-incident, the damaged OHLE was removed and subsequently misplaced and was therefore not available for examination to determine the failure mode. However, a photograph was taken of the Catenary Wire shortly after the incident, Figure 8, which shows evidence of heat damage.

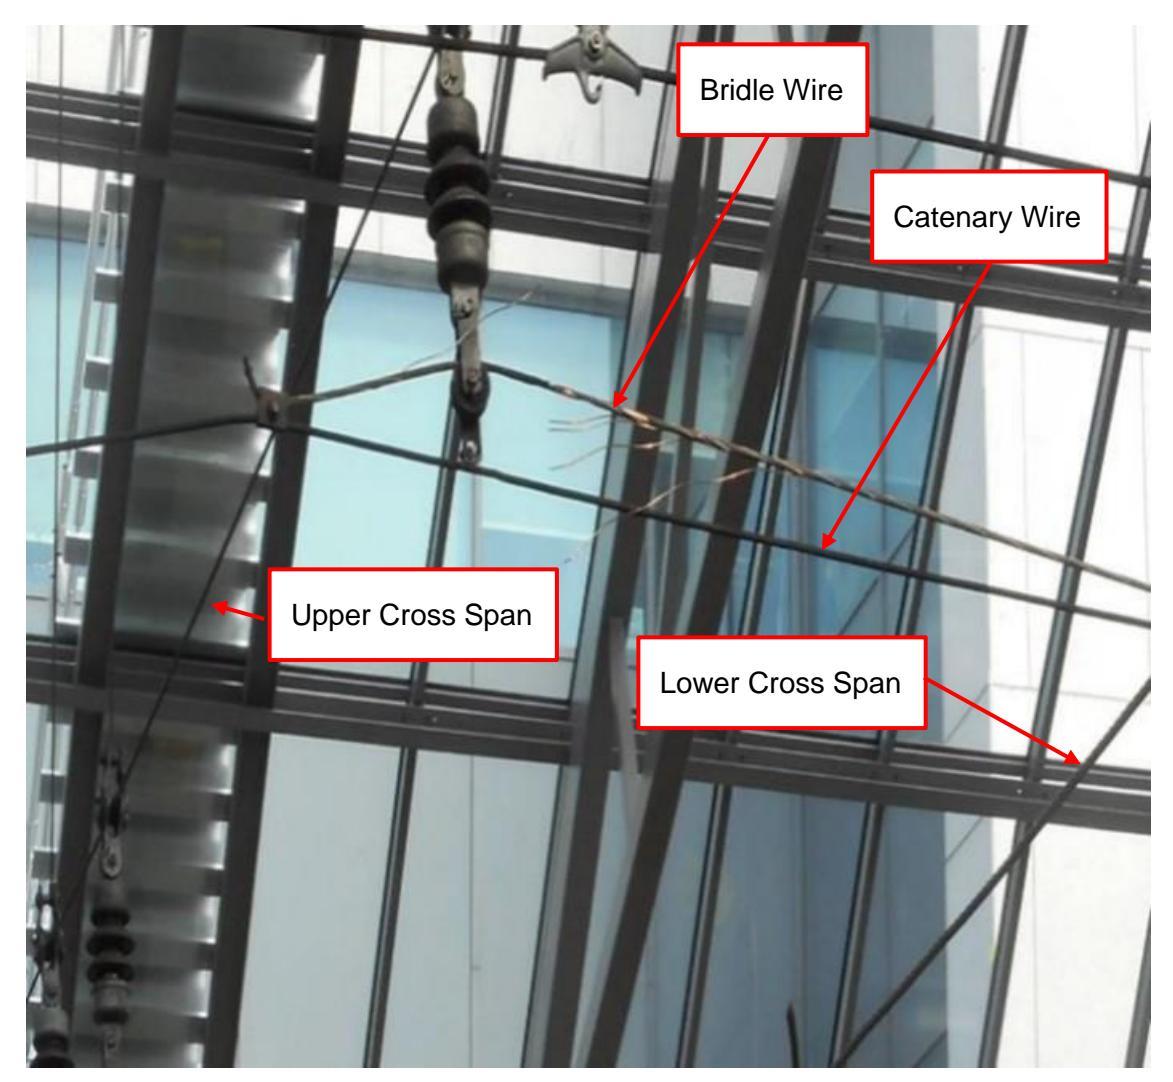
Figure 9 – Frayed Bridle Wire of Cross Span

57 Detailed inspections carried out following the occurrence indicated that a cross span wire had been struck and the bridle wire supporting the catenary wire at the upper cross span (see Figure 9) frayed under tension due to the stress the system was placed under during the events.

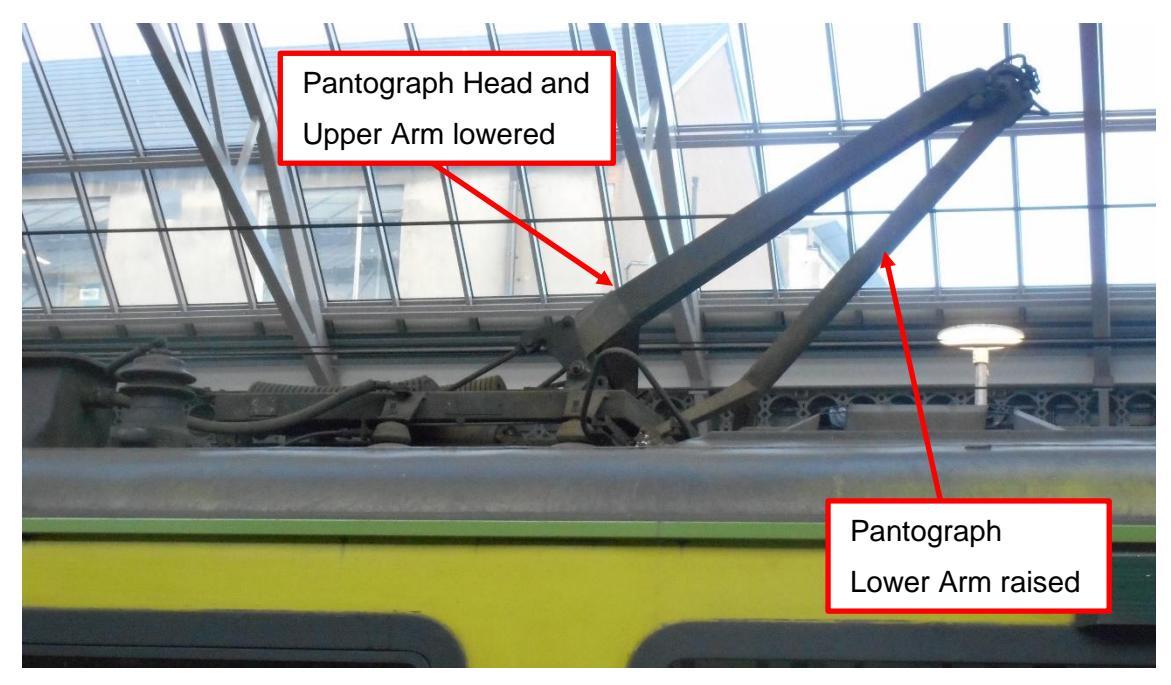
Figure 14 - Pantograph 396 post-incident

83 A post-incident examination of the Pantograph 396, while still mounted on the roof of EMU
8128, identified that the Pantograph Head and Upper Arm had lowered and the Lower Arm
had raised (Pan Flip), see Figure 14.

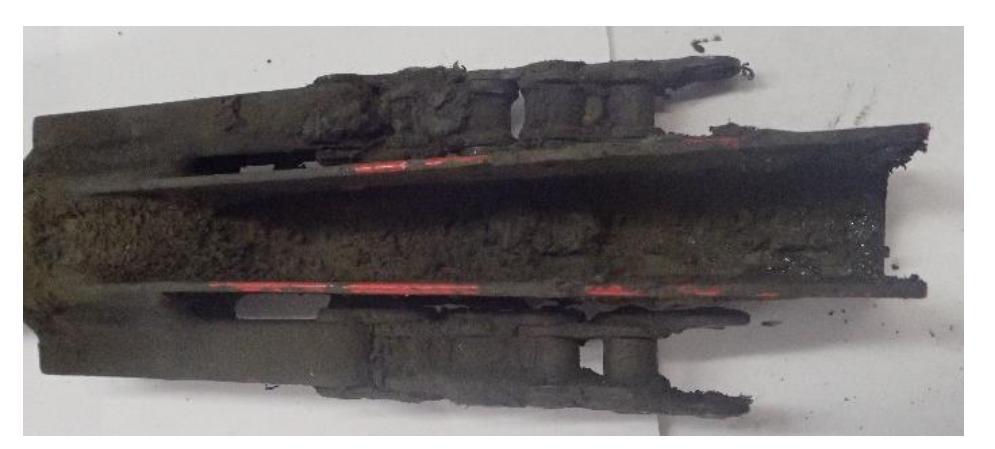
Figure 15 - Post-incident photograph of outer chains joined to the 4th Bar

84 All three elbow chains had broken. The grease on the pantograph elbow chains from Pantograph 396 had broken down and formed a dark thick paste impregnated with grit and had lost its lubricating and rust preventative properties.

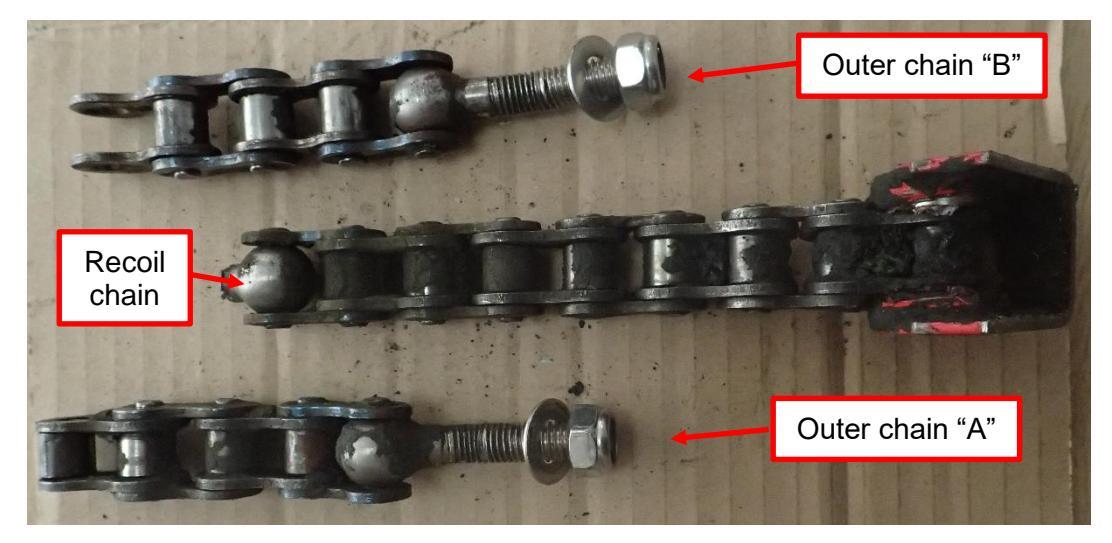
Figure 16 – Broken elbow chains

85 After cleaning the elbow chains of Pantograph 396, the two outer chains were found to be broken at the chain links and the centre or recoil chain was broken at the anchoring screw, see Figure 16.

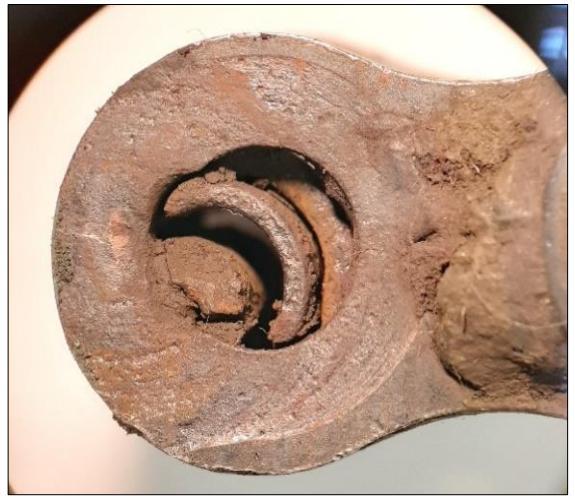
86 Further examination of the outer elbow chains found considerable wear and corrosion had taken place over a period of time. On outer chain "A" approximately half of the roller bush and pin was worn away with evidence of corrosion pitting at the failed link, see Figure 17. On outer chain "B" the pin and roller were missing, and the pin had worn away the link hole, there was clear evidence of corrosion pitting on the failed link, see Figure 18.

Figure 17 – Chain link "A" roller bush and pin worn

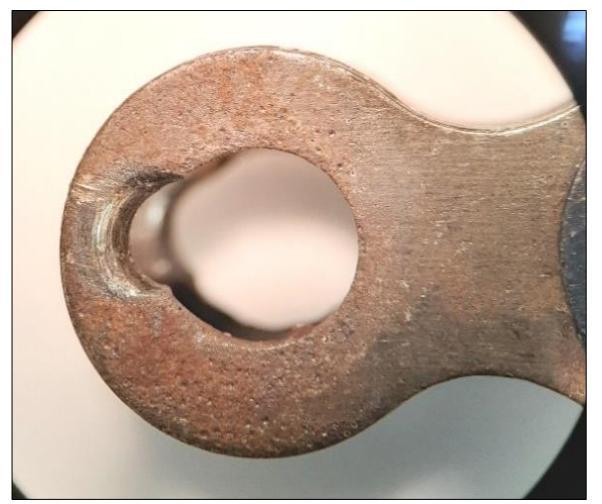
Figure 18 – Chain link "B" pin and bush missing. Pin wear mark on the link hole.

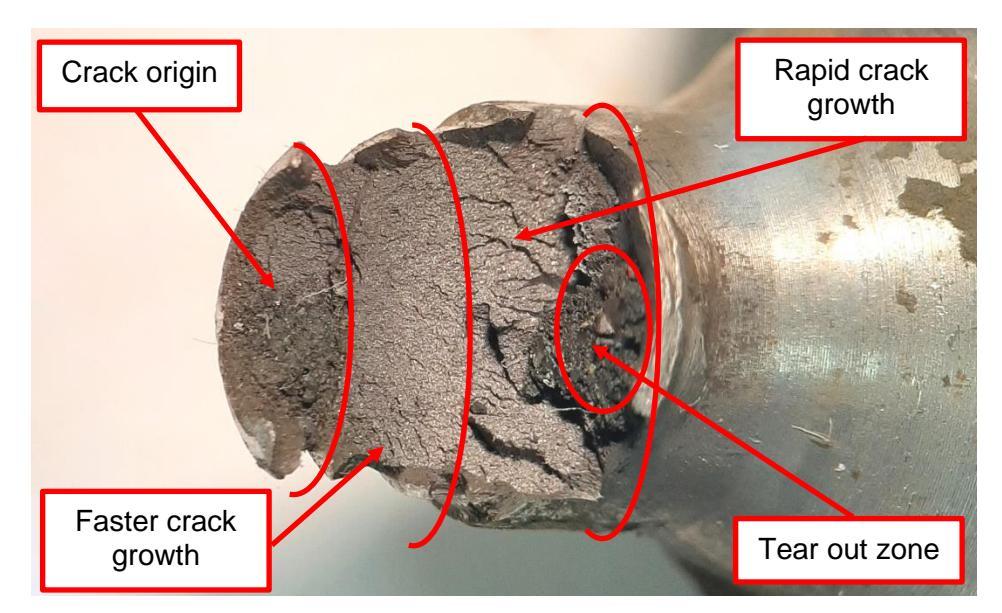
Figure 19 – Anchoring screw failure

87 The centre or recoil chain had failed at the root of the third thread from the ball head of the anchoring screw. There were four distinct phases to the anchoring screw failure: initial slow development; followed by faster growth; fast fracture; and, finally tear out as a result of overload from the two outer chains failing, see Figure 19.

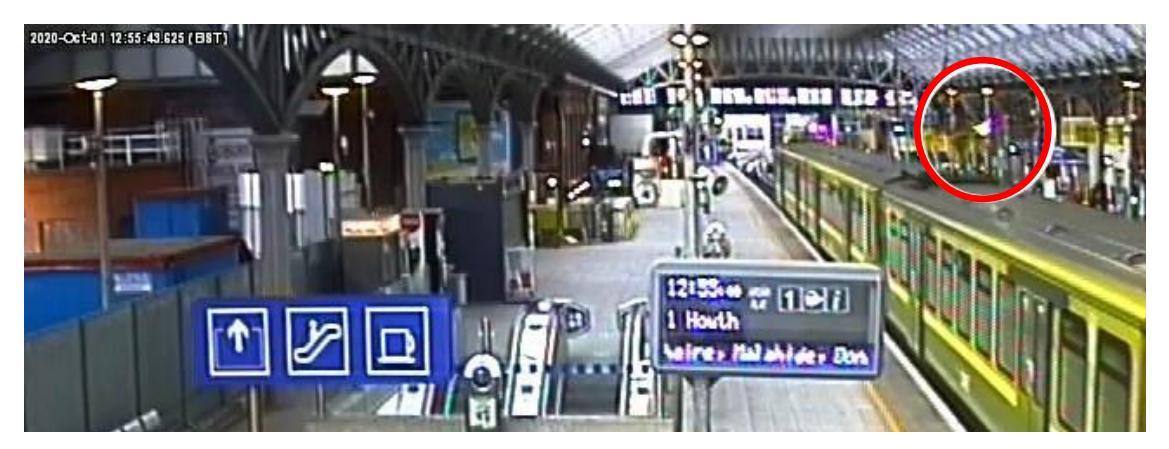
- 88 In the six months prior to the incident, Pantograph 396 received maintenance intervention, as scheduled, with no issues identified (paragraph 81).
- 89 On Thursday 1st October 2020, Train E920, the 12:04 hrs DART service from Greystones to Howth, departed Greystones on time.
- 90 Train E920 served all scheduled stops as far as Grand Canal Dock Station on time, departing Grand Canal Dock at approximately 12:55 hrs heading for its next scheduled stop, Pearse Station.
- 91 At 12:55:30 hrs, Train E920, entered the canopied area of Pearse Station, and slowed on its approach to the stopping point of Platform 1.
- 92 At 12:55:43.625 hrs (times are taken from the CCTV clock), the head of Pantograph 396 (housed on EMU 8128) loses contact with the OHLE, resulting in an *arc flash*, circled red in Figure 20⁹.

Figure 20 - Head of Pantograph 396 loses contact with OHLE resulting in arc flash

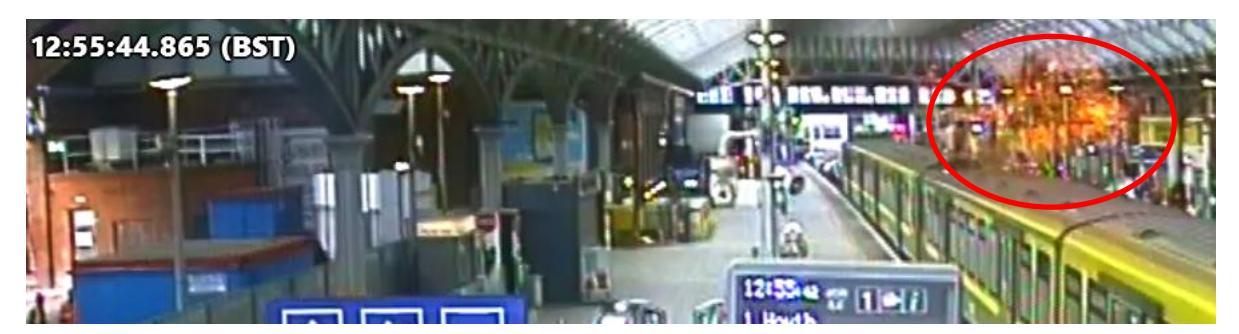
- 94 The SCADA log notes "CB (Circuit Breaker) static overcurrent trip" at 12:55:44.621 hrs and "LTD (Line Test Detection) in operation", "ON", the system performs a Line Test at 12:55:44.843 hrs.
- 95 At 12:55:44.865 hrs, the raised Lower Arm of Pantograph 396 makes contact with the Lower Cross-Span Wire of the OHLE causing it to flip, forcing the Upper Arm and Pantograph Head onto the roof of the train, resulting in a short circuit and a large flash over, circled red in Figure 22.

Figure 22 - Pantograph Head short circuits against the train roof causing a large flash over

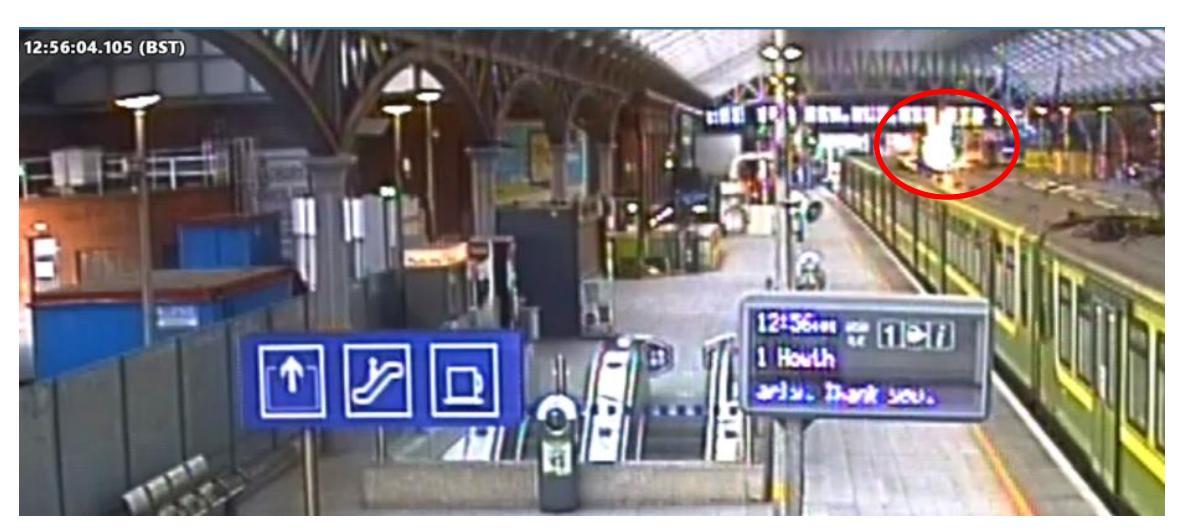
- 98 At 12:56:03.907 hrs SCADA records "CB static overcurrent trip". At 12:56:03.103 hrs "1500 V DC undervoltage" is recorded by SCADA. At 12:56:04.105 hrs, the Auto Reclose function activates (paragraph 51), restoring the power to the section, resulting in a second short circuit and large flash over (circled in red in Figure 22), just before the pantographs lowered.

Figure 23 - Second short circuit and second flash over

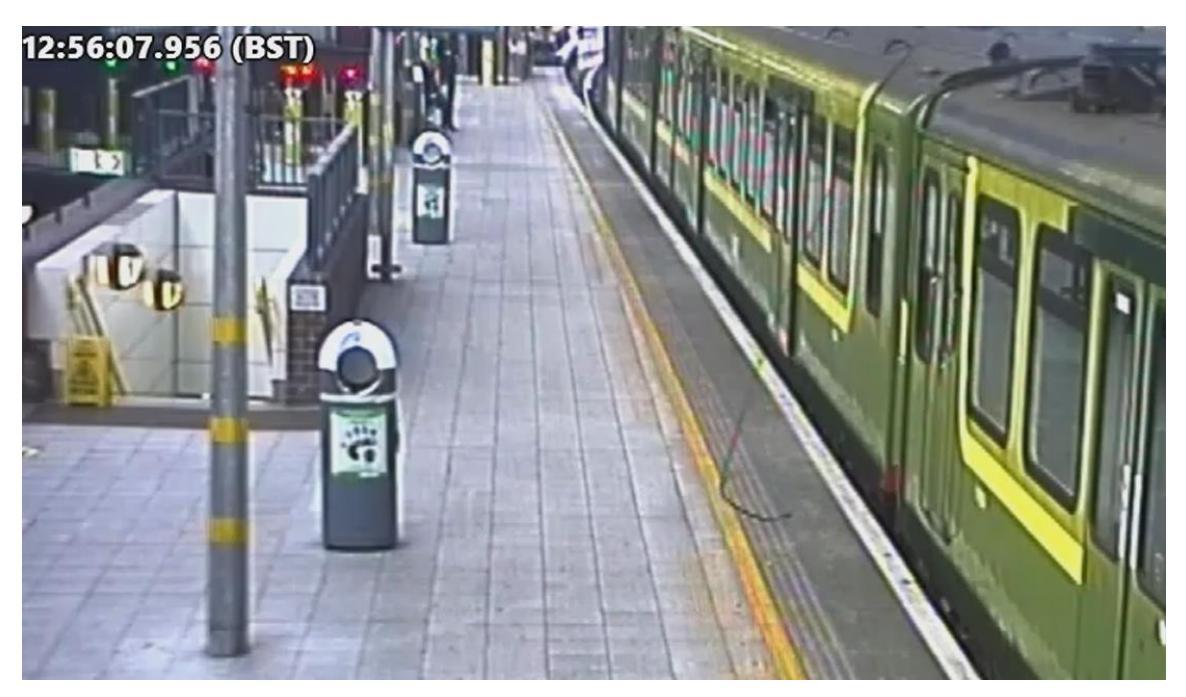
Figure 24 – Catenary Wire on Platform 1

99 The Catenary Wire of the OHLE, then detached and fell onto Platform 1, see Figure 24.

- 100 At 12:56:22.736 hrs, SCADA records that the "1500V DC undervoltage" is "OFF"; clearing the "fault" and restoring the power. While the Catenary Wire was on Platform 1 the Auto Reclose initiated a second closure resulting in current been present on the Catenary Wire on Platform 1 for approximately forty-six seconds.
- 101 At 12:57:08.216 hrs, SCADA records "1.5 kV circuit breaker", "Open Executed"; the ECO (paragraph 54) isolates the OHLE in the section.

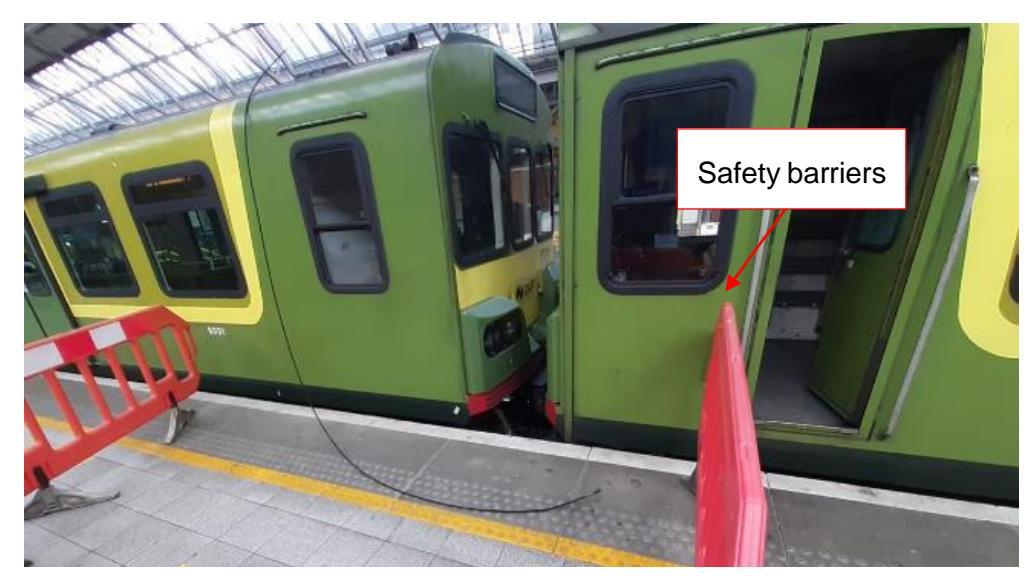
Figure 25 - Catenary Wire with safety barriers

102 Staff members from Pearse Station placed safety barriers around the Catenary Wire on Platform 1 (Figure 25).

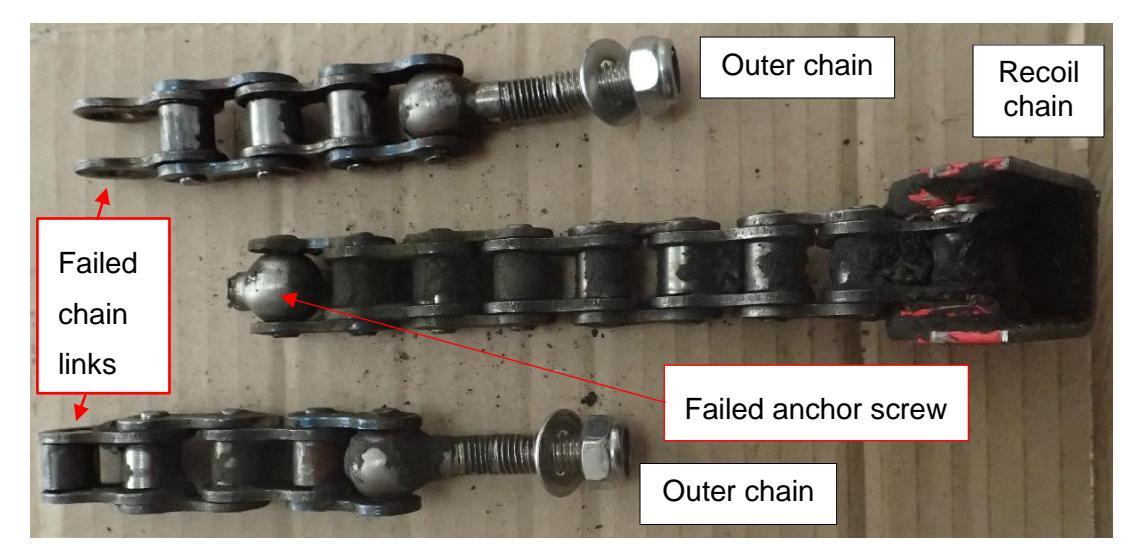
Figure 26 – Failed chain assemblies

- The post-incident examination of the Elbow Chains of Pantograph 396 showed that all three chain assemblies failed. The two outer chains failed first, failure was at the chain links (Figure 26) which were found to have been subject to considerable wear and corrosion over time (paragraph 86). The excessive wear in the chains was likely as a result of a loss of lubricant and rust preventing properties of the grease. This is based on the fact that the grease on the chains at the time of failure was impregnated with grit and dirt (paragraph 84) despite undergoing maintenance intervention eleven days before the failure (paragraph 81).

- The centre Recoil chain failed at the anchor screw (Figure 26) as a result of an overload from the two outer chains failing (paragraph 0).
