# Railway Accident Investigation Unit Ireland

Annual Report 2020

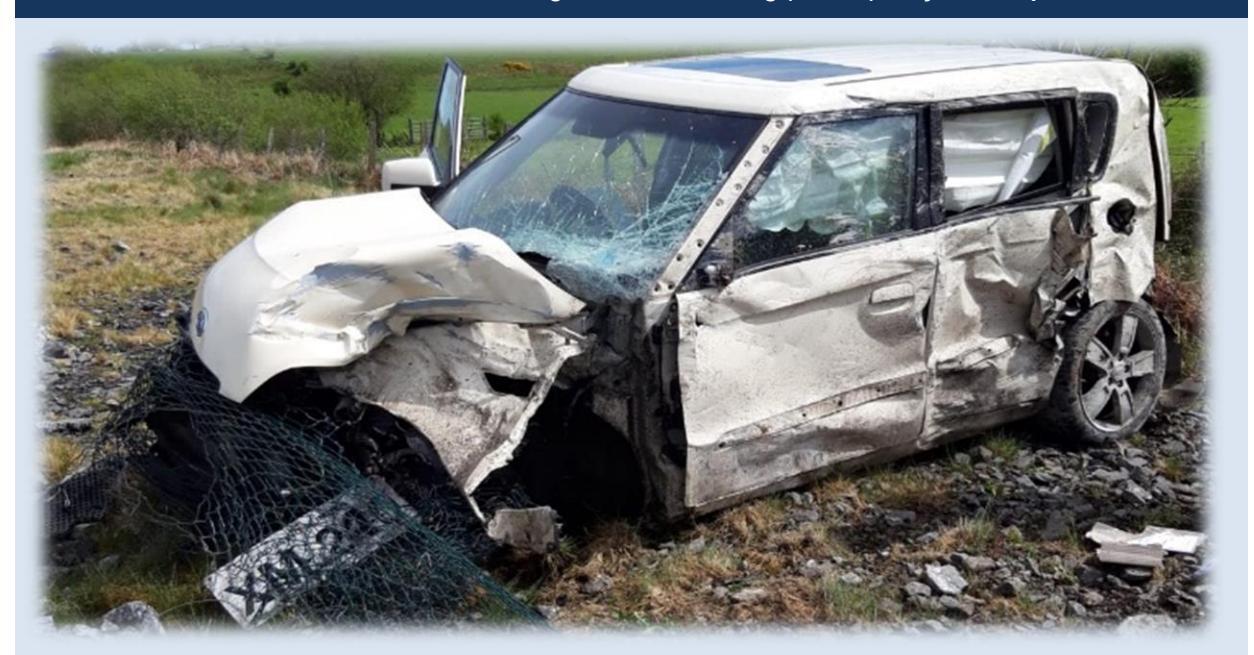
Collision between a car and a train at IÉ Kilnageer Level Crossing (XM240), Mayo, 29th April 2020

At approximately 13:40 hrs on the 29<sup>th</sup> April 2020, the 13:10 hrs passenger service from Westport to Dublin (Train A809) was approaching Kilnageer Level Crossing (LC) XM240, located approximately six kilometres (km) from Castlebar, County Mayo. At the same time a car approached LC XM240 with the gates open (left open by a previous user) and began travelling through LC XM240. When the driver of Train A809 saw the car, he made a full-service brake application; however, the train could not stop in time and struck the car.

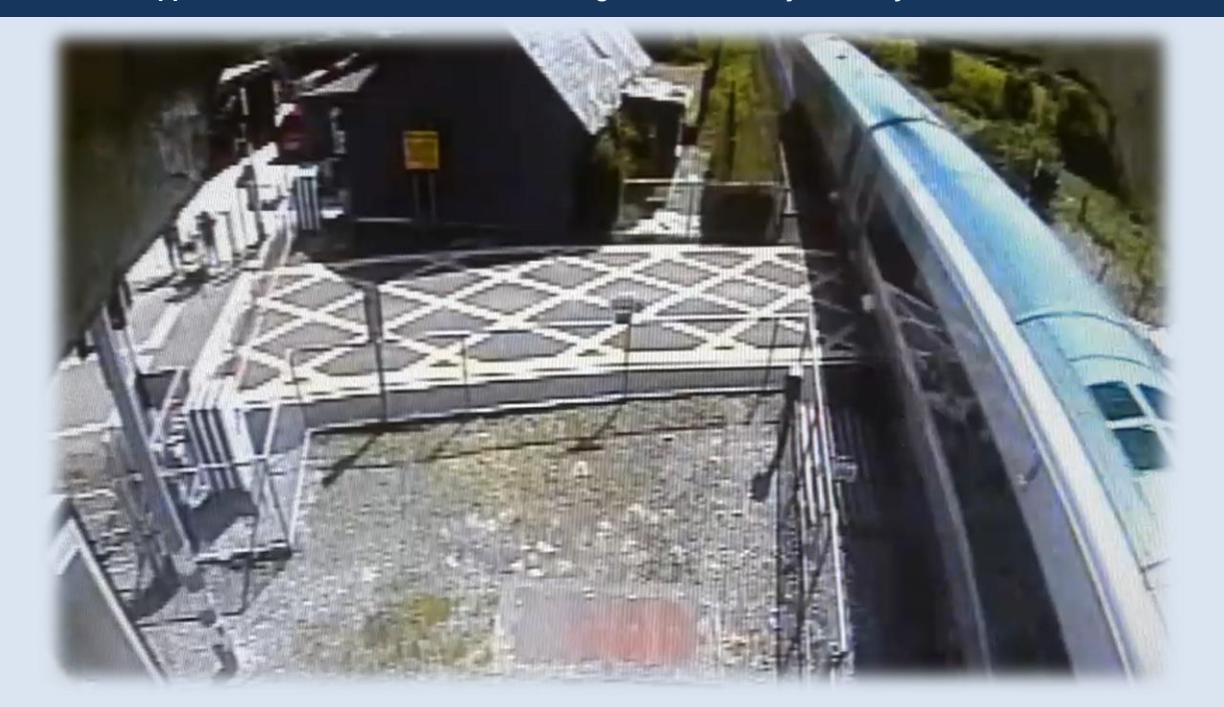
Person entrapped in lowered IÉ CCTV level crossing, Ashfield, Offaly, 24th May 2020

At approximately 12:13 hrs on the 24<sup>th</sup> May 2020, a Level Crossing Control Operative (LCCO), located at Athlone Local Control Centre (ALCC) cleared Closed-Circuit Television (CCTV) Level Crossing (LC) XA068, located in Ashfield, Offaly for the passage of the 11:00 hrs passenger service from Galway to Heuston (Train A703) while a member of the public (MOP) was inside the barriers of the level crossing.

The MOP had requested assistance from LCCO using the telephone provided at the level crossing. LCCO advised the MOP that they would raise the barriers and instructed the MOP to stand beside some level crossing equipment (clear of the tracks, but within the confines of the level crossing). LCCO did not raise the barriers and allowed Train A703 to pass through LC XA068. The MOP was uninjured as a result of this incident.

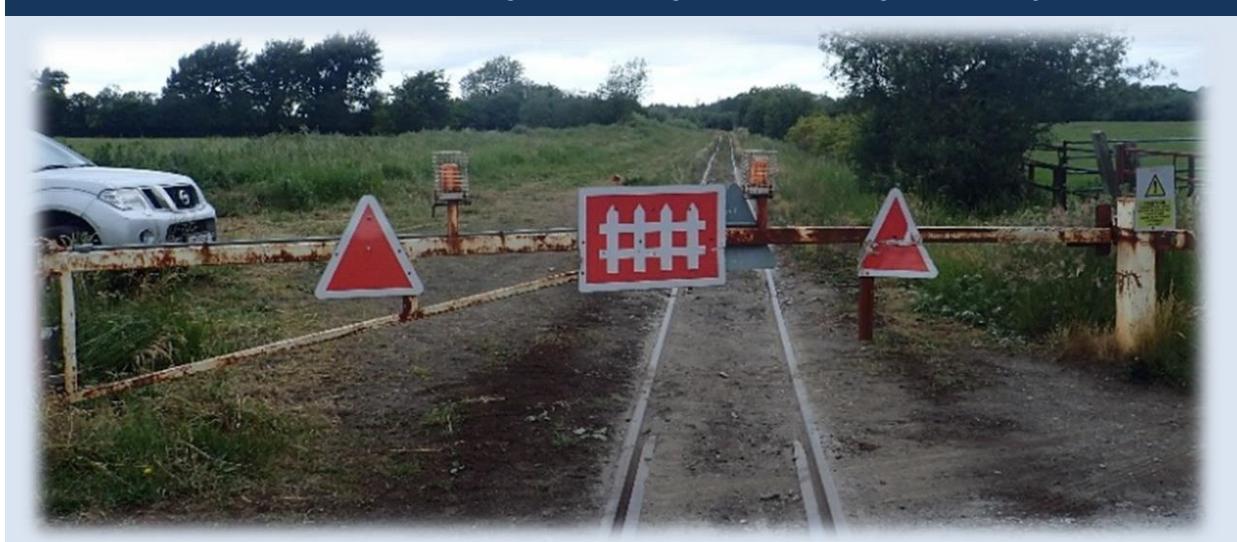
At approximately 13:15 hrs on the 8<sup>th</sup> June 2020 a Bord na Móna (BnM) double rake system travelled through Kilcolgan Level Crossing, closing and opening the derailing points to allow passage through the crossing. At some stage after the passage of the double rake through Kilcolgan Level Crossing, the derailing points were placed in the closed position (possibly by trespassers).

Approximately two kilometres away, works were being undertaken at BnM Worksite 610A, Lemonaghan, in preparation for track renewal work. The works included the transport and unloading of ballast at Worksite 610A by means of a Locomotive, a Flat Wagon and an Excavator. During the ballast unloading, ballast fell from the Flat Wagon onto the track; which in turn resulted in the Flat Wagon derailing during a shunting manoeuvre. The Locomotive was uncoupled from the Flat Wagon to facilitate the rerailing and a lifting chain was placed around the excavator bucket and the Flat Wagon coupling. The Flat Wagon was then lifted, aligned with the track and lowered onto the rail. The chain was removed from the Flat Wagon coupling and the Flat Wagon rolled away towards Kilcolgan Level Crossing.

On approach to Kilcolgan Level Crossing, the Flat Wagon passed over the derailing points (in the closed position) allowing the Flat Wagon to continue towards the gates. The Flat Wagon collided with the first gate at Kilcolgan Level Crossing forcing the gate across local road, L70075, before colliding with the second gate forcing it open away from the road. The Flat Wagon came to a stop approximately 50 metre (m) past Kilcolgan Level Crossing.

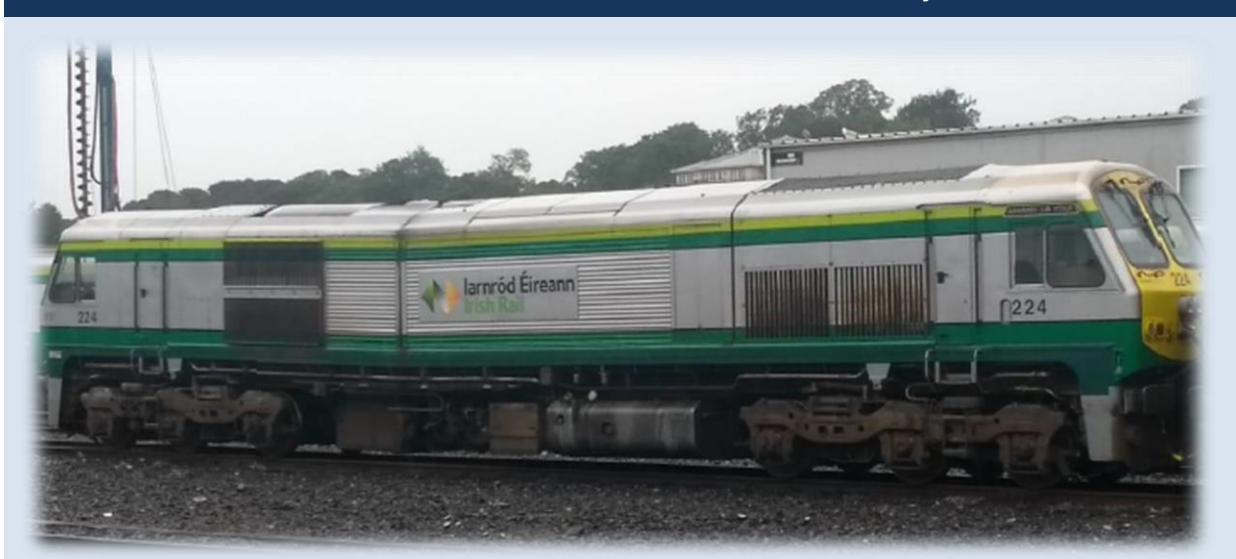
IÉ Chassis Plate Fracture on General Motors Class 201, Locomotive 224, 7th July 2020

On 6<sup>th</sup> July 2020, the 14:25 hrs Cork Kent to Dublin Heuston passenger service operated with Locomotive 224 at the rear. Locomotive 224 experienced a coolant leak and electrical fault that caused the locomotive to shut down while approaching Limerick Junction. The train was deemed a failure and hauled to Heuston Station, Dublin.

On the 7<sup>th</sup> July 2020, while Locomotive 224 was at Heuston Station awaiting transfer to Inchicore Works, a driver observed the body of Locomotive 224 was sagging near the centre point and reported it to his supervisor who in turn alerted the relevant parties. On inspection, by the CME Department's maintenance staff a main frame crack was identified. Locomotive 224 was then shunted to Inchicore Works for a more thorough examination.

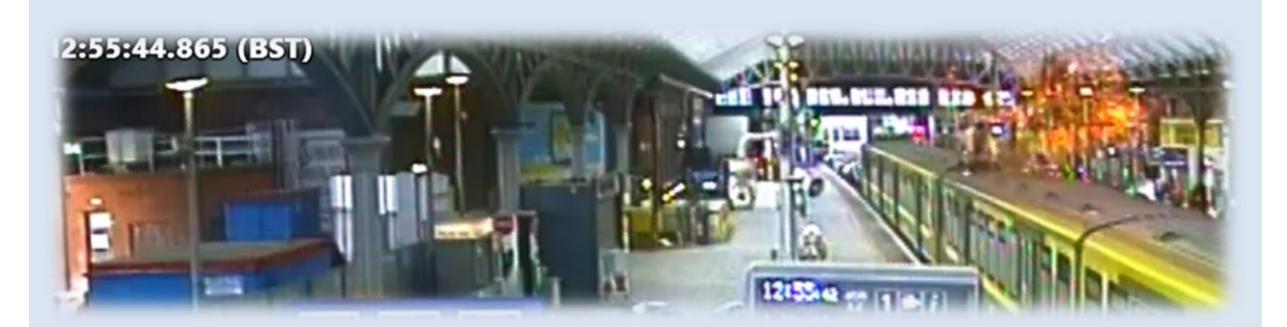
#### IÉ Overhead Line detachment, Pearse Station, 1st October 2020

At approximately 12:55 hrs on Thursday 1<sup>st</sup> October 2020, the 12:04 hrs IÉ DART service from Greystones to Howth (Train E920) was coming to a stop in Pearse Station when the second pantograph (Pantograph 396) of the train set (Unit 8128) lost contact with the Contact Wire of the Overhead Line Equipment (OHLE). The Pantograph Head and Upper Arm lowered rapidly resulting in the Pantograph Lower Arm extending to its maximum reach and contacting the OHLE. This action caused the Pantograph Lower Arm to flip, driving the Upper Arm and Pantograph Head on to the roof of the train resulting a short circuit and a large flashover. The short circuit caused a loss of power to the OHLE in the section. Train E920 coasted before been brought to a stop, on Platform 1, by the driver (Driver E920).

Driver E920, having heard the noise from the flashover, stepped onto Platform 1 to check the train and after observing the OHLE vibrating, returned to the cab and pressed the "Pan Down" button. This resulted in the lead and rear pantographs lowering but the Lower Arm of the Pantograph 396 did not lower (which was later determined to be as a result of the failure of the pantograph chains).

The DART electrification system is fitted with an Auto Reclose function which allows a high speed circuit breaker to automatically reclose after a tripping event provided a successful Line Test has been passed. After the pantograph failure, and following a successful Line Test, the Auto Reclose restored power to the OHLE causing a second short circuit. This resulted in the Catenary Wire from the OHLE breaking and falling onto Platform 1. While the Catenary Wire was on Platform 1 a second Auto Reclose resulted in power been restored to the fallen Catenary Wire. The Catenary Wire remained live on Platform 1 for approximately forty-six seconds before the Electrical Control Operator (ECO) isolated the section. There were two passengers on Platform 1 at the time but not in the vicinity of the fallen Catenary Wire.

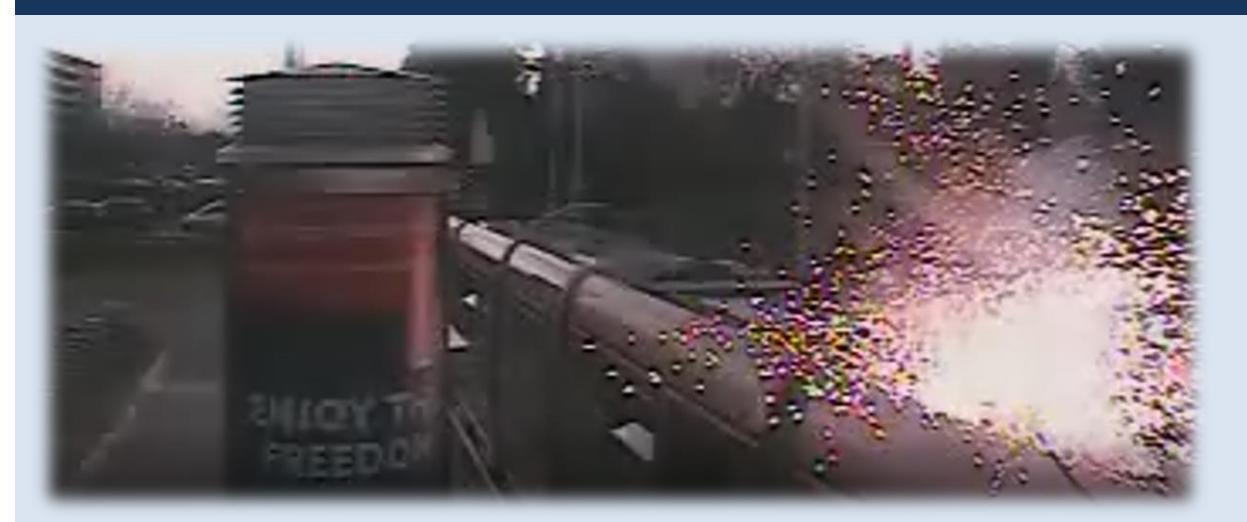
Luas Overhead Line Failure, Stillorgan, 2<sup>nd</sup> November 2020

On 2<sup>nd</sup> November 2020 the 14:31 hrs Luas Service 65 (operated by Tram 5010) from Brides Glen to Broombridge served Stillorgan inbound platform before moving forward to Signal B11. The driver of Tram 5010 (Driver 5010) noticed the Main Circuit Breaker (MCB) had opened in the driving cab (the MCB opened due to its failure to detect 750 volts (V) Direct Current from the Overhead Contact System (OCS)). The loss of 750V DC was the result of the OCS Electrical Supply System, High Speed Circuit Breaker (ESS HSCB) L1 Sandyford opening automatically due to the OCS breaking and short circuiting against the roof of Tram 5010. Driver 5010 also noticed the OCS was sagging and advised the Traffic Supervisor at the LNMC.

The Traffic Supervisor viewed the images from the Close Circuit Television (CCTV) cameras located at the Stillorgan Stop and saw the OCS had broken and was lying across the top of Tram 5010, the outbound track and platform. The Traffic Supervisor instructed Driver 5010 not to open the passenger doors and to keep all passengers inside the tram until otherwise advised. The Supervisory Control And Data Acquisition (SCADA) system indicated that the section in the area of Stillorgan was de-energised.

The Traffic Supervisor identified other trams operating in the vicinity of Stillorgan and requested they stop; which they did. Shortly afterwards, the Traffic Supervisor then began to attempt to reform service and requested that Service 88, Brides Glen to Parnell, (operated by Tram 5003) continue to Sandyford Stop and stop there. At approximately 14:37 hrs, Tram 5003 passed the Insulated Overlap (two OCS contact wires from two electrical sections which provide a continuous supply of power to the tram when the tram passes from one section to the next and also allows for de-energising of one section at a time) between Sandyford and Central Park. As a pantograph head of Tram 5003 traverses the Insulated Overlap, the pantograph bridges both contact wires and electrically connects the two sections together, re-energising the section at Stillorgan where Tram 5010 was located. The re-energising of the section at Stillorgan resulted in a second short circuit between the OCS wire and the roof of Tram 5010. The second short circuit resulted in HSCB L2 (L2 signifies out of City Centre) Sandyford and HSCB L1 (L1 signifies in to the City) Glencairn also tripping out due to overcurrent.

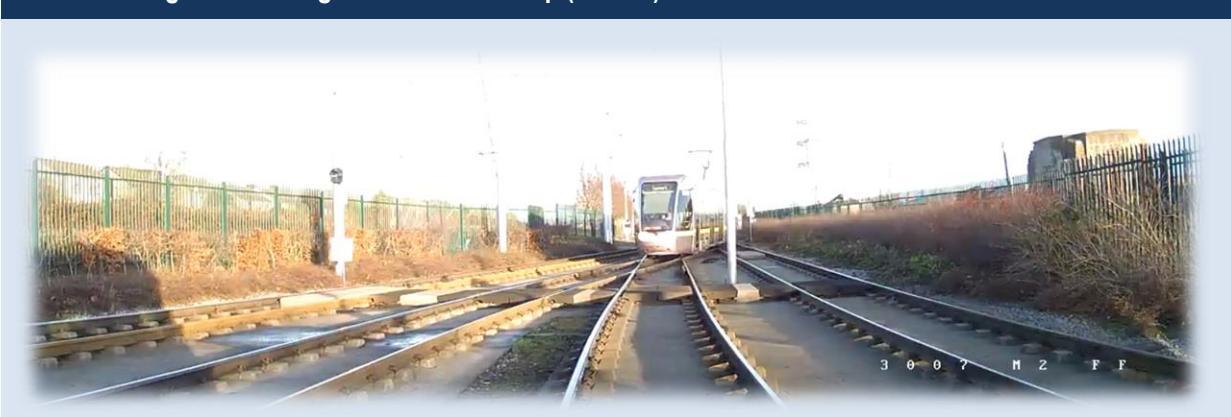
#### Trend Investigation into Signals Passed at Stop (SPASs) on the Luas Network

In February 2020, the RAIU received the monthly occurrence notifications from Transdev in relation to incidents and accidents on the Luas network in January; here it was notified that there had been a signal passed at Stop (SPAS) at Cookstown Interchange, County Dublin, on the 3<sup>rd</sup> January 2020.

On Friday 3<sup>rd</sup> January 2020, the driver of Tram 3007 (Driver 3007), departed Cookstown Inbound Platform travelling to Belgard Stop. At approximately 15:08 hrs, Driver 3007 approached and passed Tram Signal S-2e at the Cookstown LSS area, when it was displaying a "Stop" aspect. At the same time, Tram 3025, travelling Outbound towards Saggart, entered Cookstown LSS on a "Proceed" aspect. On seeing Tram 3025, Driver 3007 stopped Tram 3007, and waited for Tram 3025 to pass before continuing his journey.

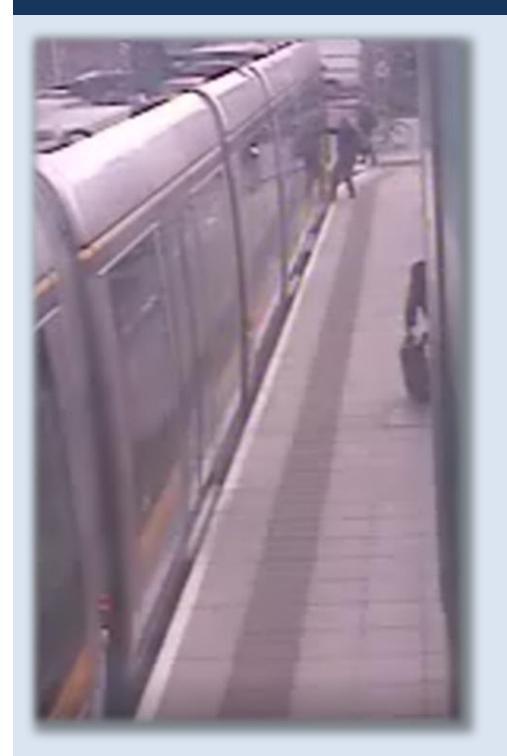
#### Passenger trap-and-drag occurrence on Luas tram at Heuston Stop, 26th March 2019

On the 26<sup>th</sup> March 2019, at approximately 14:22 hrs, a male passenger attempted to board inbound Luas tram, Tram 3011, at Heuston Stop. The passenger placed his hand between the door leaf and the door pillar of the rear most entrance door as the door was closing. The passenger's hand became trapped in the door seals. The door obstacle detection system did not detect the presence of the hand as it was less than 10 millimetres (mm); the door operation mechanism allows 10 mm obstacle detection to facilitate door closing.

The tram departed Heuston Stop nineteen seconds after the doors were closed with the passenger's hand trapped in the door. Two security staff came to the passenger's assistance, with one of the security staff communicating with the driver by radio.

The immediate cause of the passenger hand being trapped in the door of Tram 3011 was the passenger placed his hand in the door opening, as he attempted to board the tram, during the door closing sequence.

- CF-01 The Driver did not conduct an adequate visual check, using rear view monitors and mirrors during
  or after the door closing sequence; this, in part, may be as a result of deficiencies in the mirrors (absent from
  Heuston Stop) and ineffective in-cab monitors (older black and white monitors);
- CF-02 There were no labels warning the passenger of the risk of attempting to board or exit a tram while the doors are closing;

- Safety Recommendation 2020001-01 Transdev should update their suite of document for driver training (SM 017 Driver Training Plan), operations (TSI Manual) and competence assessment (SM 018 & SM 019 Competence Assessment) to include a requirement for drivers to conduct a thorough final visual check (using CCTV and mirrors) after obtaining doors closed and locked indications and before moving the tram to confirm that nothing is trapped in the doors;

- Safety Recommendation 2020001-02 Transport Infrastructure Ireland (TII) should conduct a riskbased review on whether CCTV platform monitors should be installed at high-use tram stops;

- Safety Recommendation 2020001-03 TII should conduct a risk-based review on whether the tram fleet operating on the Red Line should be upgraded with coloured rear view monitors;

- Safety Recommendation 2020001-04 Transdev and TII should develop new labels, for the application on tram doors, which warn passengers of the dangers of closing doors;

- Safety Recommendation 2020001-05 Transdev, as part of the update to the SMS 018 Competence Assessment, should formally include the assessments that should be conducted every quarter;

- Safety Recommendation 2020001-06 Transdev should brief drivers on the operation of the door mechanism, and specifically explain the removal of obstacle detection for the final 10 mm of door travel; this briefing should then be incorporated into their suite of training and competence management documents;

- Safety Recommendation 2020001-07 Transdev should develop and implement an induction training and competency assessment program for security staff, which should include training and assessment in the use of safety critical communications;

- Safety Recommendation 2020001-08 Transdev should update their Work Instructions (WIs) to ensure that appropriate testing is conducted for sensitivity of obstacle detection, door impact for closing forces and obstacle removal forces; the requirements set out in Irish Standard (I.S.) EN 14752 should be used, as appropriate;

- Safety Recommendation 2020001-09 Transdev should update their drugs and alcohol policy to include explicit requirements that testing is conducted post incident/accident where the actions of a driver may have contributed to the incident/accident. Transdev should also develop a system whereby a decision not to test an individual is documented with clear justification for the decision provided;

- Safety Recommendation 2020001-10 Transdev should update their Chain of Care Procedure mandating that drivers are subject to appropriate developmental supports (such as assessment, monitoring and supervision) post incident/accident. Depending on the type of incident/accident, and whether the actions of the driver contributed to the incident/accident, specified periods of time of continuing developmental supports should be set.

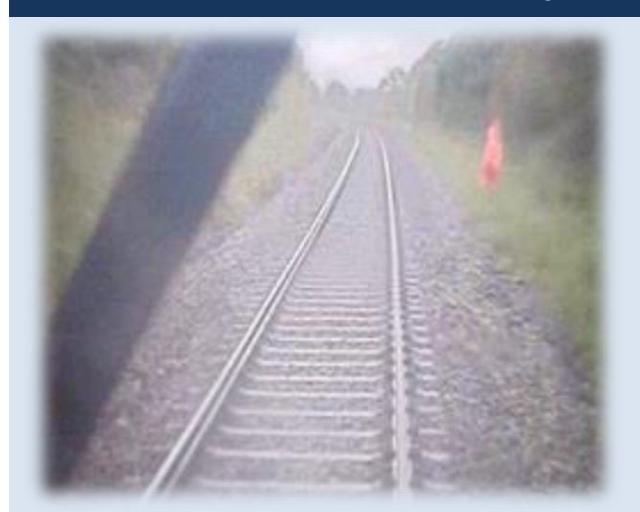
#### Near miss with an larnród Éireann Patrol Ganger near Woodlawn, Galway, 4th June 2019

At approximately 10:04 hrs on the 4<sup>th</sup> June 2019, the 09:30 hrs passenger service from Galway to Heuston train departed Woodlawn Station. On route to Ballinasloe Station, on a curved section of track, the driver saw a person in high visibility clothing walking on the line in the five foot with his back to the oncoming train. The driver placed the train brake in the emergency position and sounded the train horn to warn of the train's approach. The person identified was an IÉ-IM Patrol Ganger who then stepped off the

track into the cess, approximately four seconds before the train passed. The driver brought the train to a stop and reported the incident. The weather at the time of the incident was raining with high gusts.

The immediate cause of the incident was that Patrol Ganger was in a position of danger as the requirements of the IÉ Rule Book could not be met in full for his patrol length. Contributory factors to the incident were:

- CF-01 The location of the incident did not have the required sighting distances available for a patrol ganger to conduct the inspection within the parameters set out in the IÉ Rule Book;
- CF-02 The Patrol Ganger was walking in the same direction as the oncoming train;
- CF-03 There was adverse weather conditions at the time of the incident, which may have affected the Patrol Ganger's ability to hear the train.

- UC-01 The IÉ-IM Chief Civil Engineer's (CCE) Department Risk Assessment and Section B, Part Two of the IÉ Rule Book are not practical in the provision of protection to patrol gangers at locations with inadequate sighting distances;
- UC-02 There appears that IÉ-IM have, over a long period of time, accepted a certain element of risk in relation to track patrolling given that known dangers are not being adequately mitigated by patrol gangers or their managers.

- Safety Recommendation 202002-01 IÉ-IM should review its track inspection methods to see if technological/ mechanised systems and/ or other safety measures could be implemented to eliminate/ minimise track worker exposure to railway hazards whilst undertaking the task of track patrolling;
- Safety Recommendation 202002-02 IÉ-IM should, through their risk assessment process, conduct a
  review of the patrol lengths, with the objective of identifying all patrol lengths with associated risks, and
  introducing adequate mitigation measures to eliminate these risks. Consideration should be given to the
  introduction of technologies (such as anti-collision devices) for use by patrol gangers, with the objective of
  warning patrol gangers of oncoming trains.

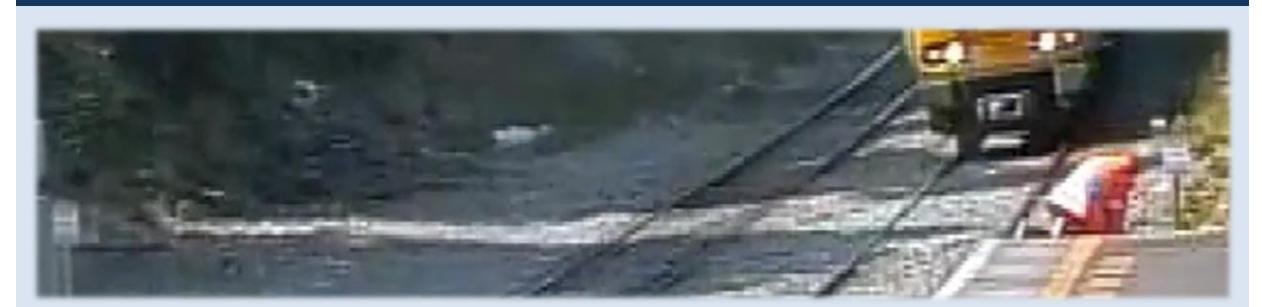
Near-miss collision between a train and an IÉ-IM staff member, at Rush and Lusk Station, 20th June 2019

At approximately 09:50:31 hrs, on the 20th June 2019, a member of IÉ-IM's SET Department's staff (to be referred to as SET Worker) accessed the railway line at Rusk and Lusk Station and began walking on the railway line (Up Line). The SET Worker was accessing the railway line to inspect electrical equipment associated with a nearby SET location case.

Seven seconds later the SET Worker sees the 08:00 hrs Belfast to Connolly passenger train approaching on the Up Line and starts to walk towards the other railway line (not occupied by the train, the Down Line). At 09:50:42 hrs, while standing in the middle of the Down Line, he raises his hand above his head to acknowledge the presence of the train, he is not in a position of safety. Two seconds later (09:50:44 hrs) the SET Worker walks across to the Down Platform and leans his elbow down on the platform and raises his other hand to acknowledge the train for a second time, he is not in a position of safety.

- What special protection arrangements are required either at night or during the day.
- Safety Recommendation 2020003-02 IÉ-IM should brief all staff of their requirements, under the IÉ Rule Book, to wear their high visibility clothing correctly.
Collision between an larnród Éireann passenger train and rail-mounted maintenance equipment, Rosslare, Wexford, 11th January 2020

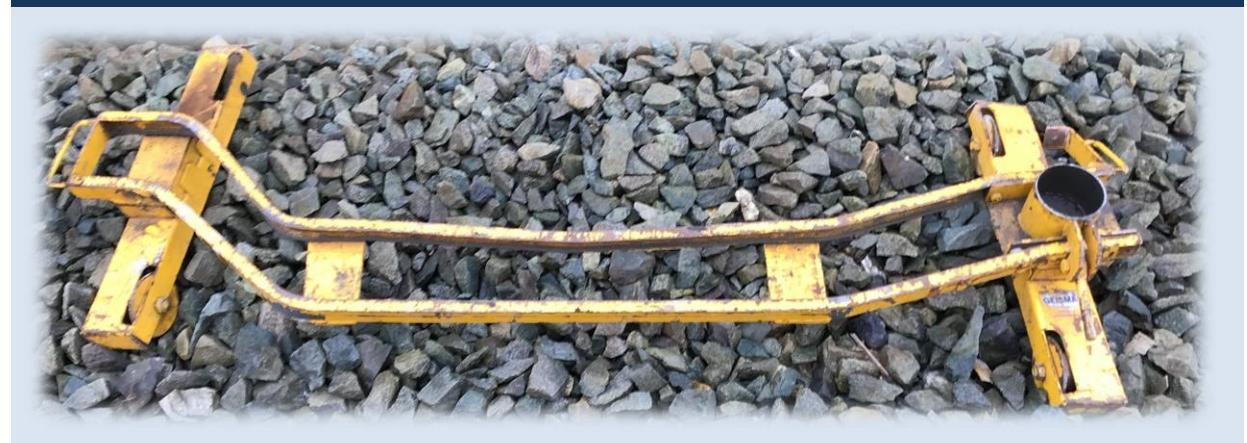
On 11<sup>th</sup> January 2020, T3 Possessions were granted between the 112 Mile Post (MP) 880 yards and the 112 MP 1320 yards (Rosslare Strand to Rosslare Europort) for IÉ-IM CCE Department in relation to the Rosslare Coastal Erosion Project.

The work being undertaken in the T3 Possessions included the erection of viewing distance marker boards (sometimes referred to as V Boards) on the north and south sides of a newly re-opened level crossing, adjacent to Hayesland IÉ-IM compound. There were four members of CCE staff, working in pairs, erecting the V Boards on the north and south sides of the level crossing. The pair working on the south side included the Person In Charge Of Possession (PICOP)/ Engineering Supervisor (PICOP/ES) and the other pair, working on the north side, included the Acting Permanent Way Inspector (APWI).
