Railway Accident Investigation Unit Ireland

INVESTIGATION REPORT

Collision between a car and a train at Level Crossing XM190, Mayo, 9th September 2023

RAIU Investigation Report No: 2024-R003 Published: 12/12/2024

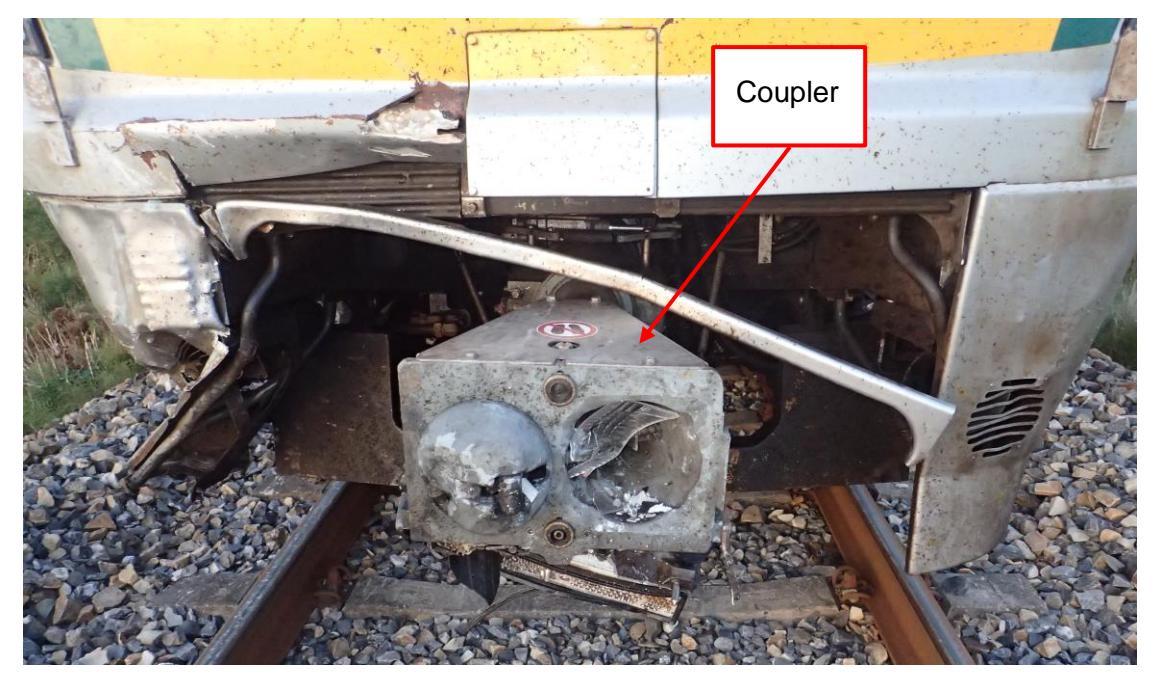
Figure 2 – Damage to Train A804

21 The Chief Mechanical Engineer's (CME) Department examined Train A804 and recorded damage to the body work, coupler (which was in the extended position) and pneumatic braking system of the leading carriage (see Figure 2); estimating the total cost of repair to Train A804 as €263,005.

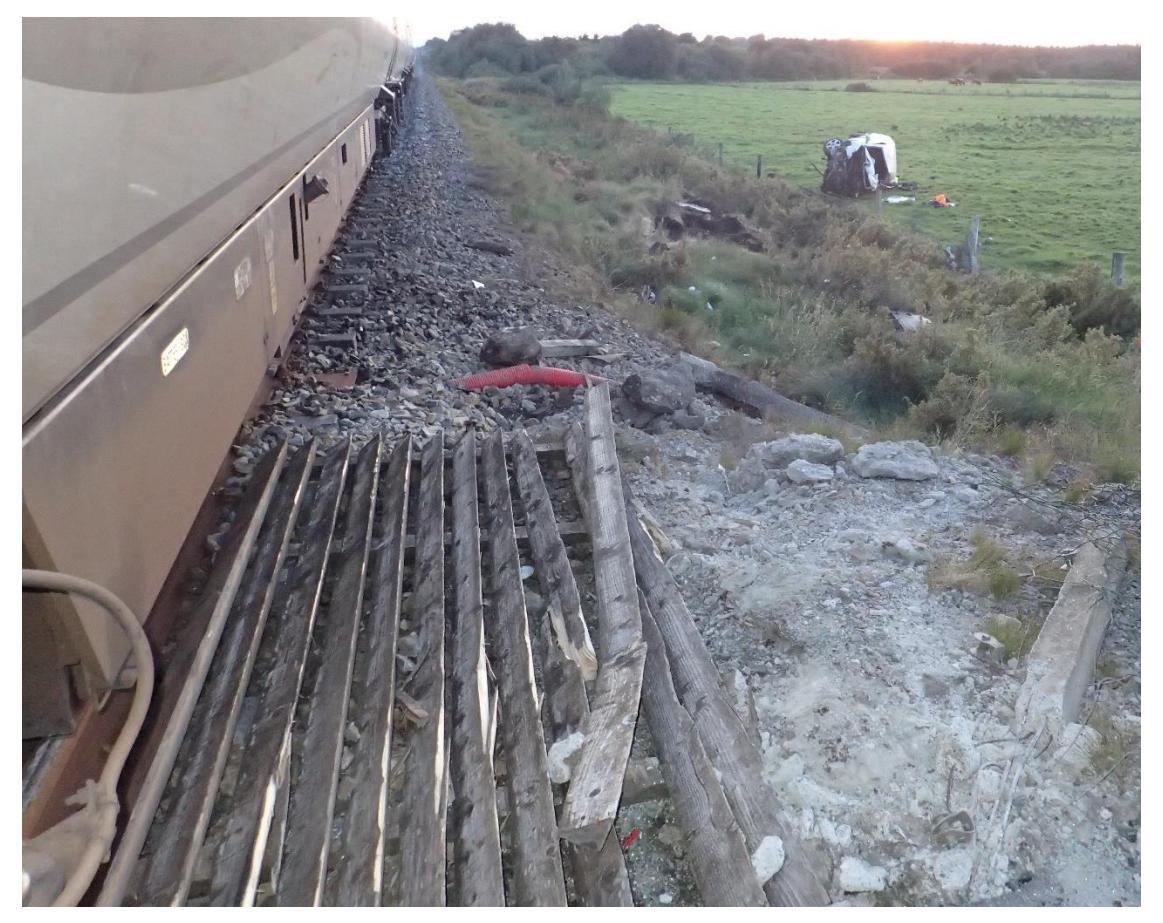
Figure 3 – Damage to level crossing infrastructure

22 There was some damage to cattlegrids and fencing.

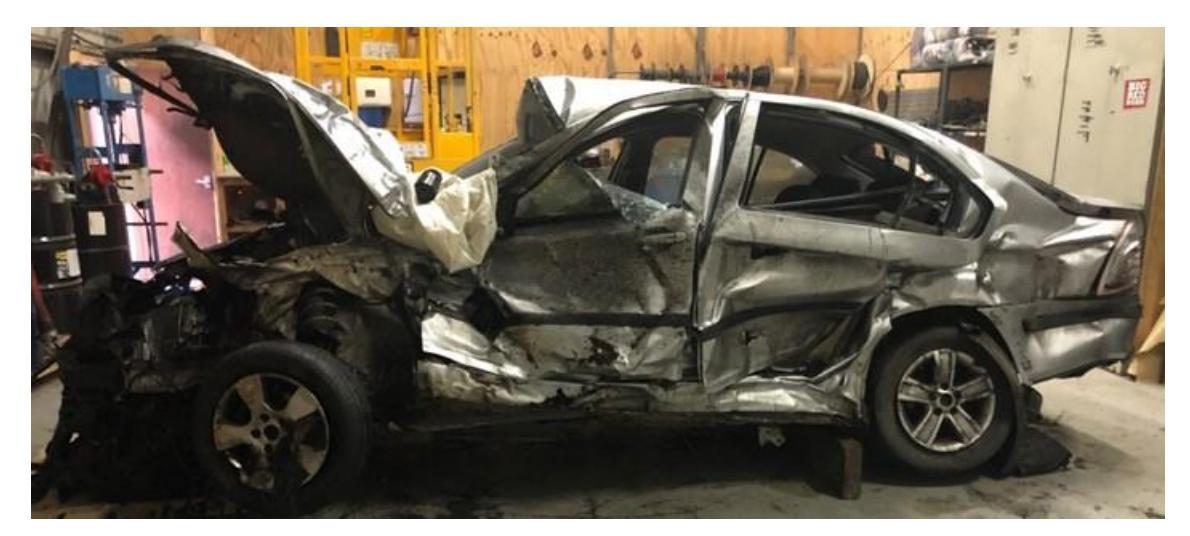
Figure 4 – Damage to the car

23 The Skoda Octavia was examined by An Garda Síochána Public Service Vehicle (PSV) Inspector (An Garda Síochána Inspectors who undertake vehicle examinations) who noted "massive" damage to the passenger's side front of the car, crushing inwards the passenger's side of the car including the chassis leg, dash, bulkhead, the bonnet and the roof (see Figure 4). The engine was broken out to of the car. Both passenger side doors and the quarter panel and both wheel rims and tyres and the suspension arm were damaged. Both driver's side doors the wing and quarter panel were damaged. The driver's side front wheel rim was damaged. The brake pipe was damaged at the master cylinder. Both passenger side dampers/shocks were damaged.

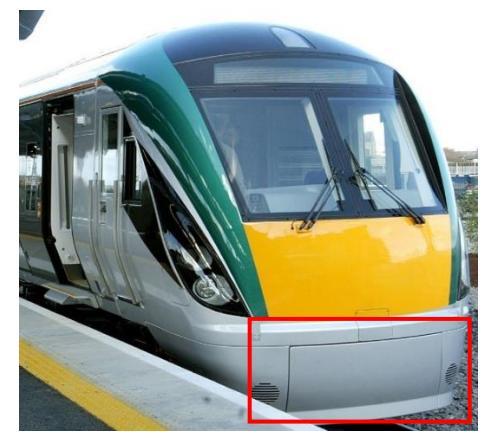
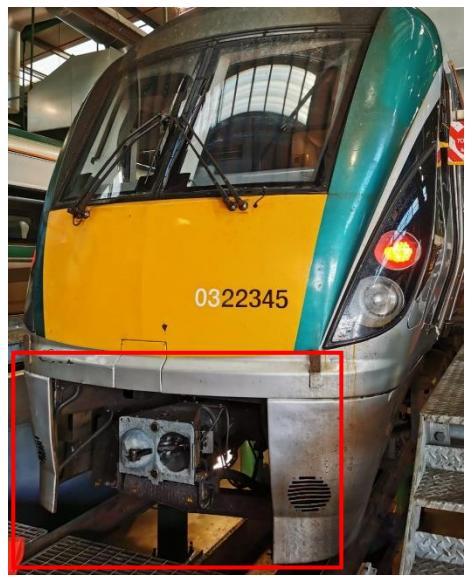
Figure 7 – Modification to hatch

- 52 In January through March 2023 there was an issue with the couplers on the ICRs; when the coupler was being retracted it was damaging coils within the coupler. On the 6th January 2023, the Head of Health & Safety IÉ-RU issued a Shed Notice (700/29 RU23) for the 22000 Class DMU (ICR), which stated "At present some 22000 Class DMU (ICR) trains will not retract the coupler. If this happened the train may continue in service as normal. Once this has been resolved a further notice will be issued". This decision to leave the couplers in the extended position was to limit the damage from the coils when retracting and any potential associated service affecting failures⁵.

⁵ It is noted that the CME Heavy Maintenance Manager engaged with the manufacturer of the coupler in terms of reliability of the coupler running in the permanently extended position, whereby the manufacturer stated that "there are additional forces presented by the increased length of the coupler (acting as a lever arm) when the head is in the extended position", however the manufacturer noted there would be "minimal risk to reliability" in the "short term" with increased monthly checks (to assess the vertical alignment of the couplers for any signs of degradation); this was signed off by the manufacturer in March 2023. There was no time scale on the couplers being left in the extended position, however, IÉ-RU staff travelled to the manufacturer to assist with a resolution.

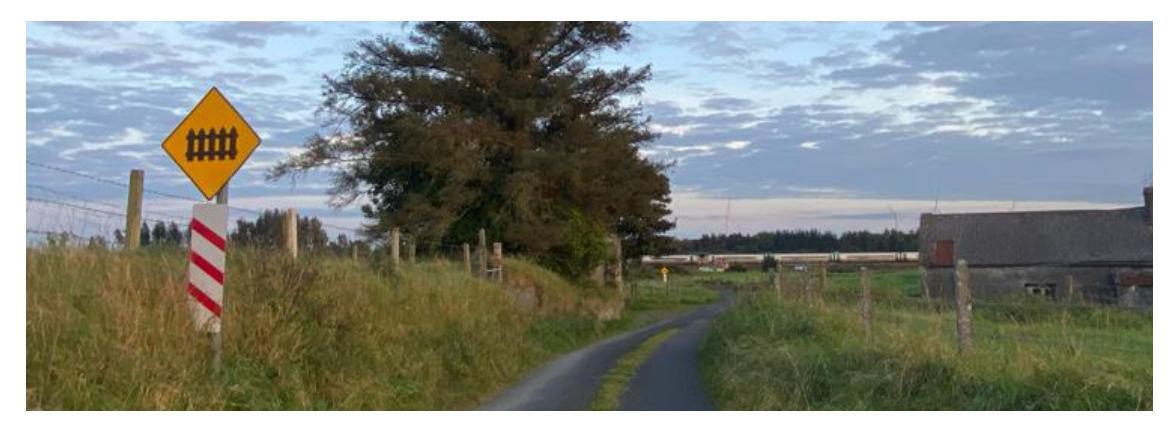
Figure 12 - W 121 and W 122 Signs (Upside LC XM190)

SF-01 – SF-01 - Sign W 121 does not portray clear meaning that the user is approaching a UWLC, a hazard (i.e. live railway) and does not indicate the severity of not adhering to the warning (i.e. being struck by a train). At the time of the accident, a *Decision Support System* (DSS), which provides information for users on the approach of trains, was present at LC XM190 but had not been commissioned as a result of difficulty in getting electricity to the location.

64 The required Signs W 121 and W 122 were erected at three locations on each of the approaches to LC XM190 in accordance with the Traffic Signs Manual (paragraphs 61 and 62), see Figure 12 for an example of the advance warning signs on the approach to LC XM190.

- Safety Recommendation 2024003-01 The Department of Transport should continue to trial the new design sign (Sign W126), in consultation with the relevant stakeholders, with a view to replacing Sign W121. The RAIU maintain that the advance warning signs on the approaches to OP Type level crossings should portray the hazard (i.e. the road user is approaching a live railway) and indicate the severity of not adhering to the warning (i.e. possible collision with a train);
- Safety Recommendation 2024003-02 IÉ-IM should replace their "Warning Trains" sign, located at OP Type level crossings, to the new proposed advance warning sign (Sign W126), once included in the Traffic Signs Manual.

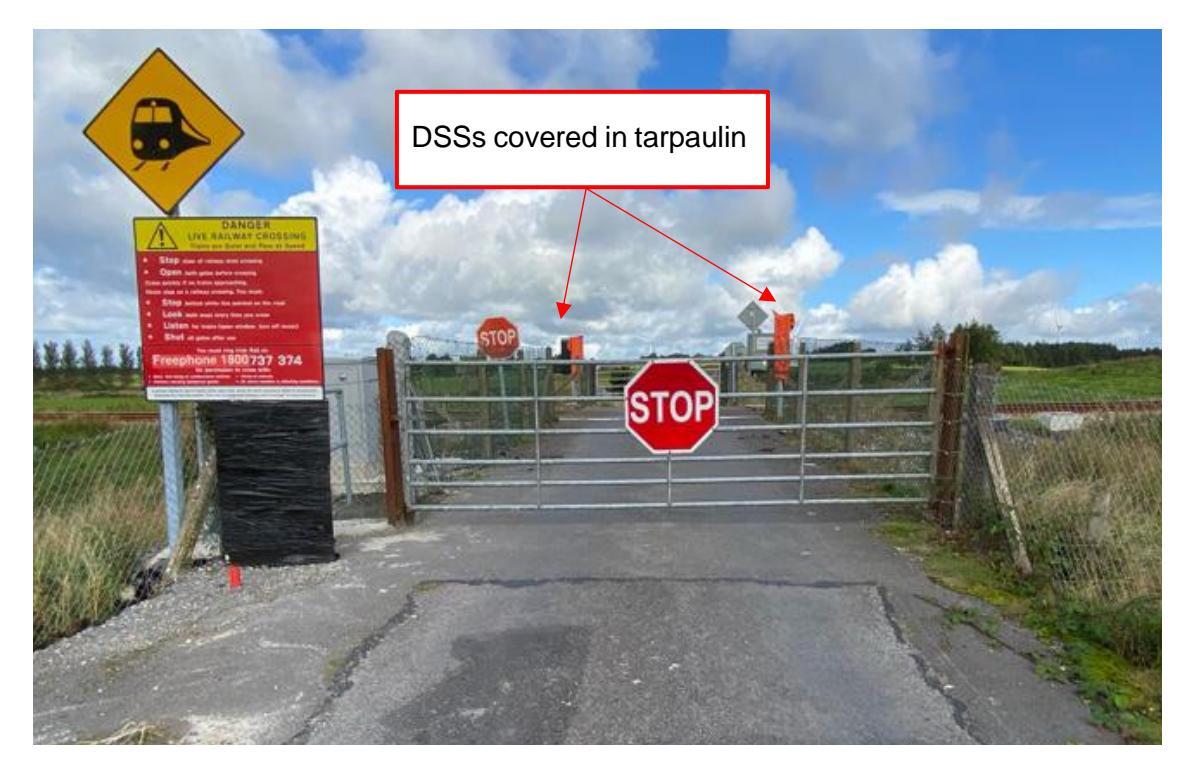
Figure 17 – DSS covered in tarpaulin

- 80 Prior to the accident, IÉ-IM, in conjunction with ESB Networks attempted to agree, with a local landowner, a proposed electricity supply route through their adjacent land to the DSS, however, the landowner would not agree on the proposals presented¹².

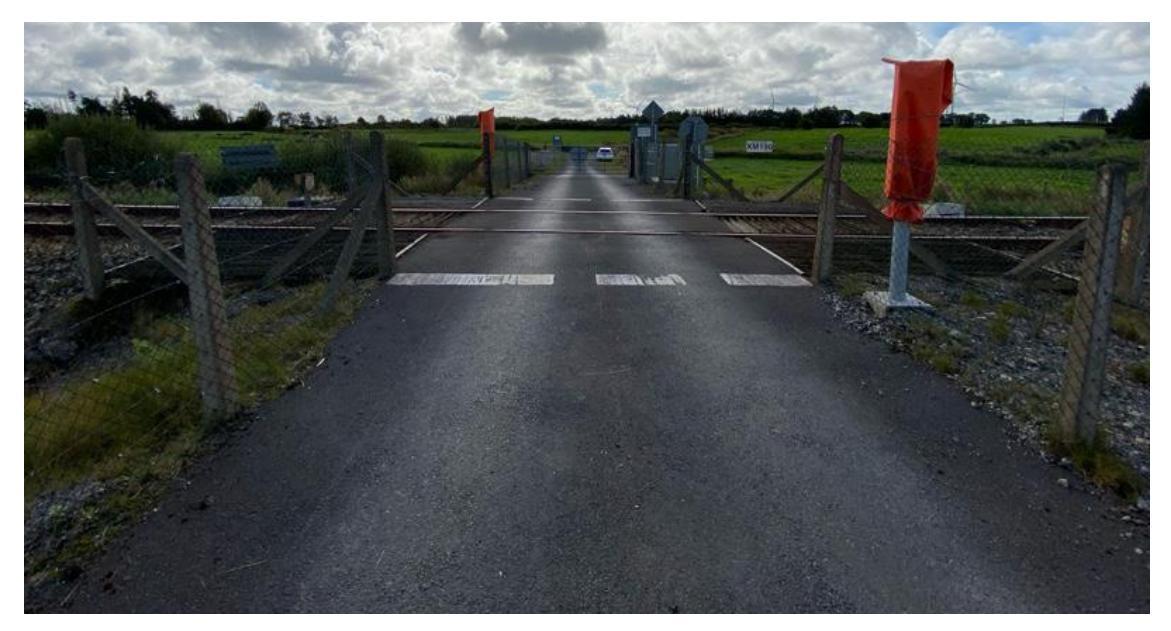
Figure 26 – View of approach to railway

125 The gates at LC XM190 had been left open to road traffic by a previous user in contravention to the law (paragraph 60) and travelled past the open gate, see Figure 26.

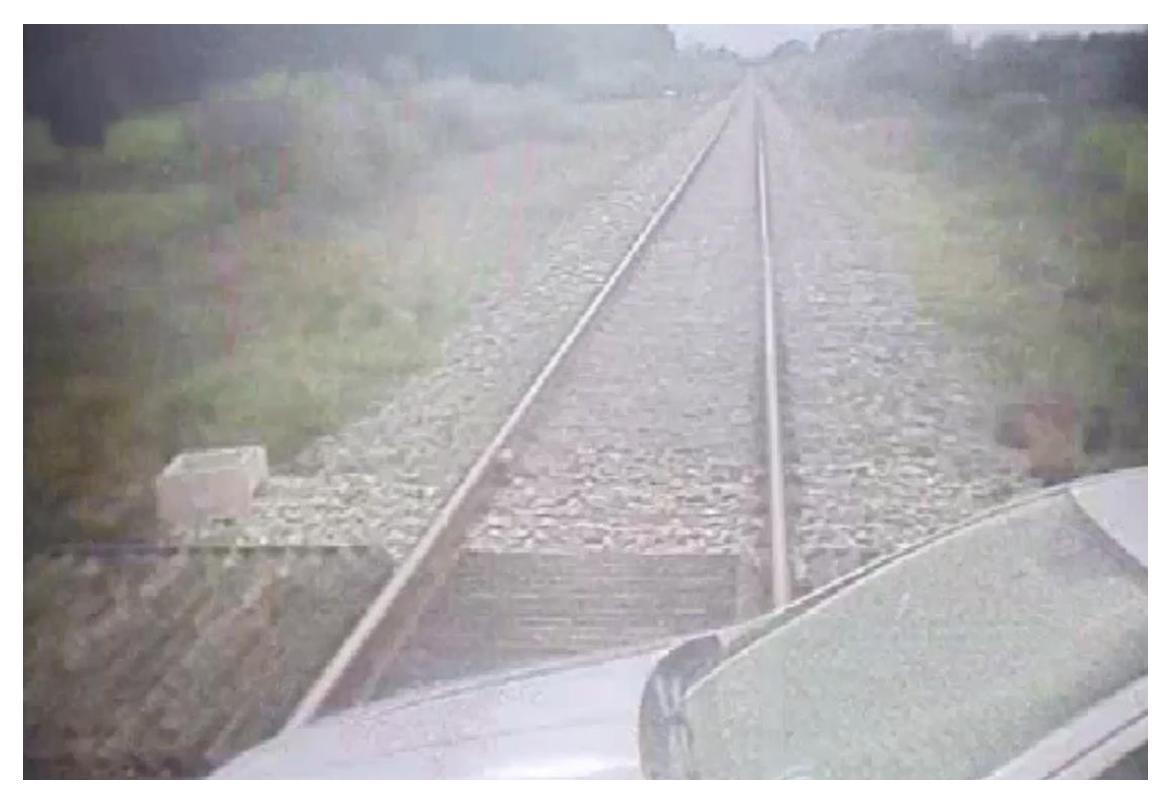
Figure 29 – Position of car at point of impact

130 At 15:15:08 hrs, Train A804 struck the car and was propelled approximately 31 m into an adjacent field landing on the passenger side, see Figure 29 for position of the car at moment of impact.
