**Railway Accident
Investigation Unit**

INVESTIGATION REPORT
Near miss at Knockcroghery Level Crossing,
XM065, Co. Roscommon
31st January 2017

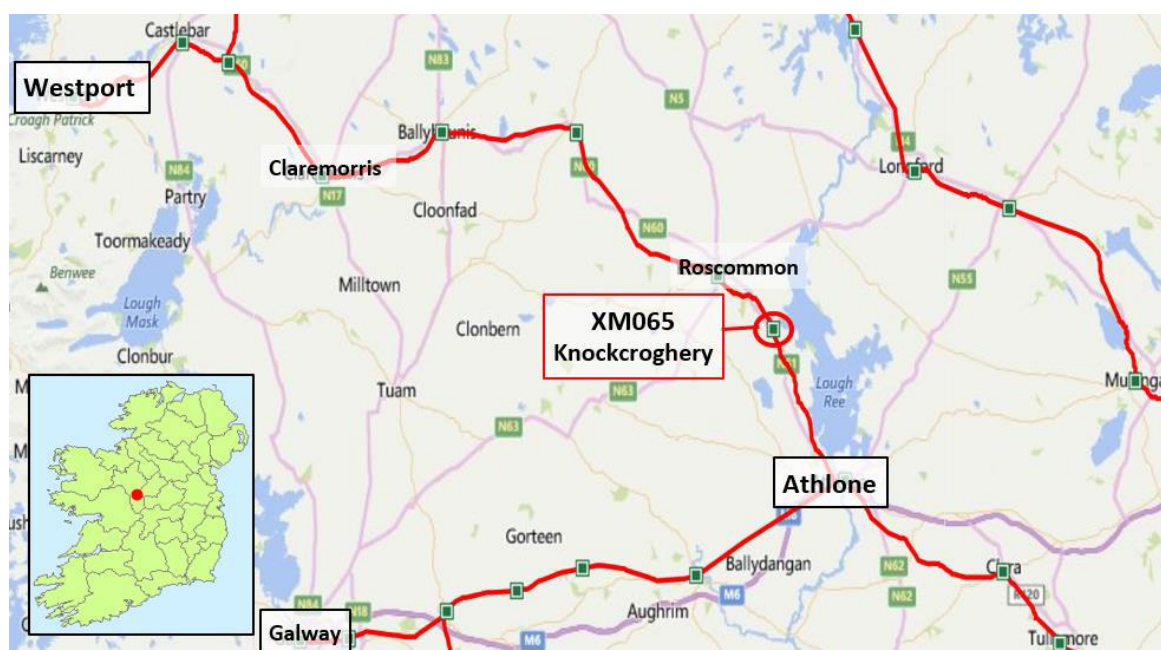
Figure 2 – Location of the incident

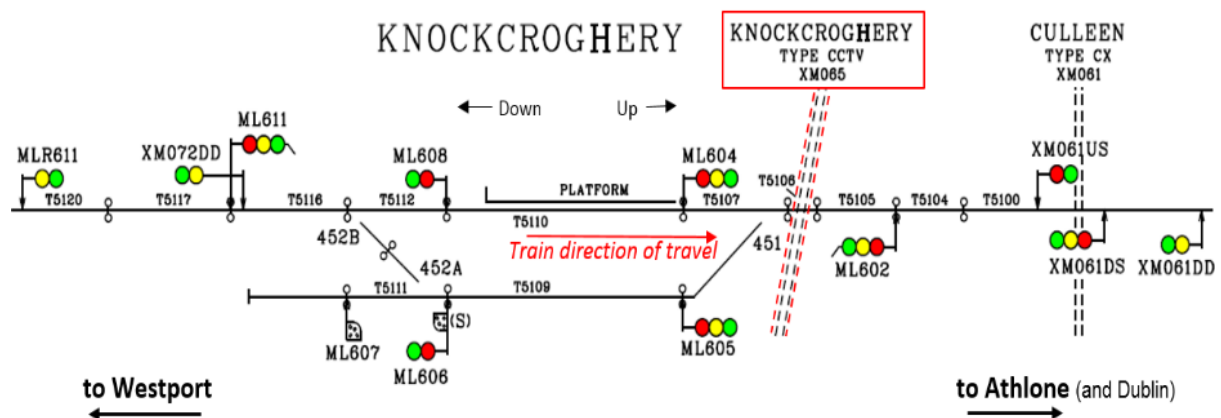
Figure 3 – Signalling layout

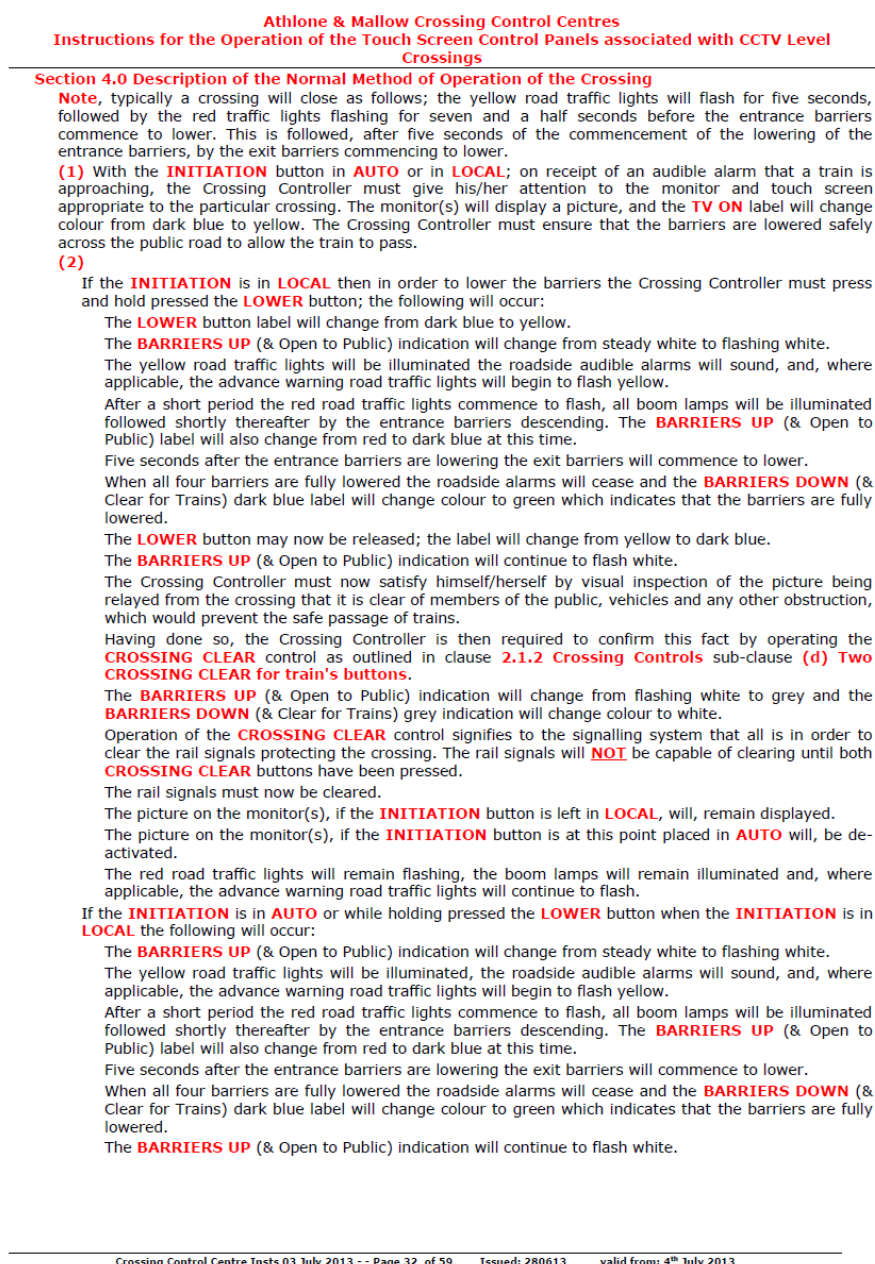
Figure 21 – Typical page from LCCC Instructions

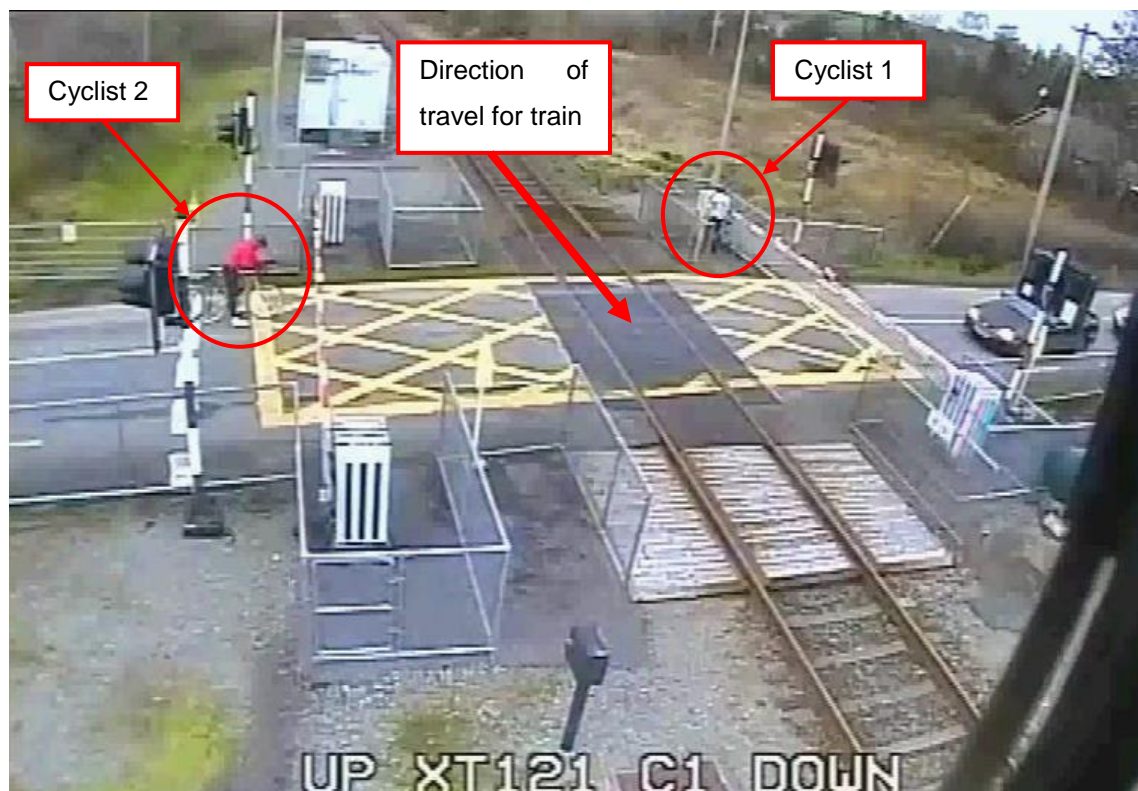
Figure 30 – Cyclist 2 within the confines of the Level Crossing

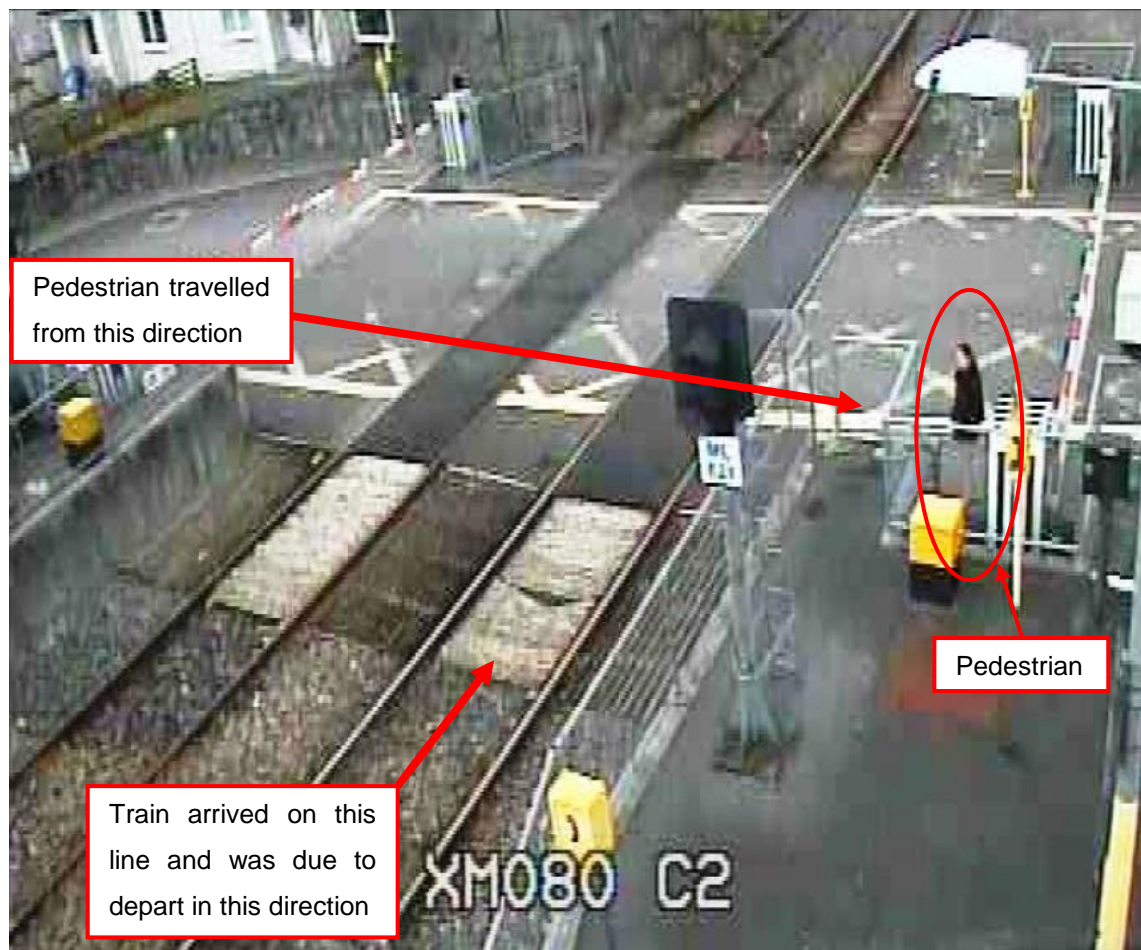
Figure 32 – Pedestrian within the confines of LC XM080 while the barriers are lowered
