**Railway Accident
Investigation Unit
Ireland**

INVESTIGATION REPORT

Broken rail, Newbridge, Kildare, 23rd February 2023

RAIU Investigation Report No: 2024-R001

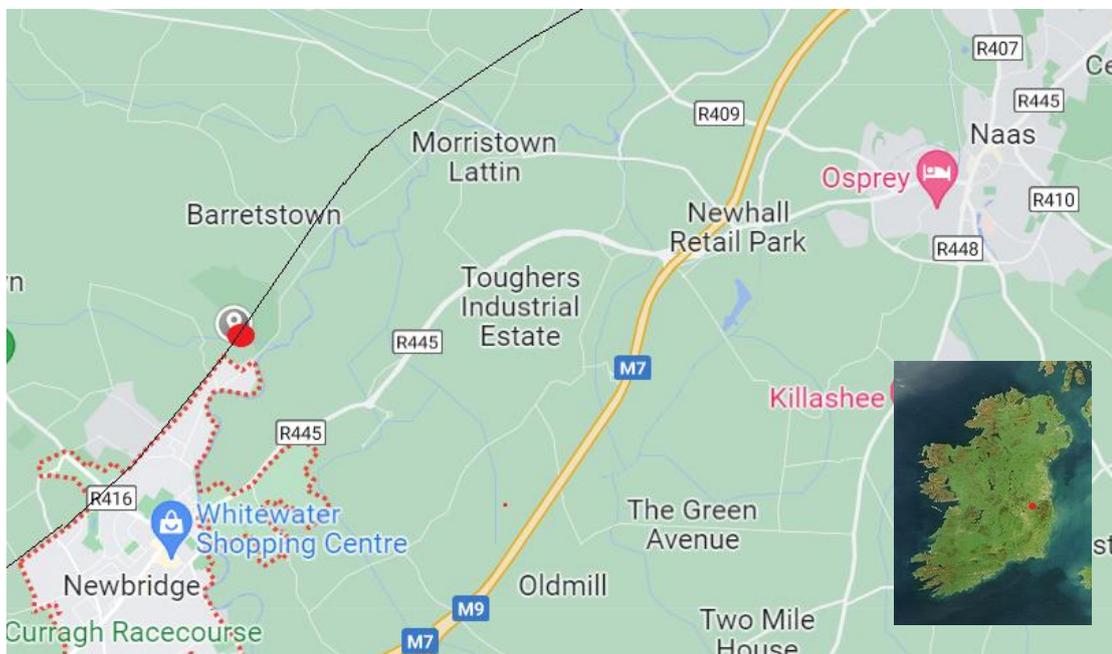
Figure 1 – Location of the broken rail

23 The broken rail occurred between Newbridge and Sallins & Naas Stations, County Kildare at a location 24 miles and 300 yards from Dublin Heuston on the Cork mainline (see Figure 1), approximately 2 kilometres (km) from Newbridge Station. The railway line is a on a low embankment which transitions into a cutting after the location of the broken rail.

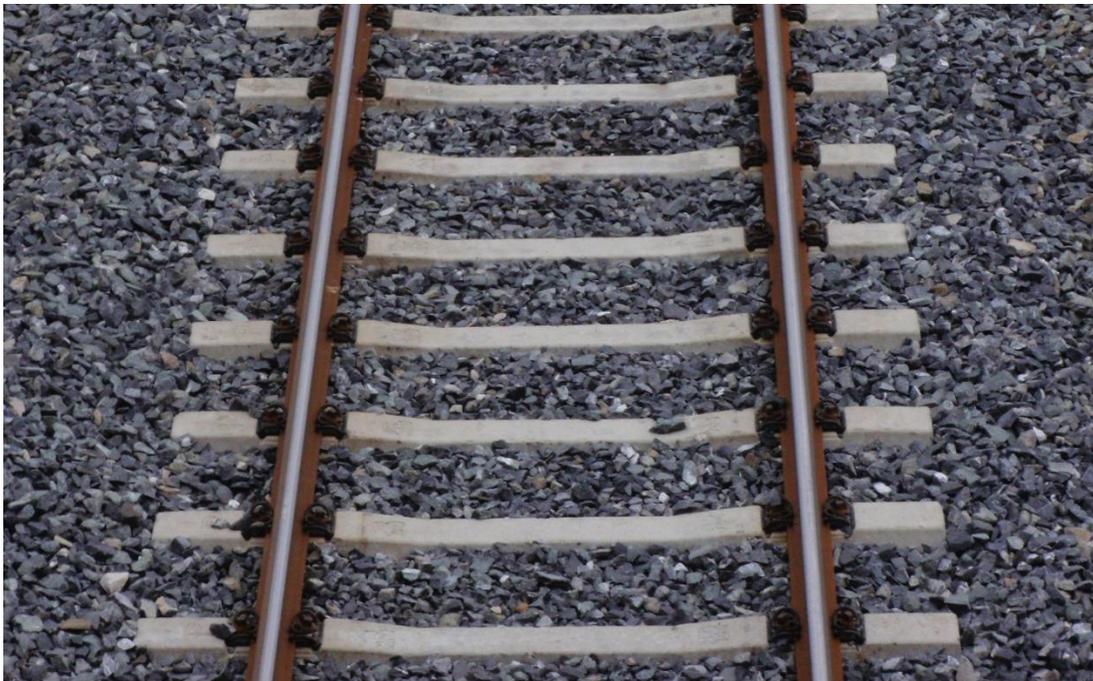
Figure 3 – Flat bottom track as installed at the location

- 46 The railway at this location consists of a double track line with flatbottom CWR mounted on concrete sleepers in ballast, see Figure 3.

- 47 The track on the affected line was recently re-laid as part of the Cork Line Rehabilitation Project with new rail, sleepers and ballast.

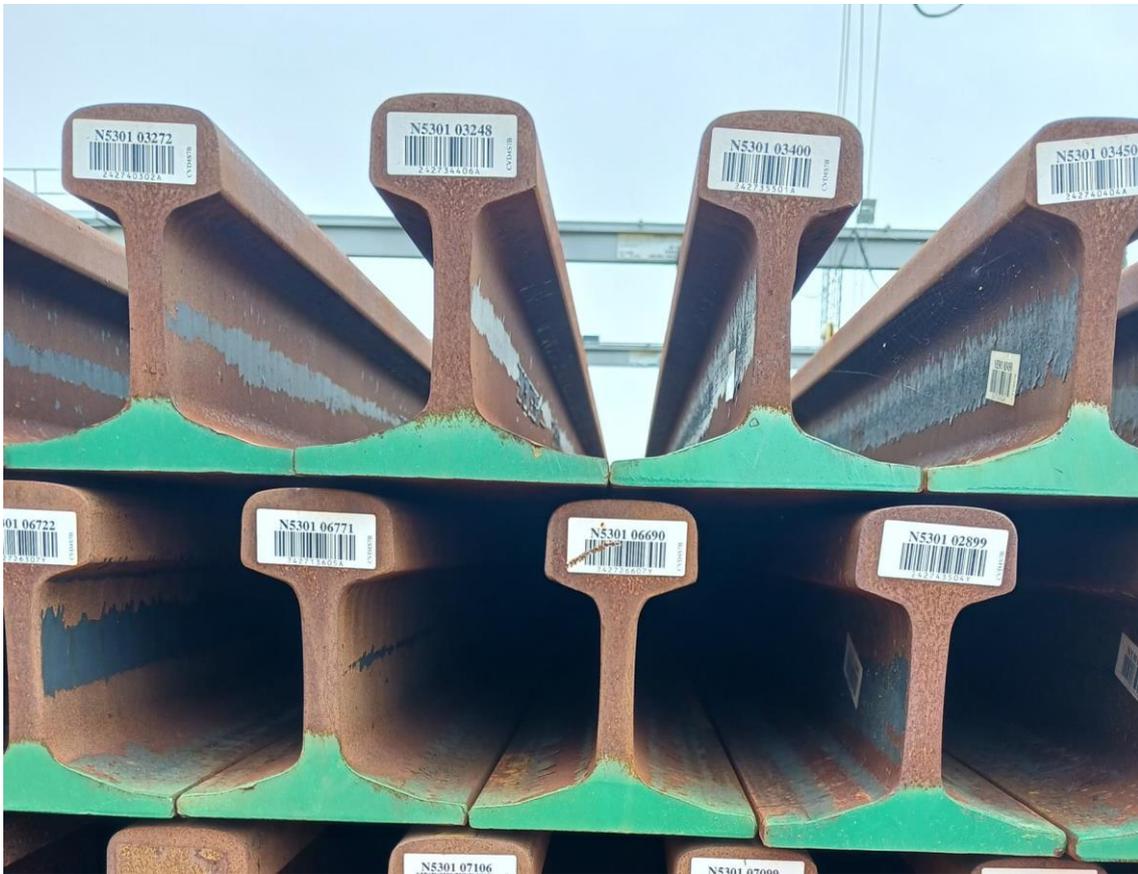
Figure 5 – Rail ends in the stacks before welding

- 51 Arcelor Mittal follows EN Standard EN13674-1 Vignole railway rails 46 kg/m and greater (EN13674-1) which defines rail production quality standards. The rail production process includes *ultrasonic* and *eddy current testing* for the detection of the presence of abnormalities and defects in manufacturing and the inclusion of slag and “flat spots” into the material. The testing of the full width of the foot of the rail is not mandated in the standard. The dimensional tolerances of the rail are also defined, which includes the squareness of the rail ends.
- 52 The rail is handed over to the IÉ-IM and inspected at the quayside and then collected at approximately bi-weekly intervals by train for transport to Portlaoise Rail Welding Plant, where the rail is stored in stacks whilst awaiting welding with paint applied to the foot of the rail to identify the rail type (Figure 5).

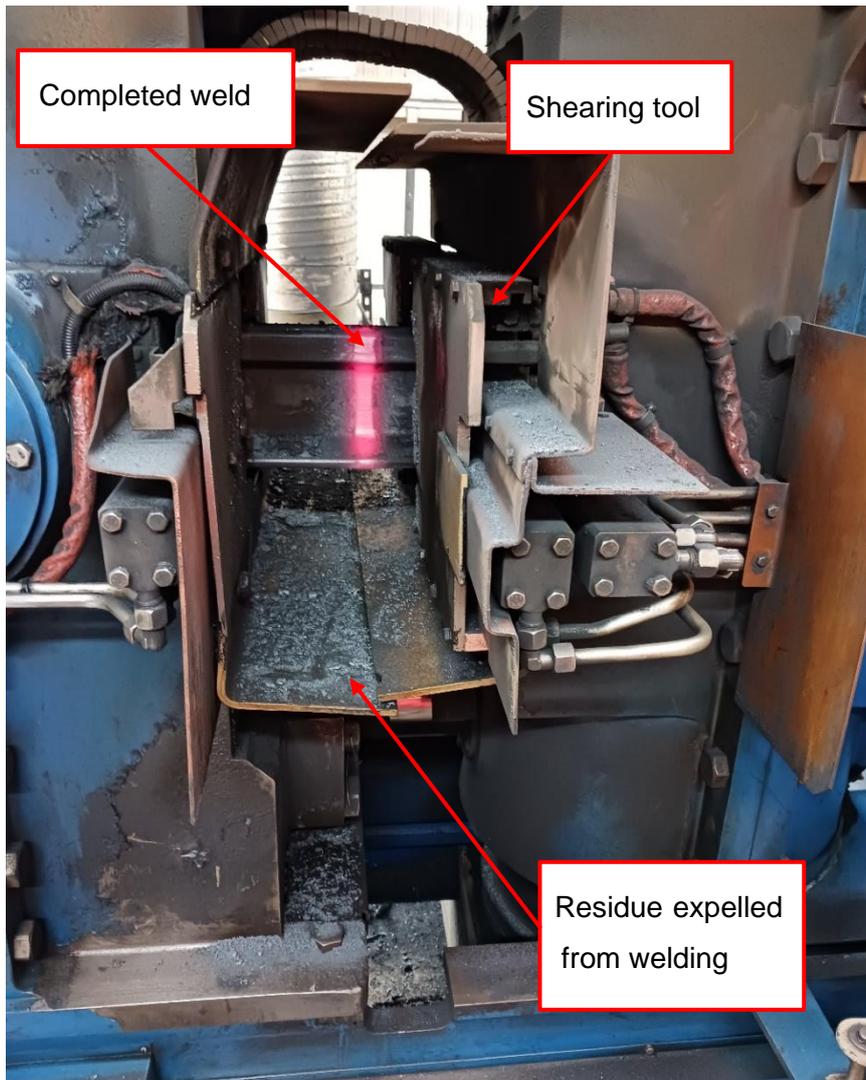
Figure 7 – Flash butt welder with a completed weld in situ

- 67 Flash butt welding is a resistance welding process which is widely used in a static rail welding plants where the machinery is permanently installed. In the welding machine, electrical current is used to create an arc or flashing between the ends of two rails held in very close proximity. This heats the rails sufficiently to melt the surface of the rail, in the process expelling particles of oxides (e.g. rust) and contaminants. Following the flashing or heating phase, the rail ends are forged together by a mechanical force (see Figure 7).

- 69 The operator must select the correct welding programme based on the rail type and input the weld number.
- 70 The operator starts the extraction system and commences the welder. The welding cycle is automatically controlled, including the flashing, forging and stripping of the excess material displaced from the upset zone, which is then “stripped” or sheared off with a tool whilst it is still in a plastic state (see shearing tool in Figure 7).
