# **Railway Accident Investigation Unit Ireland**

## **INVESTIGATION REPORT**

### **Derailment of DART passenger service, at Points DL115, Dun Laoghaire, 13<sup>th</sup> September 2017**

**RAIU Report No: R2018 – 001  
Published: 15<sup>th</sup> August 2018**

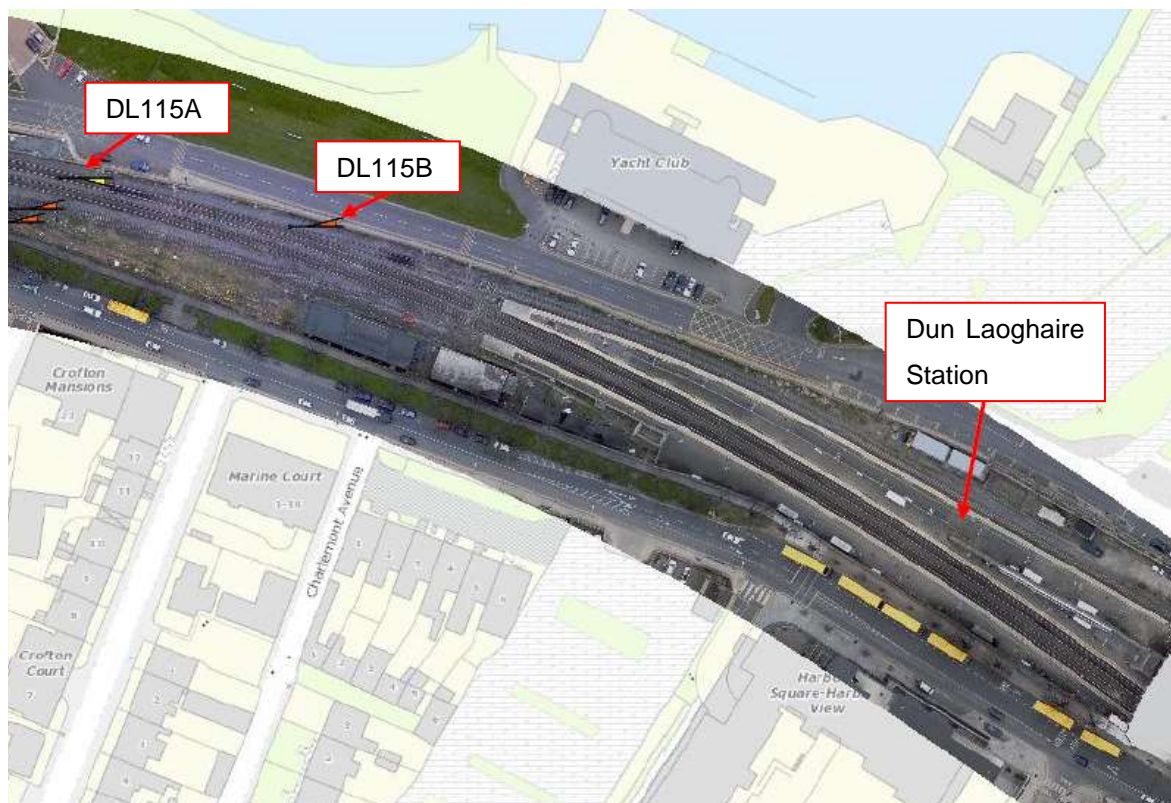
**Figure 4 – Location of Points DL115 (DL115A facing, DL115B trailing)**  
(Figure taken from IÉ Report)

38 At Dun Laoghaire, Points DL115 are situated on the down road on the Dublin side of Dun Laoghaire Station, see Figure 4; and allow movement of trains from the main line in the *normal* position or into the Bay Platform 3 in the *reverse* position. The points can be requested (normal or reverse) by the Controlling Signaller under regular conditions or manually by a Points Operator as a result of a failure.

39 DL115A points are located at the five mile 1591 yards at Dun Laoghaire on the Pearse to Shanganagh Junction, see Figure 4. The points are constructed from 113 pound flat bottom rail and are approximately twenty-one years old.

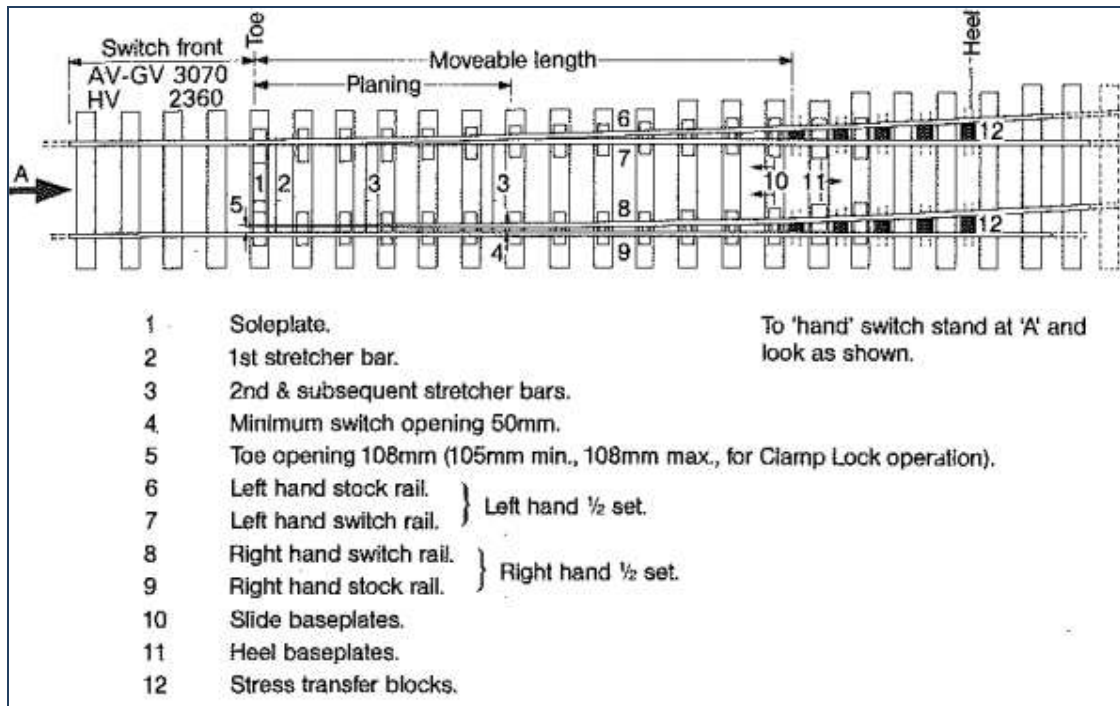
Figure 5 – Points components

40 Points DL115 are classified as *Clamp Lock Points* which use a hydraulic system for the movement of the switch rail. The points operate by guiding one track to another by the movement of the switch rails items 7 and 8, in Figure 5.

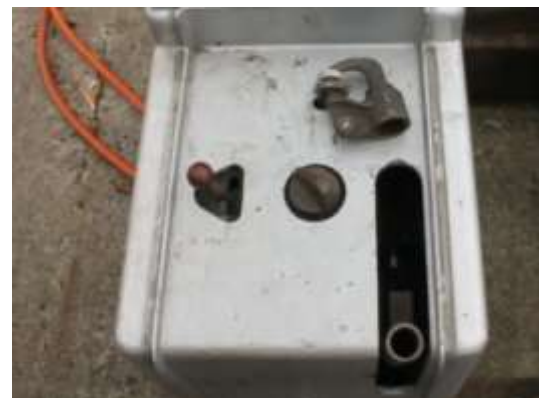
**Figure 7 – Photograph of Clamp Lock Mechanism**

- Access to the hand controls is by unlocking the cover of the points machine and lifting it back. The hand controls of the machine consist of (see Figure 6 for illustration from General Appendix & Figure 7 for a photograph of the mechanism):
