Railway Accident Investigation Unit

INVESTIGATION REPORT

Difflin Light Rail Passenger Fall, Co. Donegal

17th December 2016
RAIU Report No: 2017 -001
Published: 7th November 2017

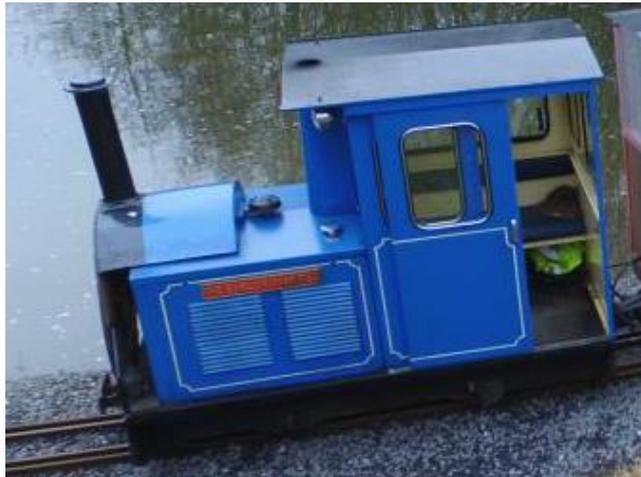
Figure 2 – Diesel Locomotive: “Earl of Oakfield”

17 DLR operates two locomotives, one steam and one diesel powered. The locomotive involved in the accident was the diesel locomotive, the 'Earl of Oakfield', see Figure 2; which is a 1500 kilogram (kg) (1.5 tonne) diesel engine locomotive. The maximum allowable speed of the train is 16 kilometres per hour (km/h) (10 mph); with the speed being controlled by a throttle lever.

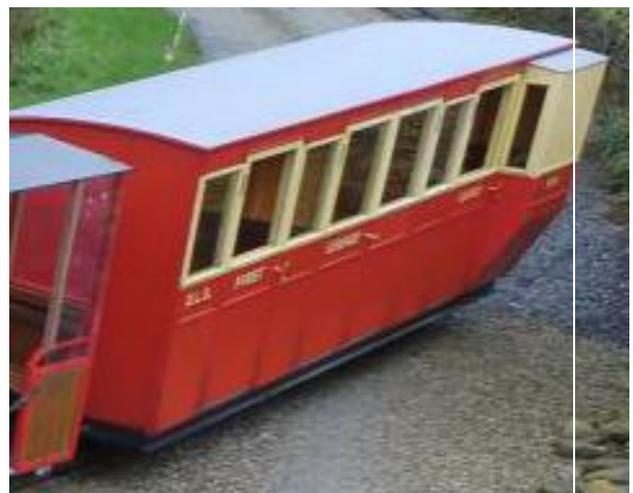
Figure 4 – Enclosed carriage

18 The locomotive can pull a combination of carriages, consisting of various types of carriages: open carriages where chains secure the access and egress point of the train (Figure 3); enclosed carriages (Figure 4) which have doors that close to form a fully enclosed carriage; and, freight wagons.

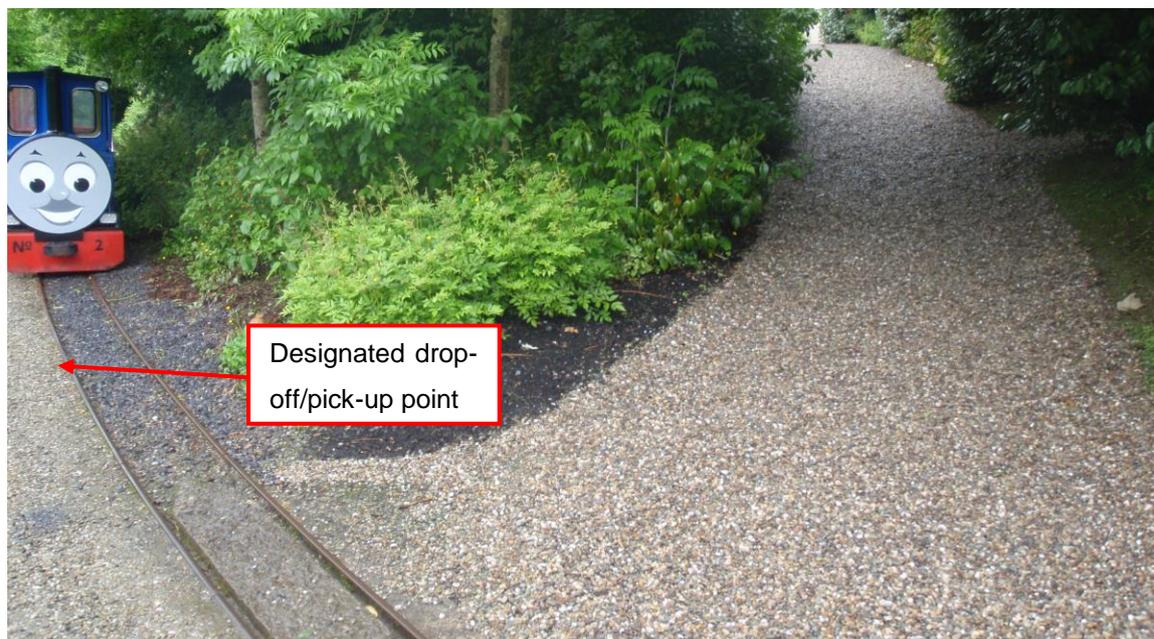
Figure 8 – Gravel pathway from designated drop-off/pick-up point to Santa's Grotto

101 The train departed from Oakfield Park Station and travelled out to Santa's Grotto and exited the train at the designated drop-off/pick-up location (Figure 8).

102 Upon attending Santa's Grotto the family walked back to the designated drop-off/pick-up location, via a gravel walkway; and once instructed to do so, the family boarded the train to return to Oakfield Park Station.

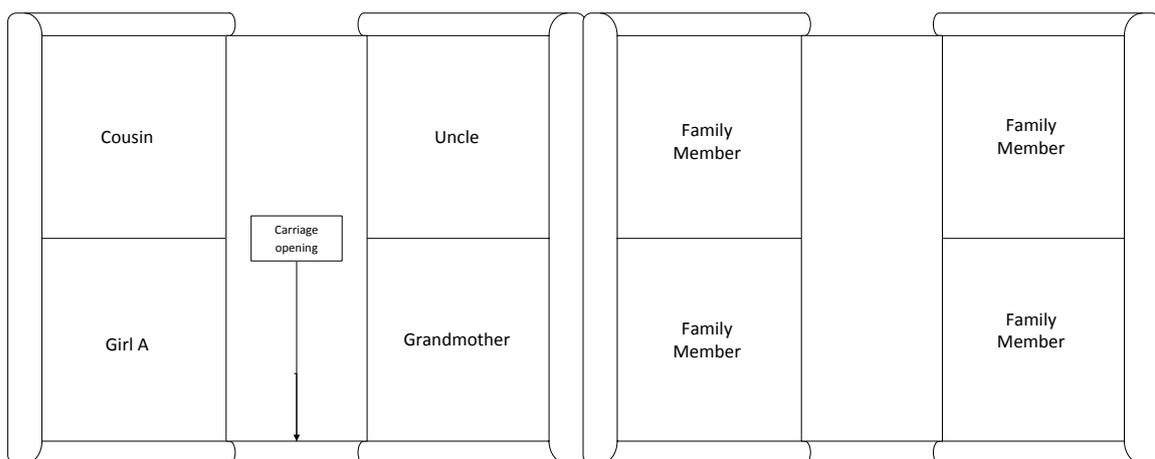
Figure 13 - Seating positions within the carriage

103 The family sat in same open carriages for return journey. Two children sat facing two Adult Family Members and beside each other. Girl A was sat on the left hand side of the coach, see Figure 13.
