**Railway Accident
Investigation Unit**

INVESTIGATION REPORT
Car strikes train at level crossing XM250,
Knockaphunta, Co Mayo
8th June 2014

RAIU Report No: R2015 – 002R1
Published: 04/06/2015

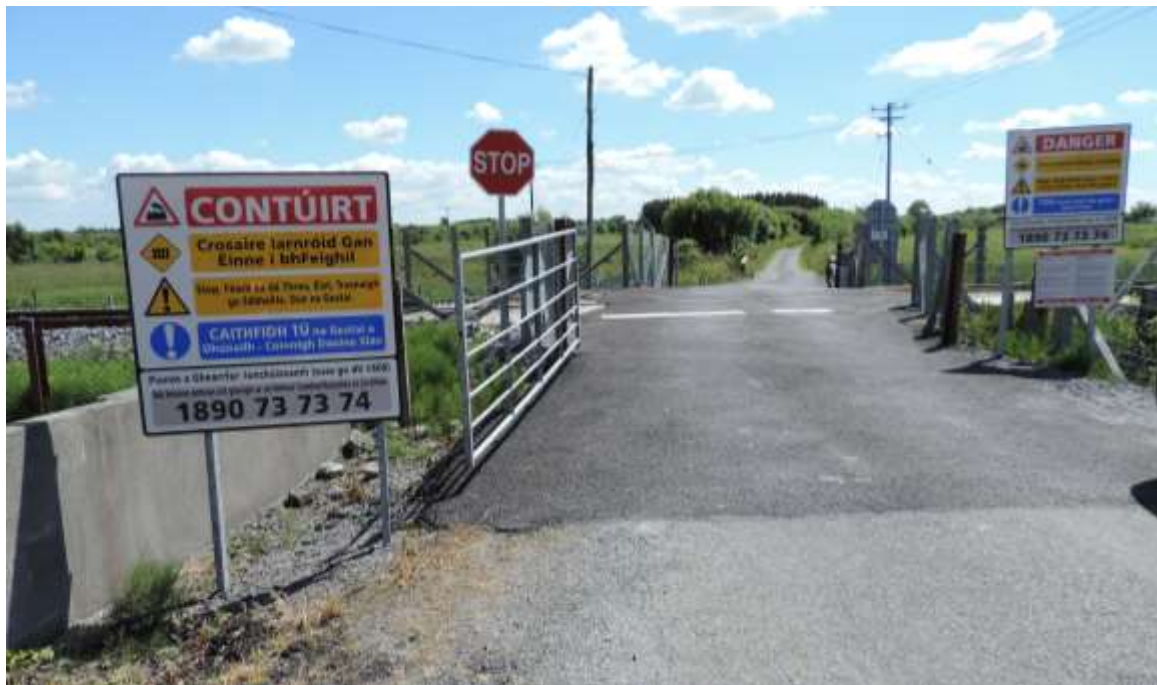
Figure 5 – Knockaphunta Level Crossing, XM250 (with user operated gates open)

- 14 The line from Athlone to Westport is a single track *bidirectional line*. The track is plain line with *flat bottom continuously welded rail* (CWR) mounted on concrete sleepers in ballast. No factors in relation to the condition of the track were found to have contributed to the accident.
- 15 Knockaphunta is located within one kilometre (km) from Castlebar town. The level crossing is located on a public regional road which connects the N5 national road (Longford to Westport) to the N84 national road (Castlebar to Galway) see Figure 5. The speed limit for this section of road is 80 kilometres per hour (km/h).

- 16 IÉ have designated the level crossing as an OP Type crossing (Occupational on a Public Road) and is identified by IÉ as asset number XM250. OP Type crossings are unattended level crossings, on public roads, where the level crossing gates are normally closed to road traffic. They are *user operated*, meaning they require the user to open and close the level crossing gates in order to cross the railway.

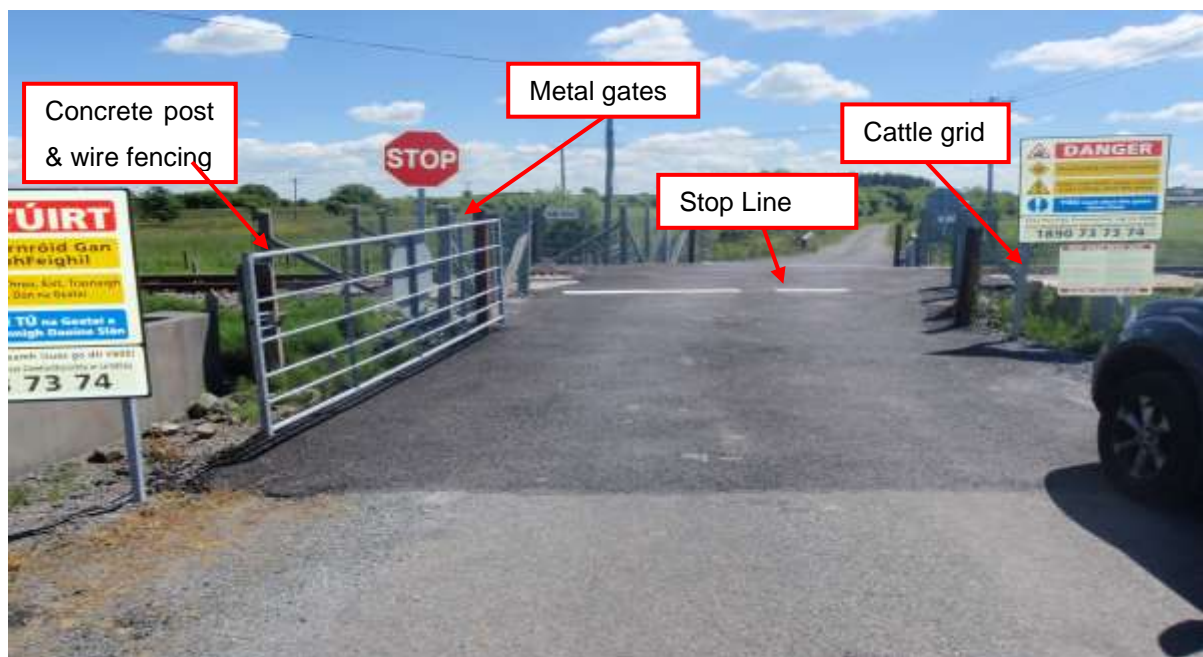
Figure 9 – Features of the level crossing

- 41 Knockaphunta Level Crossing is located on the Mayo Line at 151 miles 1141 yards from Dublin (Broadstone). As mentioned previously IÉ have designated the level crossing as an OP type crossing and is identified as asset number XM250.
- 42 The level crossing gates are 4.3 m wide metal gates positioned on each side of the level crossing, which open away from the railway. The surface of the intersection of the road with the track is stone mastic asphalt, which provides a level surface over the track. *Cattle grids* are installed adjacent, on each side of the roadway, where it crosses the track. There is concrete post and wire fencing running between the gates and the boundary hedges. See Figure 9 for some of the features of the level crossing.

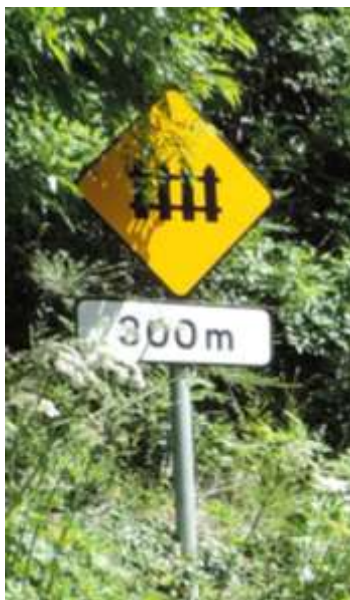
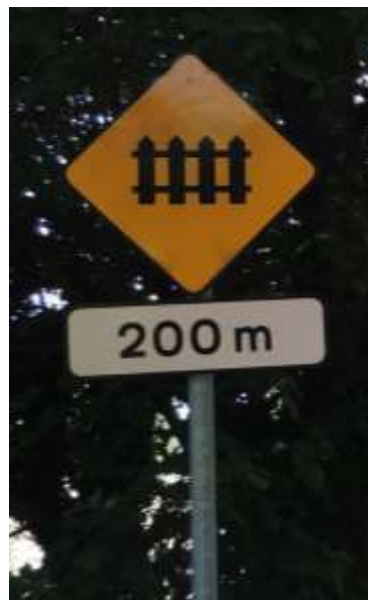
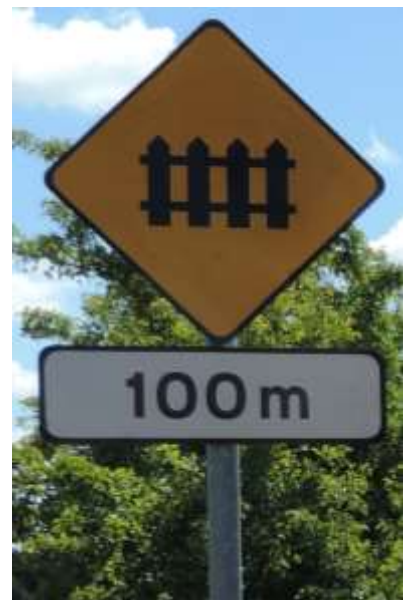
Figure 11 – Level Crossing with No Flashing Red Signals

- 44 On both approaches to the level crossing, the 'Level Crossing with No Flashing Red Signals' (W121) warning signs, as designated in the Traffic Signs Manual 2010, are positioned as count-down signs at 100 m intervals (at 300 m, 200 m and 100 m), see Figure 11.

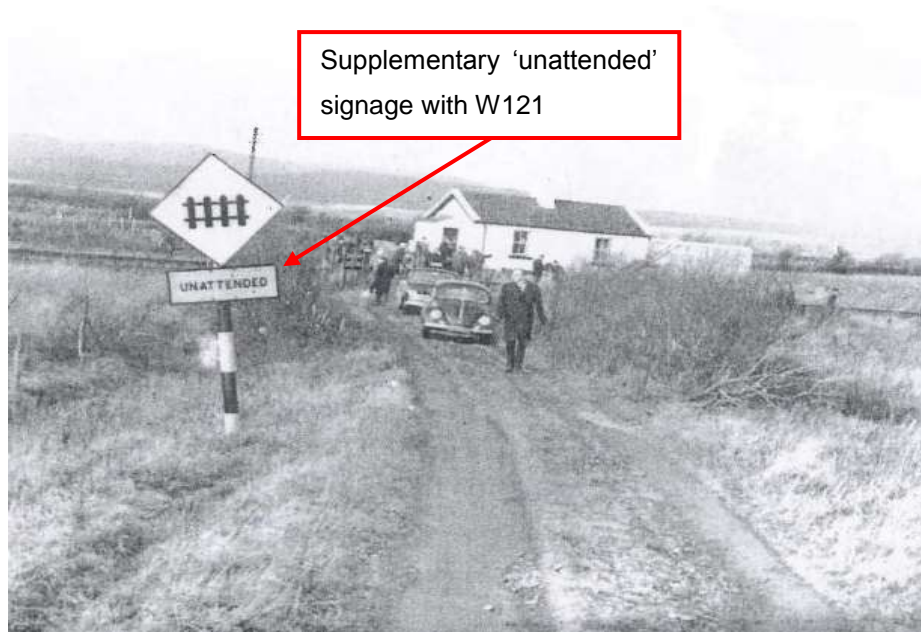
Figure 12 – Signage at Knockaphunta Level Crossing in December 1967

- 45 Historically, this W121 sign was supplemented with an additional information sign with the word 'Unattended' in black on a white background, giving the road user a reminder that they were approaching an unattended gated user operated level crossing, see Figure 12.

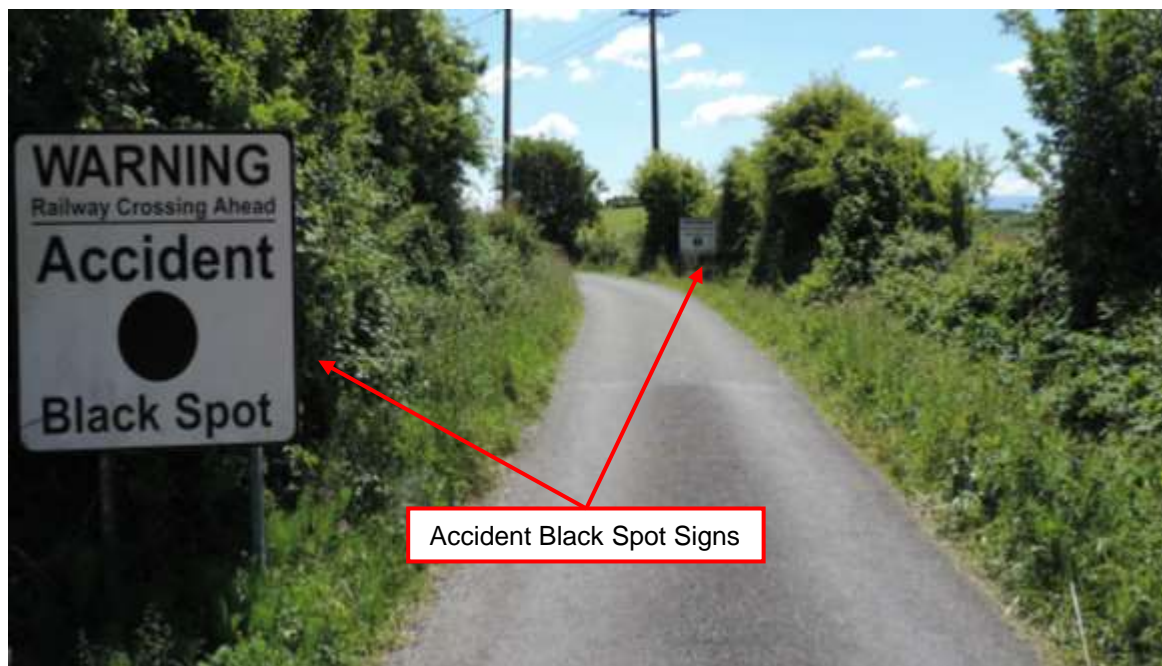
Figure 13 – Accident Black Spot signs

- 46 In addition to the W121 signage, there are two 'Accident Black Spot' signs situated between the 100 m sign and the level crossing on the up side approach, see Figure 13.

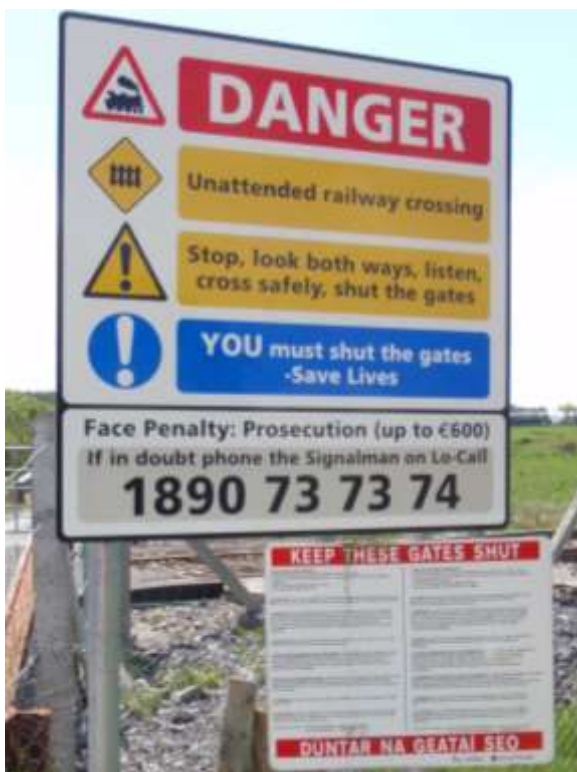
Figure 14 – 'Danger' & 'Keep these gates shut' signage

- 'Stop' sign located within the railway boundary;
- IÉ 'Danger' sign, in the English language, including the statements: "unattended railway crossing"; "stop, look both ways, listen, cross safely, shut the gates"; "you must shut the gates – save lives" and penalty notice (Figure 14);
- IÉ 'Danger' sign in the Irish language, including the above statements in Irish;
- IÉ 'Keep these gates shut' sign which includes requirements related to closure of the gates and penalty notices associated with the failure to close gates (Figure 14);
- IÉ 'Have you shut the crossing gates?' signage, which is located on the rear of the IÉ 'Danger' signage (Figure 15).

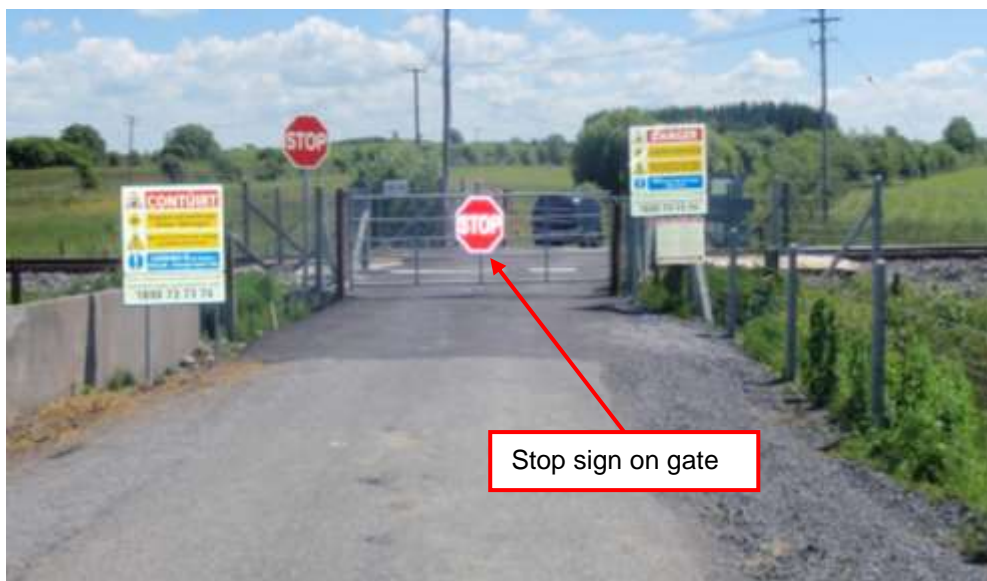
Figure 16 – Stop signal on gate

- 49 In addition to the IÉ signage a stop sign is fixed to the centre of the gate and an additional stop sign is located on the left side on the approach to the crossing as stipulated in the DTTAS Traffic Signs Manual (2010) Section 6, see Figure 16. Section 6.15.9 of the Road Signs Manual (2010) states that “At crossings with gates, a stop sign shall be fixed to the gate such that, when the gate is closed, the sign is approximately in the centre of the approaching road traffic lane. However, where the gates are operated by the road user or where attendant operated gates are not interlocked with the railway signals, a stop sign shall also be erected on a post on the verge adjacent to the crossing stop line. This sign is required to ensure that all traffic stops before crossing, as the presence of an open gate does not mean that a train cannot cross”.

- 50 Although the signage exceeds the requirements set out in CCE-TMS-380, the suitability of this signage was questioned by the RAIU during previous level crossing investigation, namely the ‘Car Strike at Murrough Level Crossing, XG173, County Galway, 14th February 2011’. This investigation report, published in February 2012, recommended that “IÉ should review the suitability of the signage at user worked level crossings on public and private roads, ensuring the human factors issues are identified and addressed”.

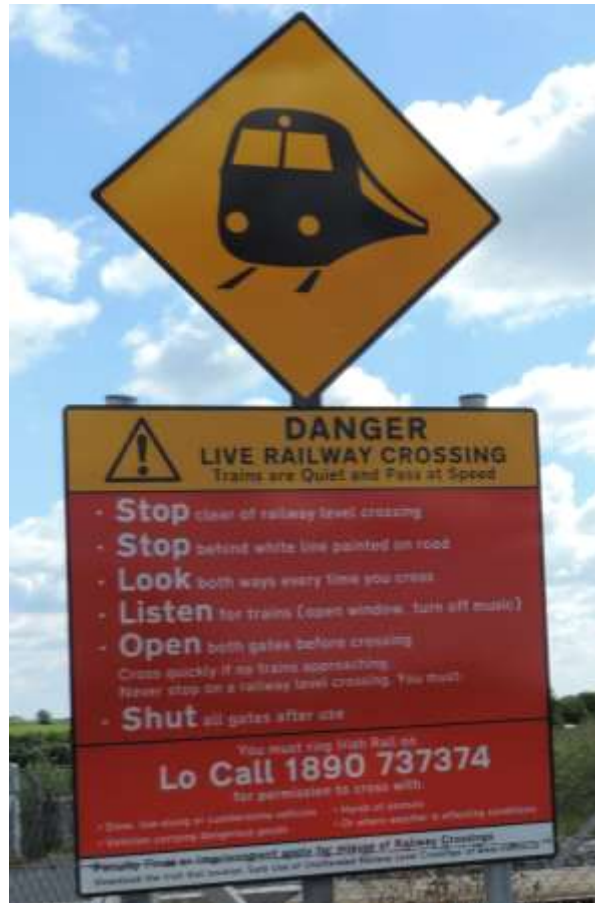
Figure 17 – New signage being trialled by IÉ

- 51 As a result of this safety recommendation, IÉ engaged external human factors consultants, NTTX Ltd, to review and develop new information signage which is currently on trial. In an NTTX Ltd report, published in January 2013, NTTX Ltd found that the older signage, as shown in Figure 16, was “busy and confusing”. IÉ then commissioned NTTX Ltd to develop new signage, an example of this new signage is shown in Figure 17, this signage is currently being trialled at Level Crossing XN240, Kilnageer, Manulla, Co. Mayo.

- 52 The new signage gives the user instructions on the safe method of crossing, such as how to use the stop line (discussed in paragraph 58) painted on the road and instructions to open the driver's window and turn off any music.
- 53 At the time of publications of this report, there is no definitive result of the outcome of this trial from IÉ IM.

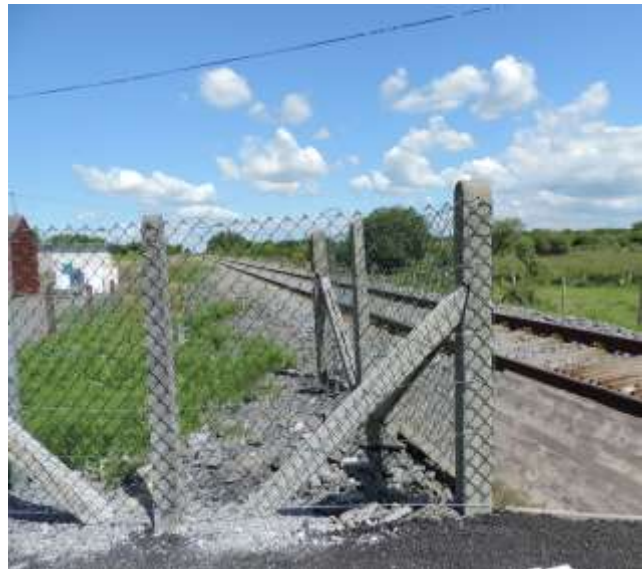
Figure 21 – Car Driver's view behind New Stop Line

62 On the approach to the level crossing from the direction of the N5, there is a dwelling house with a wooden shed to the rear of the property. Figure 20 show how the drivers view is obscured by the house and shed on approach to the level crossing. However, the view towards Castlebar from behind the New Stop Line is clear and unobstructed, Figure 21.
