Railway Accident
Investigation Unit
Ireland

Investigation Report

Bearing failure on a train at Connolly Station,

Report number: 2012-R003

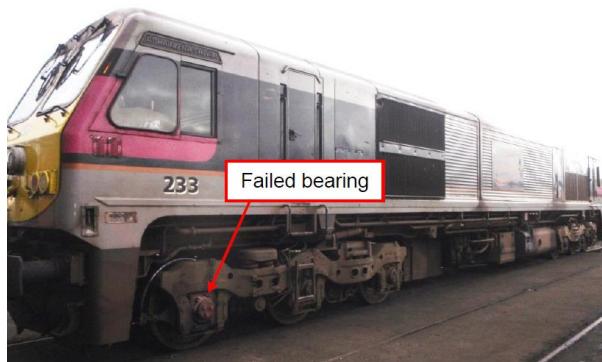
Figure 1 - Locomotive 233

- 5 The train arrived in Connolly station at 18:33 where it was inspected by a member of CME maintenance staff. The last axlebox on the right side of the train was found to be red hot and smoking. It had suffered a failed bearing. Figure 1 shows the locomotive and Figure 2 shows bearing and its axlebox after they had cooled.

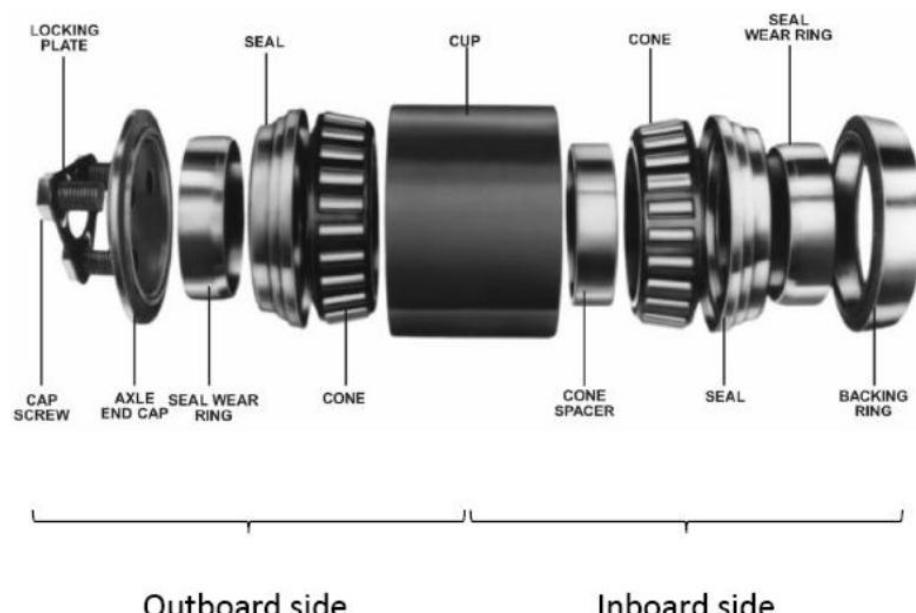
Figure 3 – Tapered roller bearing components

37 The failed bearing, bearing 794130, was an *axle journal* mounted class F *tapered roller bearing* manufactured by Timken in August 1994. The components of a tapered roller bearing are shown in Figure 3. It consists of:

49 The condition of the bearing is shown in Figures 3 to 6 and detailed below:
