**Railway Accident
Investigation Unit
Ireland**

INVESTIGATION REPORT

**Collision between an Iarnród Éireann passenger
train and rail-mounted maintenance equipment,
Rosslare, Wexford, 11th January 2020**

RAIU Investigation Report No: 2020 – R004

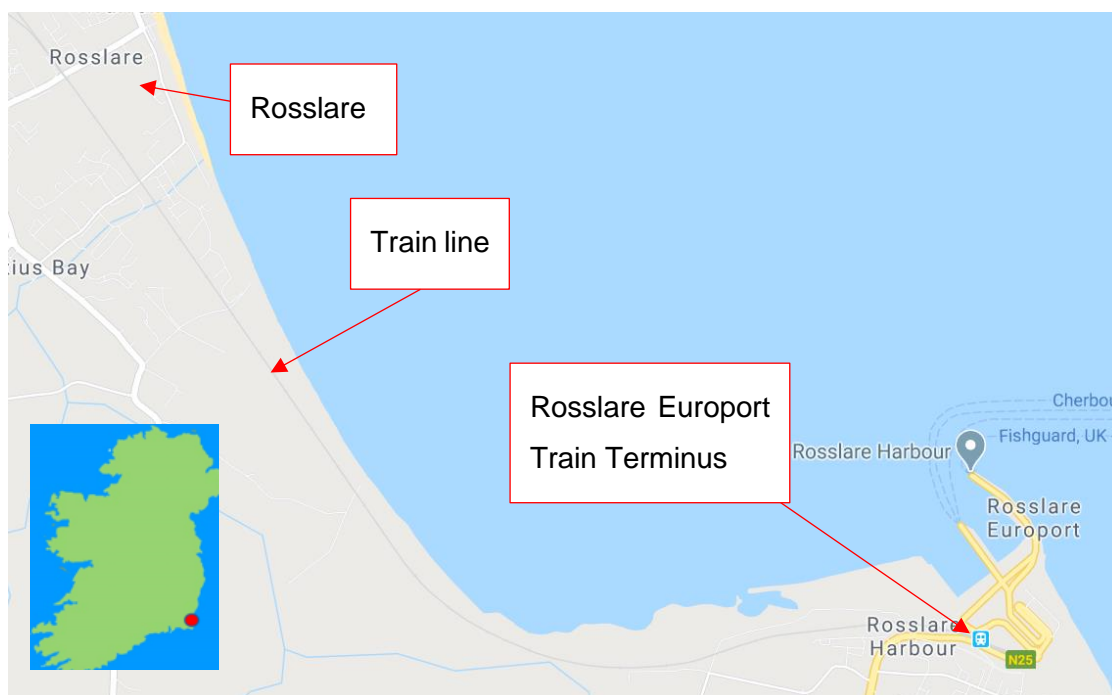
Figure 1 – Location of the accident

11 During signage erection work in a T3 Possession on the 11th January, approximately 1 ½ kilometres (km) from Rosslare Europort (see Figure 1 for location of accident), a RMME was used to transport V Boards from a level crossing access point to a worksite and back to a level crossing access point for pole extension at Hayesland Compound.

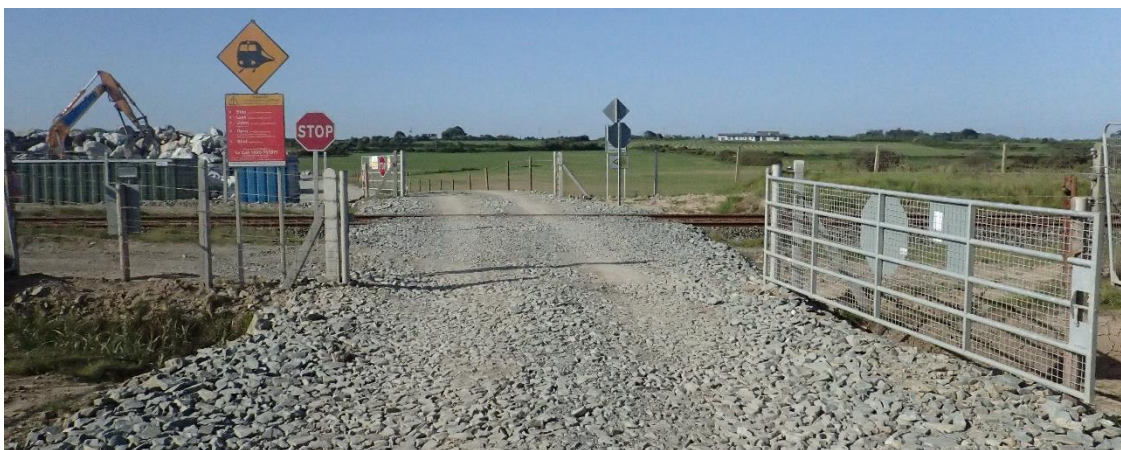
Figure 4 – Level Crossing XR102

- 25 The line on which the accident occurred is a bi-directional single line section of track between Bray to Rosslare Europort. Trains travelling to Rosslare are travelling in the Down direction, and trains travelling from Rosslare are travelling in the Up direction.
- 26 The track is plain line with flat bottom *continuously welded rail (CWR)* mounted on concrete sleepers in ballast. The maximum permitted speed from Greystones to Rosslare is 70 miles per hour (110 kilometres per hour (km/h)). No factors in relation to the condition of the track were found to have contributed to the accident.
- 27 To facilitate Rosslare Coastal Erosion Project, IÉ-IM re-opened Level Crossing XR102 (the level crossing will be re-closed once the works have been completed).

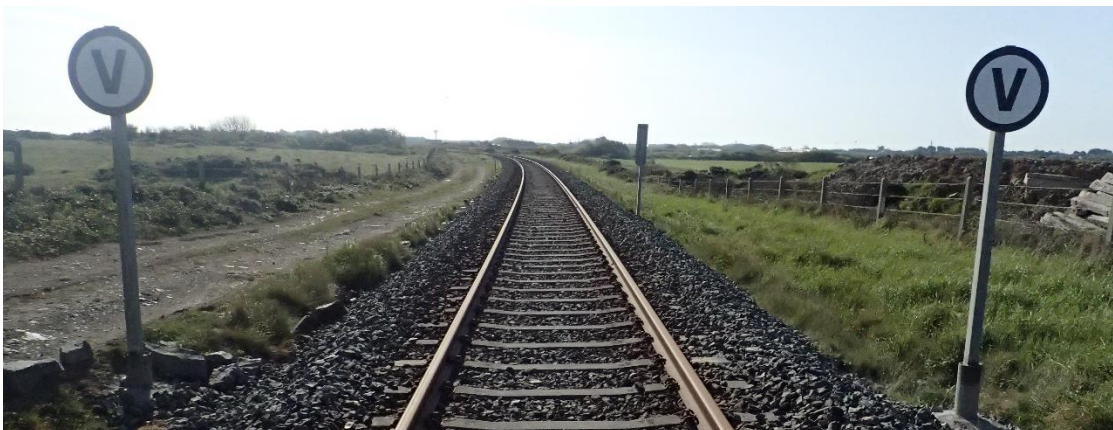
Figure 5 – Photograph of V Boards taken, when erected, after the accident

- 28 As a result of re-opening the level crossing, IÉ-IM had to erect *viewing distance marker boards* (sometimes referred to as V Boards). The V Boards were being moved, to their locations 350 m from the level crossing, by the RMME on the day of the accident, see Figure 5.

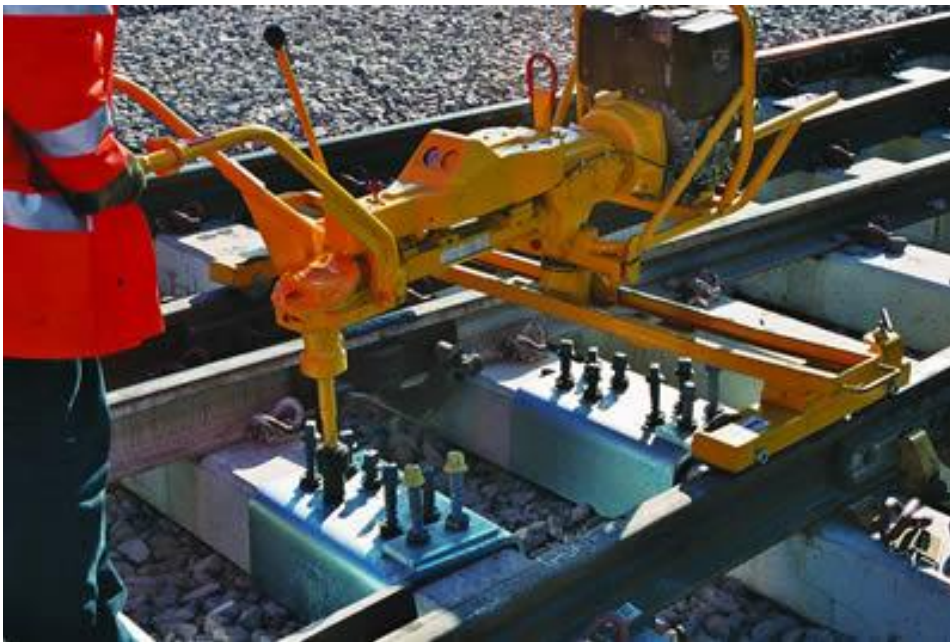
Figure 7 – Geismar Universal Power Spanner mounted on rails

- 43 The RMME involved in the accident is manufactured by Geismar; it has four steel tapered wheels running on bearings and weighs approximately 35 kilogrammes (kg). It is mounted on the rails traversing over the *five foot*.
- 44 It is primarily used to support a Geismar universal power spanner but is interchangeable with other powered machinery. The universal power spanner was not in use at the time of the accident (see Figure 7 for the unit in use for its intended purpose).

- 45 On the day of the accident, the RMME was not being used for its intended purpose, it was being used to transport the signage poles.
- 46 The RAIU requested information on the instructions for use of this RMME on the IÉ-IM network; IÉ-IM informed the RAIU that there were no instructions available for using the RMME as it was used on the day of the accident.
- 47 The RAIU also requested, from IÉ-IM, how IÉ-IM would classify the equipment used on the day of the accident; IÉ-IM classified the equipment as an RMME; it should be noted that this was classified by IÉ-IM, post-accident. In the IÉ's internal, Report of Investigation, "Collision of train A602 with a CCE trolley at 112.880 miles on the Rosslare Line 11th of January 2020", published on the 5th April 2020; they refer to the RMME as a "CCE Trolley" or a "Permanent Way Department (PWD) Trolley".
