Railway Accident Investigation Unit Ireland

INVESTIGATION REPORT

Person entrapped in lowered CCTV level crossing, Ashfield, Offaly, 24th May 2020

RAIU Investigation Report No: 2021 - R003

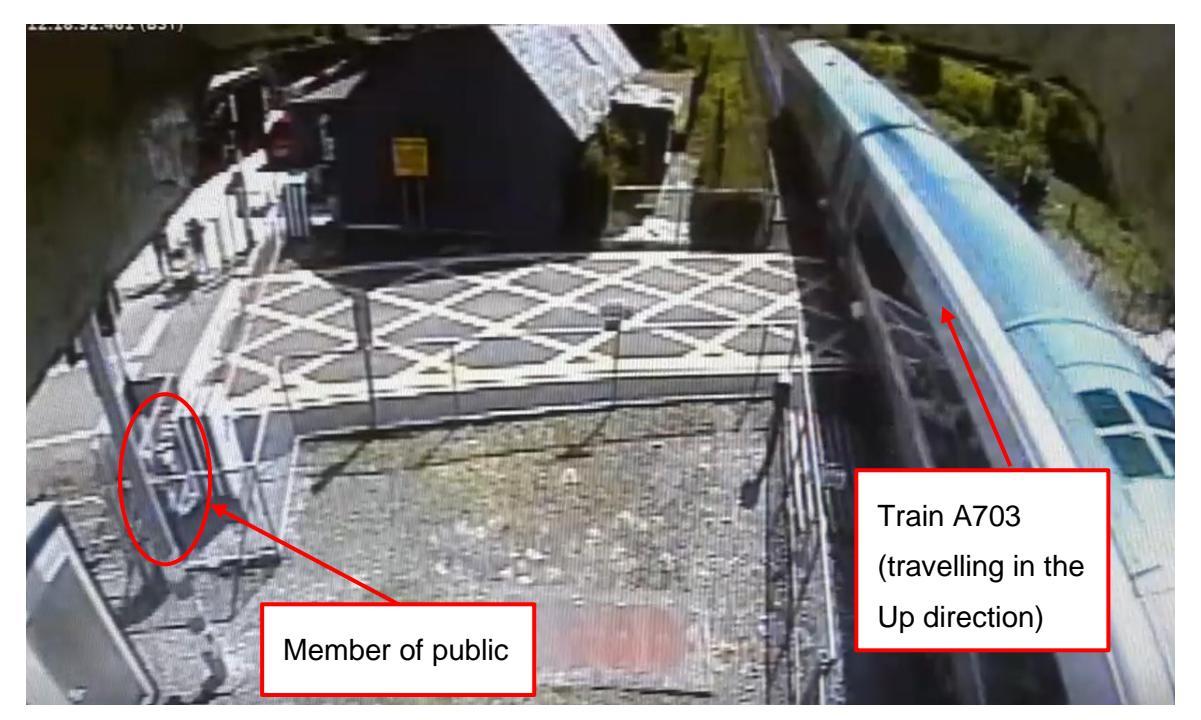
13 At ALCC, LCCO1 clears the crossing for the passage of Train A703 with one adult and child trapped inside the confines of LC XA068; the adult lifted the child over the barriers to the other adult. The trapped MOP, using the telephone at the level crossing, contacts LCCO1. LCCO1 advises the MOP that they would raise the barriers and instructs the MOP to stand beside some level crossing equipment (clear of the tracks, but within the confines of the level crossing). However, LCCO1 did not raise the barriers and allowed Train A703 to pass through LC XA068, see Figure 2.

Figure 2 – Train travelling through LC XA068 Image taken from IÉ-IM LC CCTV

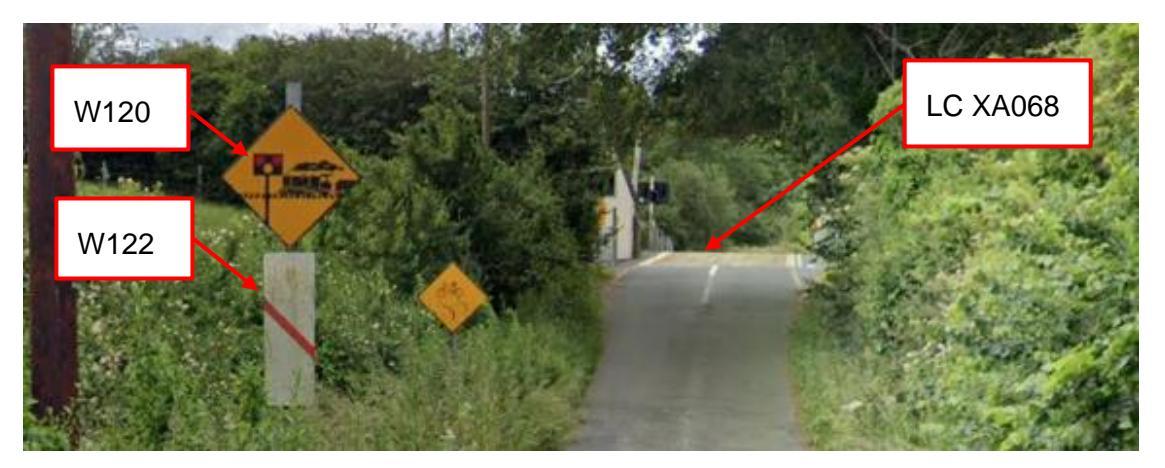
40 LC XA068 has the correct approach signage, see Figure 5.

Figure 5 – Road signage on approach to LC XA068

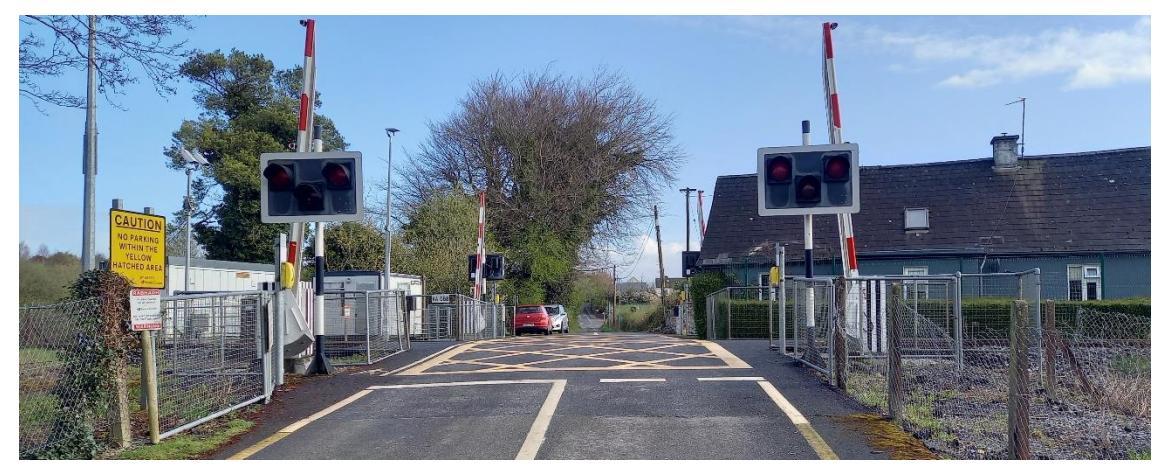
41 In addition, LC XA068 has the correct road level crossing signals located on each side of the Stop lines, see Figure 6.

Figure 6 – Flashing Red Signals & Yellow Box Markings

- 42 At the level crossing, the road is covered in Yellow Box Markings (Chapter 7, Traffic Signals Manual); this is to avoid the blocking of road traffic on the level crossing (see Figure 6). These road markings are accompanied by caution signs stating "Caution: No parking within the Yellow Hatched Area). Adjacent to the Yellow Box Marking are marking, indicating where pedestrians should cross the level crossing.
- 43 There are two signs at XA068 states "Drivers of large or slow vehicles or herds of animals must phone before crossing".
- 44 There are no signs warning pedestrians not to enter the level crossing once the warning lights and bells for the level crossing flash and sound; there are also no signs inside the barriers of the level crossing, telling MOPs what actions to take in the event they become trapped.

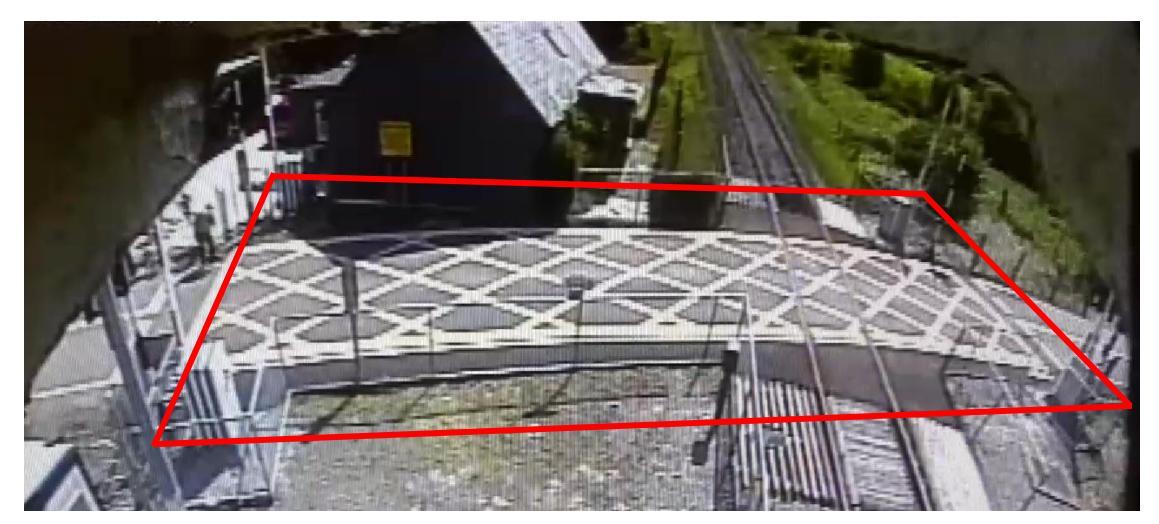
- 49 I-TEL-3516 also sets out the requirements for the location of the CCTV at the level crossings, which provide the optimum views of the level crossing e.g. nominally perpendicular to road traffic, north-facing, etc.
- 50 The CCTV cameras for LC XA068 are mounted on standard steel poles located on the Athlone side of the level crossing. The orientation of the CCTV cameras is in a south east direction. Figure 9 shows the viewing area of LC XA068.

Figure 9 – Viewing area of LC XA068

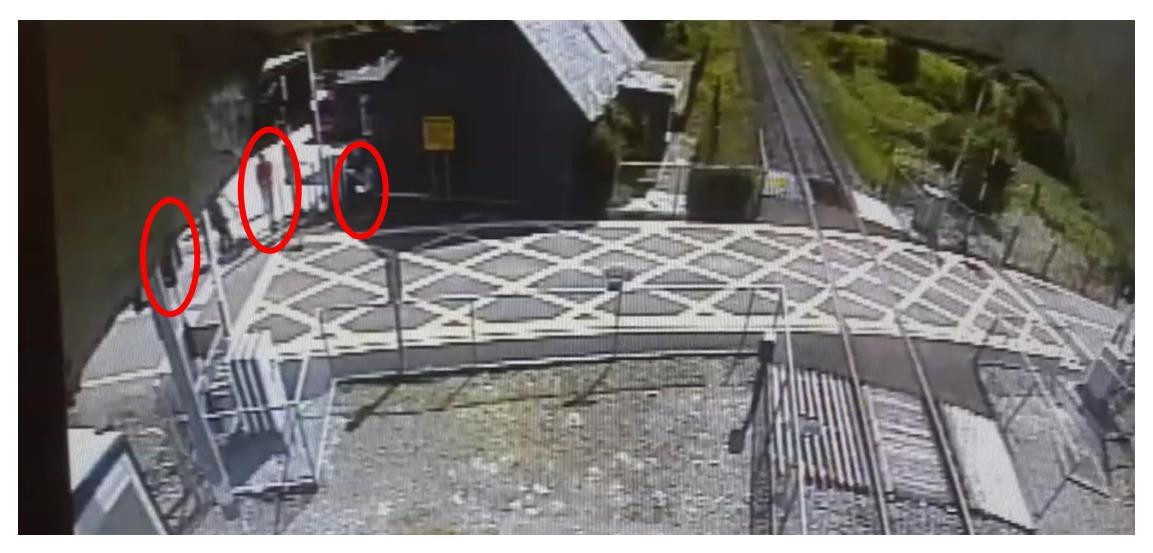
- 86 At 12:13:52 hrs MOPs (MOP1, MOP2 and Child) are at in the vicinity of LC XA068; the Child is playing with a bicycle in the confines of LC XA 068, see Figure 16 (the following CCTV still images are taken from the CCTV footage of LC XA068 from the LCCC Athlone).

Figure 16 – MOPs in the vicinity of LC XA068 (circled red)

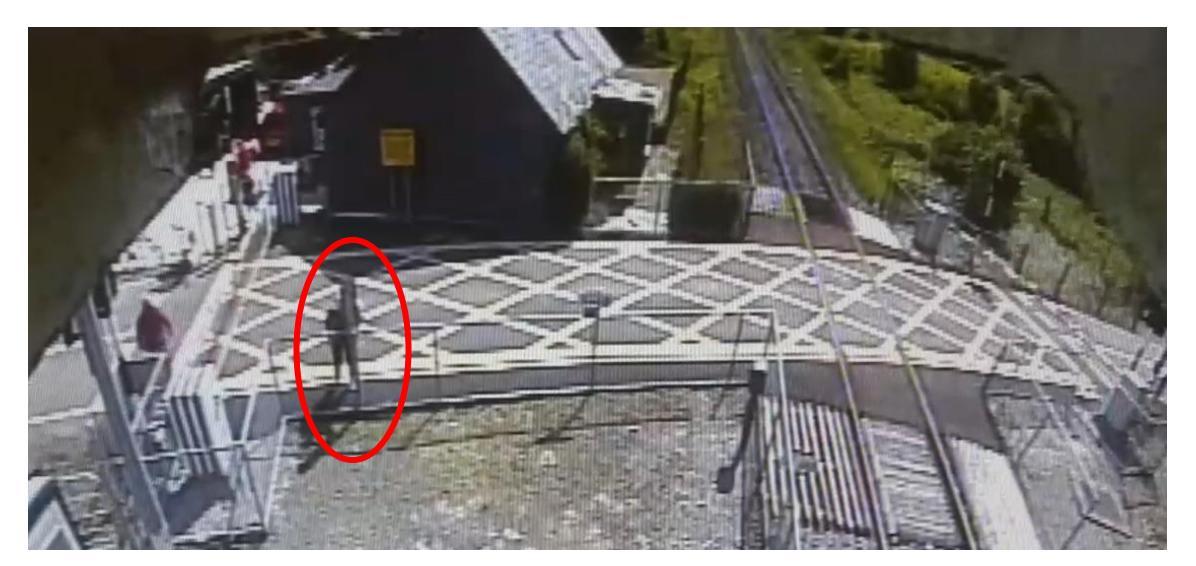
94 At 12:14:54 hrs, MOP1 walks over the telephone, see Figure 20.

Figure 20 – MOP1 at telephone (circled red)

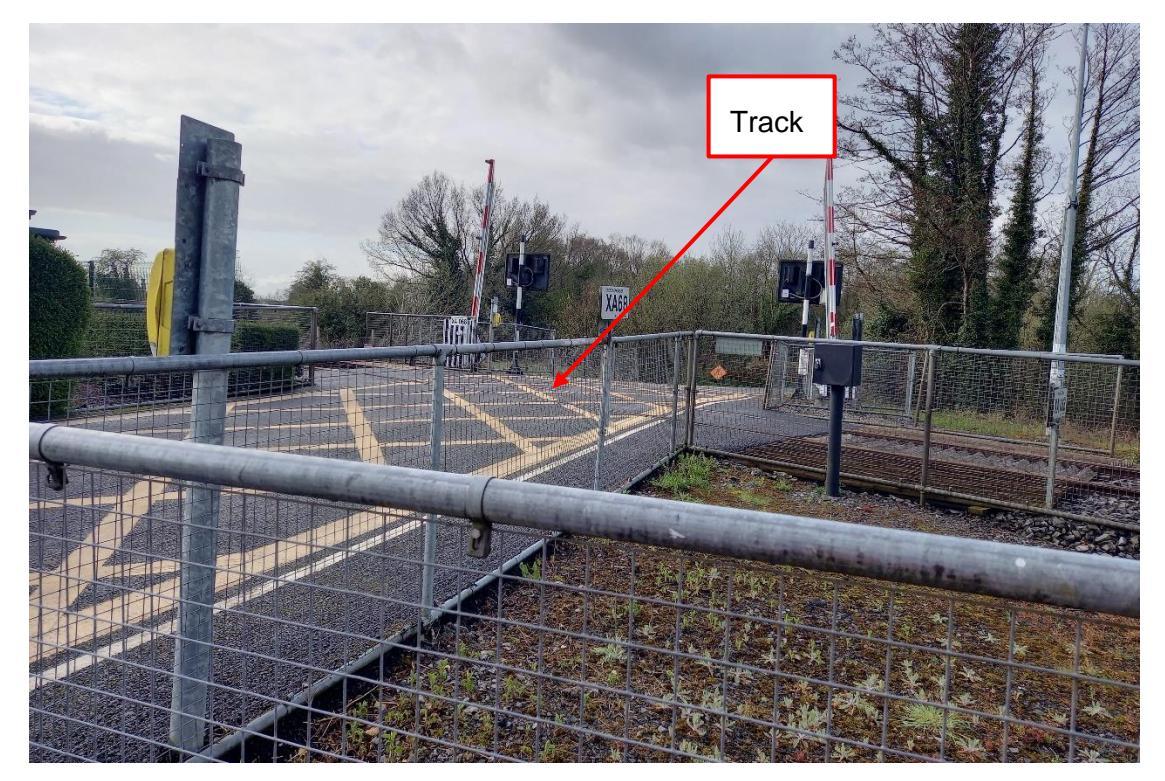
98 MOP1 is in this position at 12:16:20 hrs and remains here until Train A703 has passed through the level crossing and the barriers are ultimately raised, see Figure 22 for MOP1's position in relation to the track.

Figure 22 - View from MOP1's position behind the barrier machine taken by the RAIU

- Safety Recommendation 202103-04 IÉ-IM should develop a means to make MOPs more visible should they become trapped inside level crossing barriers and position themselves adjacent to level crossing furniture or other infrastructure; where this cannot be achieved consideration should be given to examining possible initiatives or technologies that could be introduced to provide aid and assistance to LCCOs in identifying persons/obstacles that maybe trapped within the confines of a level crossing;
