**Railway Accident  
Investigation Unit  
Ireland**

# **INVESTIGATION REPORT**

**Collision between a Bord na Móna Flat Wagon and  
Kilcolgan Level Crossing Gates, Offaly,  
8<sup>th</sup> June 2020**

RAIU Investigation Report No: 2021 – R002

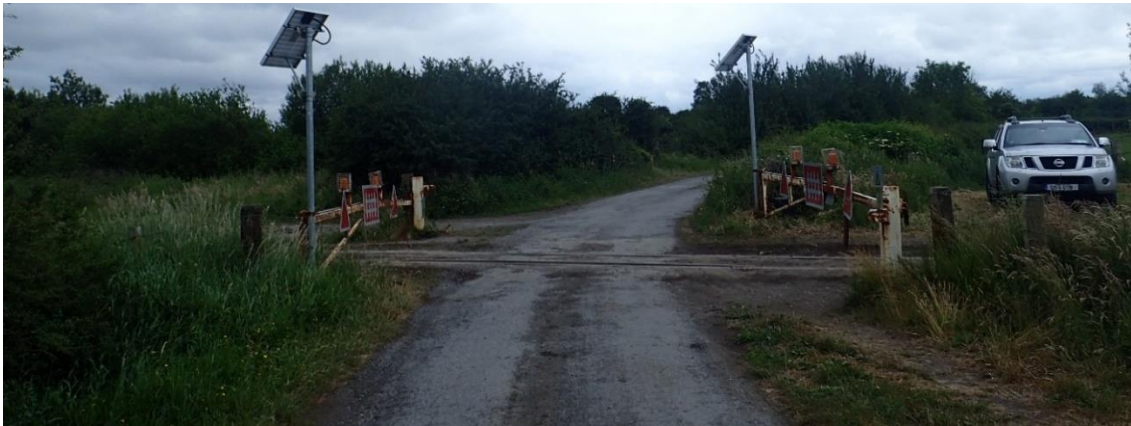
Figure 4 – Kilcolgan Level Crossing

30 Kilcolgan Level Crossing has rail recessed into the existing road surface (see Figure 4).

32 Kilcolgan Level Crossing is graded as a Grade B level crossing, meaning it is a gated crossing on a local primary/ secondary road, see Figure 4.

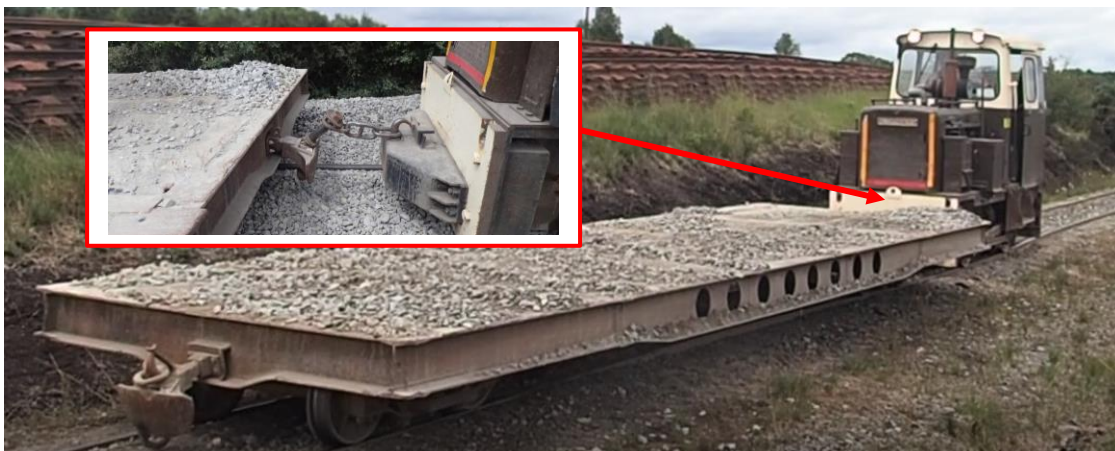
Figure 8 – Locomotive coupled to Flat Wagon (coupling arrangement inset)

40 The Flat Wagon is 29.5 feet (ft) long and 8 ft wide and has two heavy duty Diamond *Bogies*; each bogie contains two wheelsets (see Figure 8).

- 41 The Flat Wagon has a chain coupling and a 55 mm Buffer Bar (see inset Figure 8).
- 42 The Flat Wagon has no braking system.

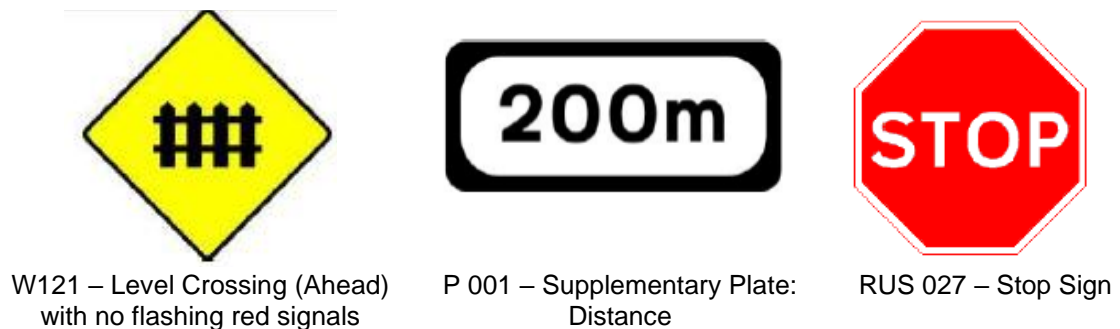
Figure 9 – Mandatory road signage on approach to and on level crossing gates

70 Chapter 6 states that "three appropriate yellow diamond 'Level Crossing Ahead' signs shall be erected on each roach road", indicating that Sign W 121 (see Figure 9) is mandatory and supplementary plates P 001 (see Figure 9) showing the distance to the junction at three location on the approach to the crossing should also be provided; in addition, two RUS 027 Stop signs (see Figure 9) should be erected on the level crossing gates.

- 111 Chapter 6, Warning Signages, of the Department of Transport's Traffic Signs Manual clearly sets out the signage requirements which must be present on the approach to and at level crossings located on the roads of Ireland (paragraphs 69 and 70). In relation to Kilcolgan Level Crossing, the mandatory requirements are that three diamond "Level Crossing Ahead" (Sign W121) signs are located on the approaches to the level crossing, with their associated distance plates (P 001), see paragraph 70 and Figure 9. At the level crossing, Stop signs should be erected on the gates of the level crossing (paragraph 70 and Figure 9). These signs are not in place at Kilcolgan Level Crossing.

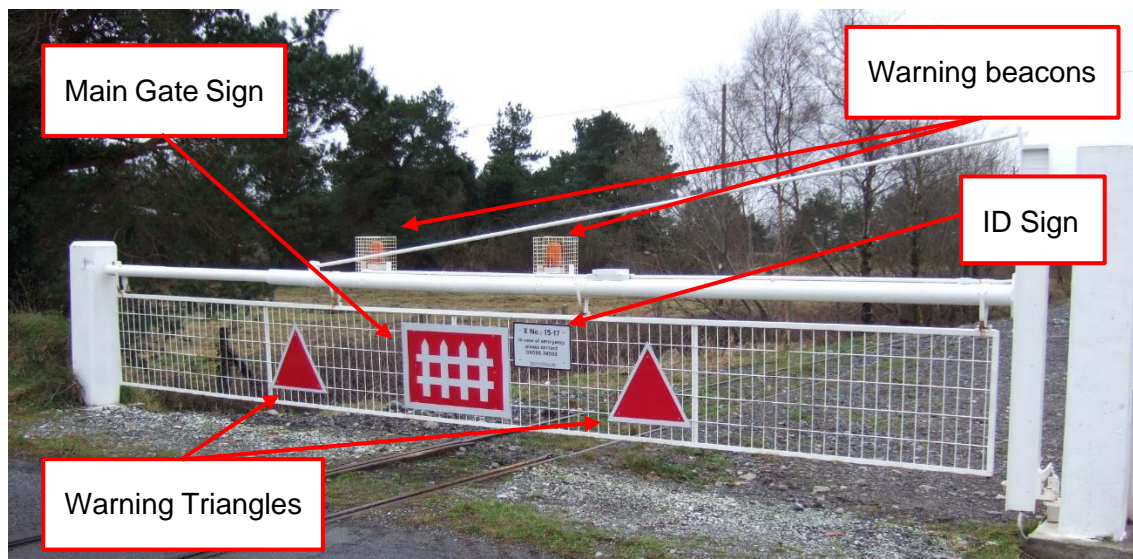
Figure 13 – Figure set out in BnM’s Specification of Level Crossings

73 Section 3.0 sets out the requirements for signage on the gate. In terms of signage on the gate, with Figure 3.2 of the section, outlining a “typical BnM Level Crossing Gate”, see Figure 13. Each gate should have two warning beacons, one “Main Gate Sign” and two “Warning Triangles” and the “ID Sign”.

- 112 In their place are signs as set out in BnM's Specification for Level Crossings document, requiring that Grade B level crossings have one diamond "Level Crossing Ahead" sign, Type B2 Sign (Figure 11) (with no distance plate) and one "Slow Level Crossing Ahead" sign, Type B1 Sign (Figure 10) erected (paragraph 71). However these were not erected at the required distances of distances of 250 m and 160 m ahead of the level crossing, respectively (paragraph 71); but positioned at distances of approximately 350 m and 260 m, respectively (paragraph 75). On the level crossing gates, BnM have, in place of the required Stop sign, BnM designed signs such as "Main Gate Sign" and "Warning Triangles" (paragraphs 76 and 77); in addition, the ID Sign was absent (paragraphs 73, 77 & Figure 12).
