INVESTIGATION REPORT

Chassis Plate Fracture on General Motors Class 201, Locomotive 224, 7th July 2020

RAIU Investigation Report No: 2021 – R004

Published: 1st July 2021

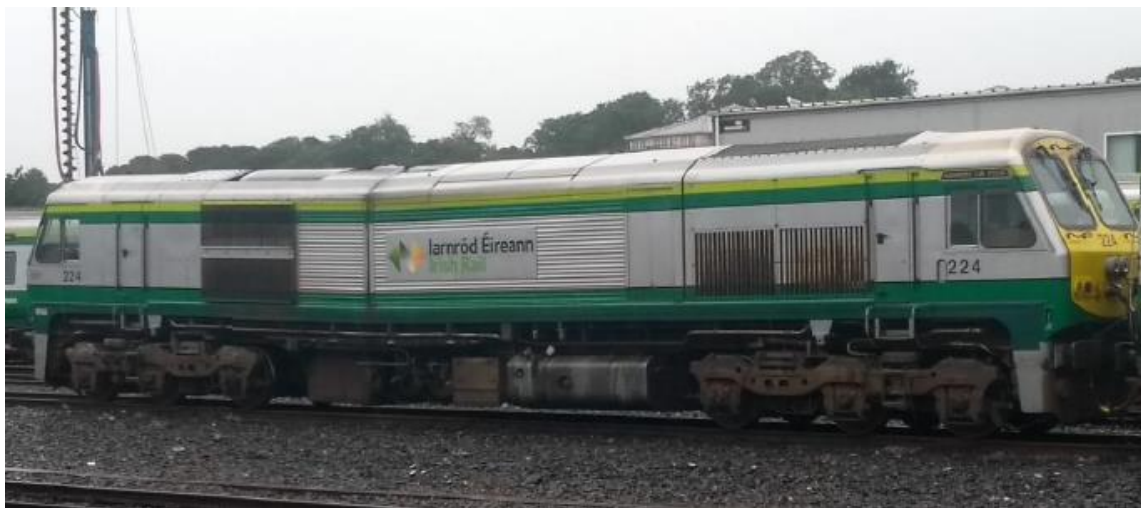
On the 7th July 2020, while Locomotive 224 was at Heuston Station awaiting transfer to Inchicore Works, a driver observed the body of Locomotive 224 was sagging near the centre point and reported it to his supervisor who in turn alerted the relevant parties. On inspection, by the Chief Mechanical Engineer’s (CME) Department’s maintenance staff a main frame crack was identified. Locomotive 224 was then shunted to Inchicore Works for a more thorough examination.

Figure 1 - Locomotive 224 at Dublin Heuston prior to transfer to Inchicore Works

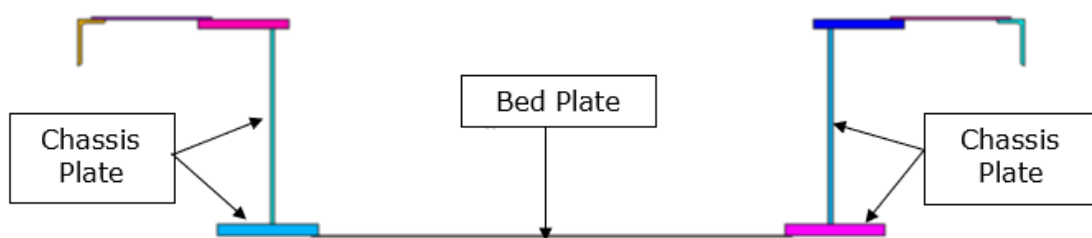
- 14 Also identified were earlier weld repairs carried out to the Bed Plate (a flat sheet of steel covering the area between two Chassis Plates that run on either side of the locomotive; and prevents oil leaks dropping onto the track, see Figure 3). These welds could only have been carried out when the engine and generator was removed (i.e. during Heavy Maintenance in 2010 or 2019, discussed in paragraph 72).

Figure 3 – Schematic of Chassis Plates and Bed Plate on 201 Locomotive

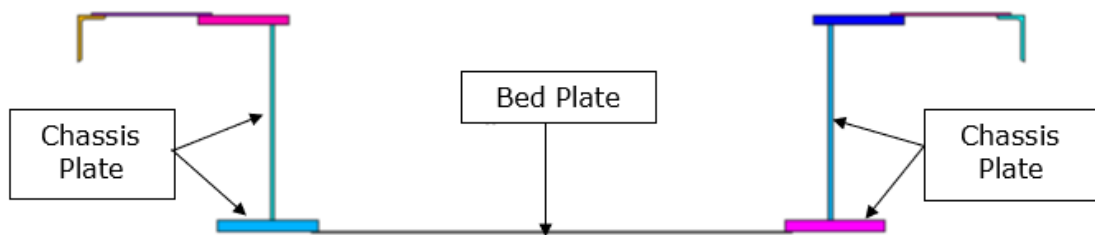
- 49 Between the two Chassis Plates a number of flat mild steel sheets are fitted to collect oil spillage from the engine and prevent oil contamination of the track. The plates are collectively known as Bed Plates (these are non-structural). The original design of the Bed Plate was a flat sheet seam welded externally and tack welded internally to the Chassis Plate during manufacture. The Chassis plate is manufactured from ASTM A572 Grade 50 steel plate and the Bed Plate is made to MS 4361 hot rolled mild steel sheet.

Figure 9 – Schematic of original Bed Plate arrangement on a 201 Locomotive

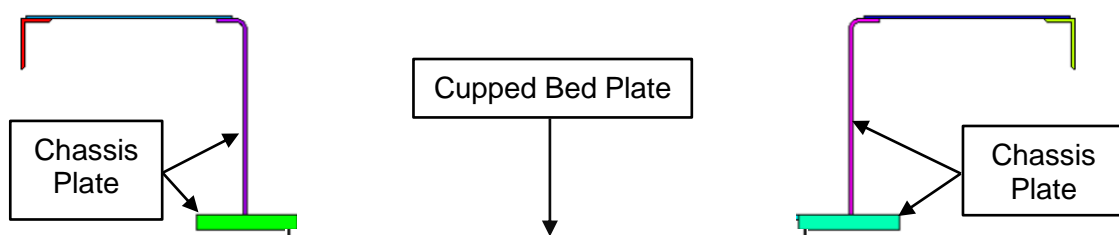
- 50 During commissioning of the 201 Locomotives GM were alerted to a number of Bed Plate cracks on the 201 Locomotive fleet, and other JT42 series locomotives (supplied worldwide by GM) and issued SA 08-007 in June 2008.
- 51 When cracks were found in the existing Bed Plate, SA 08-007 recommended a change in the design of the Bed Plate from a flat Bed Plate (Figure 9) to a cupped Bed Plate (Figure 10).

Figure 10 – Schematic of Bed Plate arrangement recommended by SA 08-007
