**Railway Accident
Investigation Unit
Ireland**

INVESTIGATION REPORT

**Near miss with an Iarnród Éireann CCE Worker
near Gormanston Station, 21st July 2021**

RAIU Report No: 2022 – R002

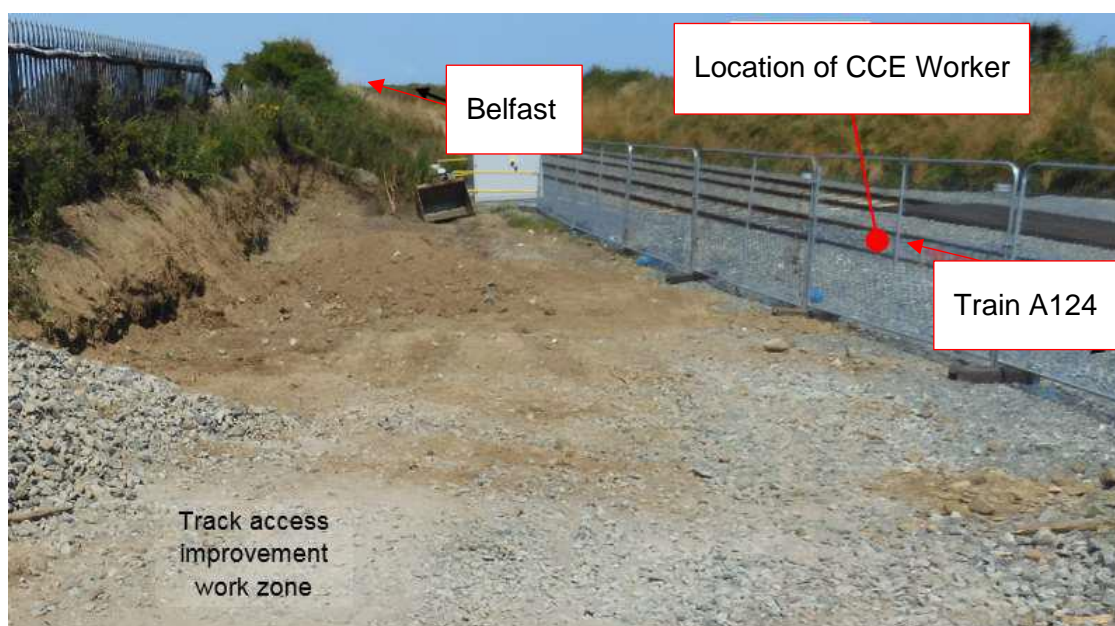
Figure 3 – Track access location

- 20 There is a car park on the western side of the station adjacent to the Platform 2. North of the car park, there is a track access point, for plant accessing the railway. At the time of the incident, there was improvement works being undertaken and the site was protected with security fencing, see Figure 3.

- 36 The CCE workers duties on the 21st July 2021 were in relation to performing of TSC for the ongoing improvement works at Gormanston track access location. The worksite was separated from the railway by means of security fencing, see Figure 3, and there was no requirement for the TSC to access the railway line as part of the improvements works.

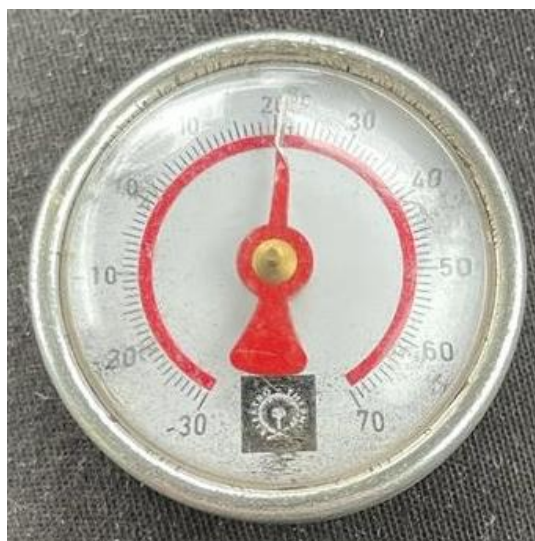
Figure 5 – Temperature gauge

- 37 The week previous to the date of the incident, the CCE Worker had been checking track temperatures at various locations due to the unusually hot weather, to prevent any track buckling or damage.

- 38 A temperature gauge, is dial measuring device, placed on side of the rail; the magnetic base holds it in place, and measurements are taken after twenty minutes, see Figure 5.
