Railway Accident Investigation Unit Ireland

INVESTIGATION REPORT

Overhead Line detachment, Pearse Station,

RAIU Investigation Report No: 2021 - R005

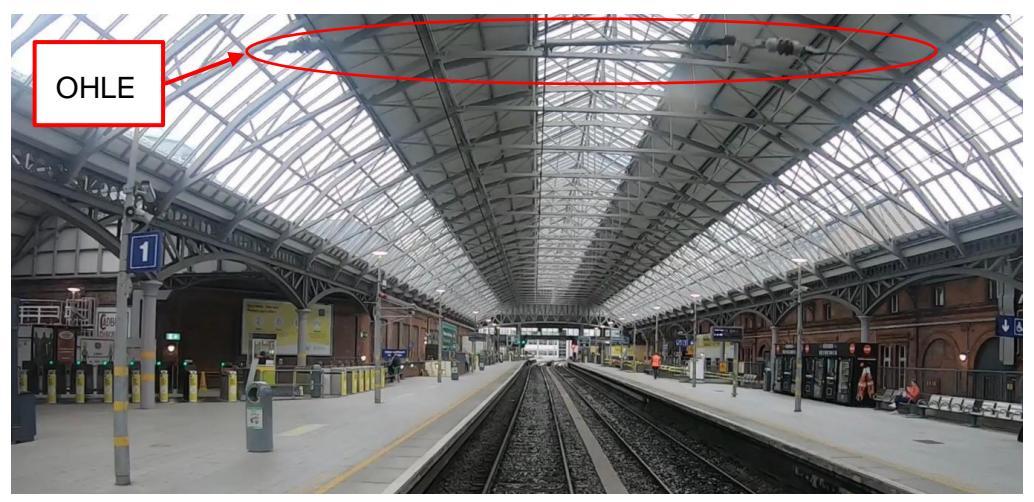
Figure 2 – The OHLE at Pearse Station

- 46 The Contact Wire height at Pearse Station is 4.46 m above the rail. Due to the infrastructure in place at Pearse Station and to limit the visual impact of the railway electrification, the OHLE within the station structure is of a 'Head Span' arrangement (i.e. the OHLE is supported by a system of wires, as opposed to cantilever arms or portal frames). This arrangement has been in situ since 1983 without any major issues.

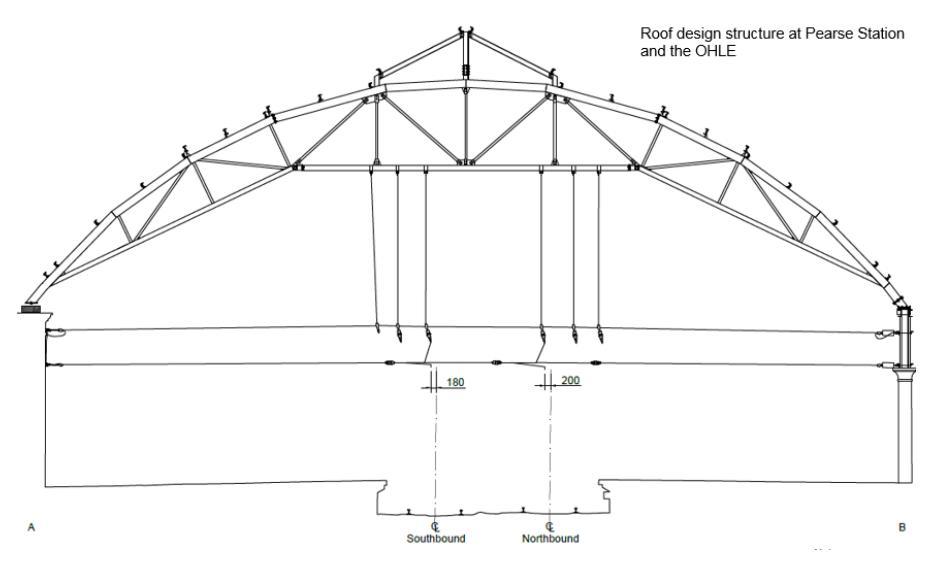
Figure 5 – Roof design structure and OHLE at Pearse Station

47 The roof of Pearse Station was replaced in recent years, with the work being completed in July 2020, Figure 5 shows a cross section of the new roof design, with the Head Span design arrangement remaining.

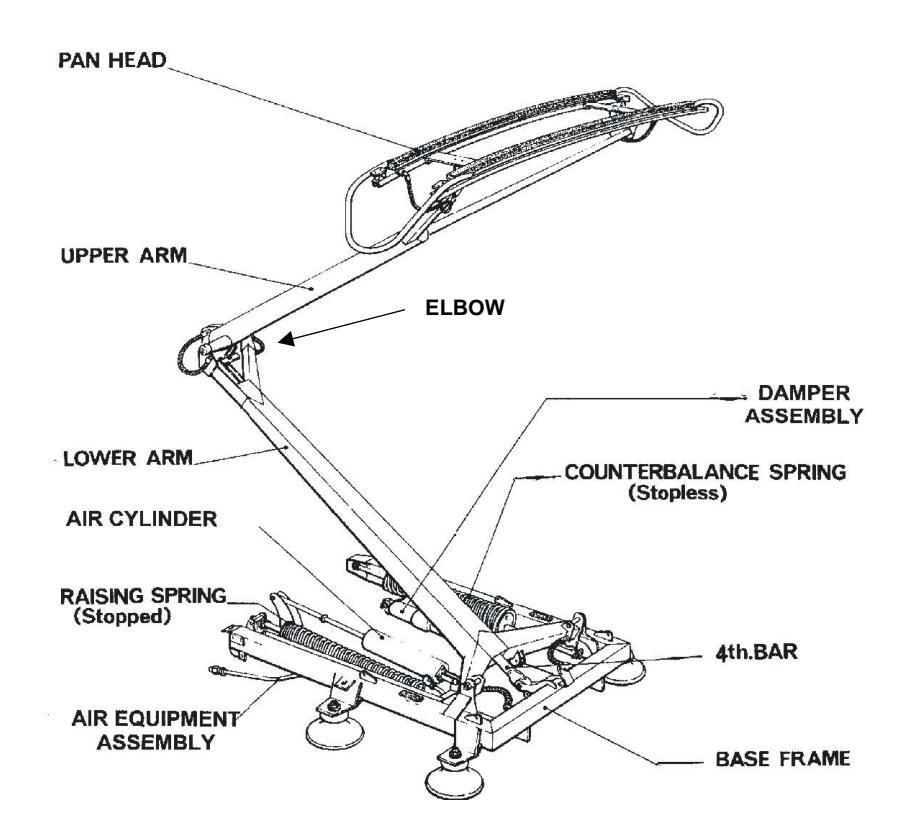
Figure 10 – Pantograph assembly on 1800 EMUs

18 The chains at the Elbow of Pantograph 396 were broken and the 4th Bar was bent (see Figure 10 for locations of damage), the damage was estimated at €6,576.

58 A pantograph is a mechanical system mounted on the roof of the Class 8100 EMU trains to convey the 1,500V DC from the OHLE line to the train. The pantograph consists of a base frame, Lower Arm and Upper Arm (hinged at the joining of the two arms is the Elbow Joint), and the Pan Head, see Figure 10. The Pantograph Head houses contact carbon strips that slide along the overhead line as the train moves.
