Investigation Report 2012–R001

Car Strike at Morrough Level Crossing, XG173,

County Galway,

14th February 2011

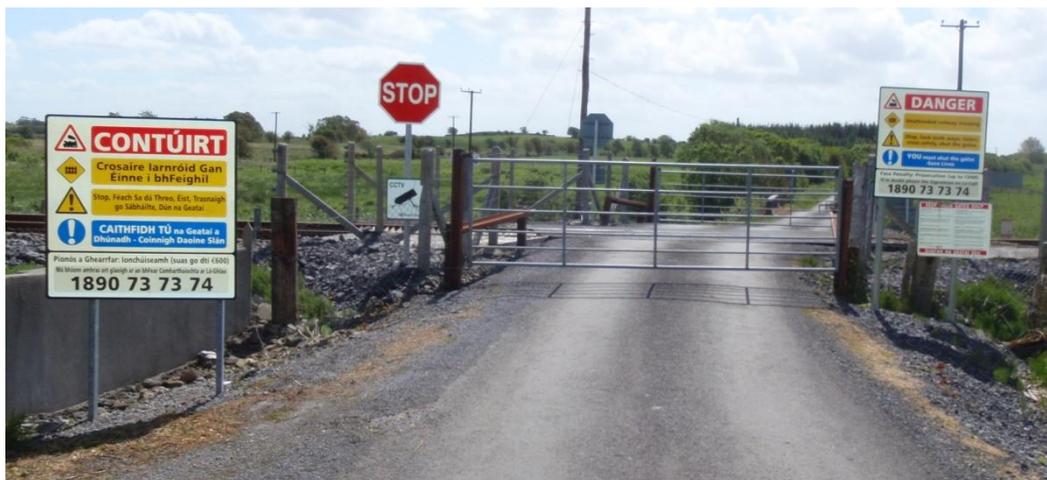
Photograph 2 – Typical user worked level crossing on the IÉ network

In the case of this Level Crossing, the private road, which runs from the R338 approaching Galway, leads into Murrough House which is a private residence owned by GMIT. The approach road to the Level Crossing is a straight, flat road with an unsealed surface, with some potholes. The Level Crossing is fitted with four ornamental wrought iron gates, which can be opened both outwards and inwards, from and towards the railway line, mounted on ornate concrete pillars. The Level Crossing gates are private residence gates adapted for the Level Crossing, and are not similar to other level crossing gates on the network such as Knockaphunta Level Crossing in County Mayo, see Photograph 2, which would be typical of a user worked level crossing on the IÉ network.

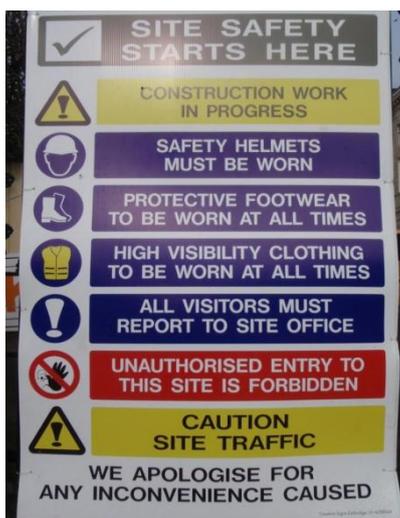
Photograph 8 - Workplace sign

Photograph 8 and 9 show the similar design layout and concept to health and safety workplace signage at a construction site.
