# Railway Accident Investigation Unit

## INVESTIGATION REPORT Runaway locomotive at Portlaoise Loop 29<sup>th</sup> September 2011

RAIU Report No: R2012 – 002  
Published: 19<sup>th</sup> September 2012

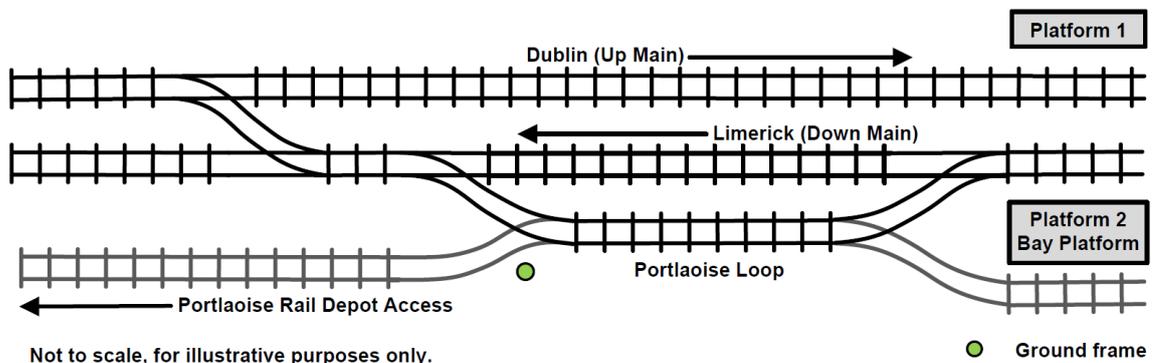
**Figure 2 – Track layout for Portlaoise Station**

- 2 Having travelled on the *Up Main* to Portlaoise, he stopped the locomotive outside Portlaoise Station in order to manoeuvre into Portlaoise Rail Depot. This manoeuvre required that he travel from the *Up Main*, across the *Down Main*, onto the *Portlaoise Loop* and into Portlaoise Rail Depot, see Figure 2.

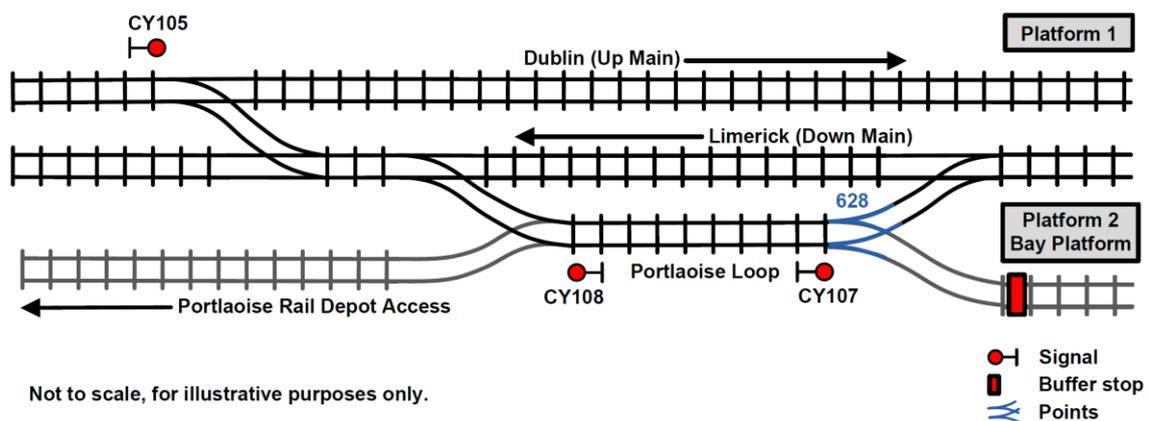
**Figure 4 – Signalling layout**

- 9 The railway line through Portlaoise is the double track route from Dublin to Cork (via Limerick Junction) and is signalled using two and three aspect *colour light signals* by the main line signalman based in CTC, Connolly Station. Running signal CY105 is an Up Mainline signal and running signals CY108 and CY107 are positioned on Portlaoise Loop (Figure 4).

- 10 When points 628 are in the normal position, the route is set for a train movement from Portlaoise Loop towards the Bay Platform road. The Bay Platform has been decommissioned and a buffer stop has been placed on the residual stub of the Bay Platform road just short of the platform ramp. This residual stub of track acts as *flank protection* for the Down Main when points 628 are in the normal position. When points 628 are in the reverse position, and CY107 indicates a proceed aspect, the route is set for a train movement onto the Down Main. Points 628 are fitted with a Track Circuit Interrupter, therefore trains passing these points towards the buffer stop, activate the track circuits and thus all protecting signals will either return to danger or remain at danger until the Track Circuit Interrupter has been reset. On the day of the accident, points 628 were set in the normal position.

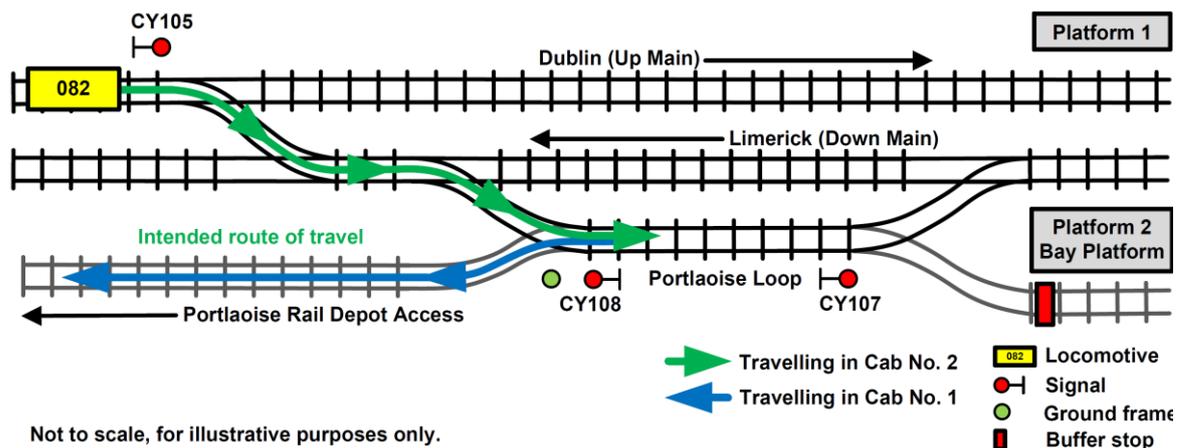
Figure 7 – Intended route of travel for the locomotive

- 46 The Train Driver then travelled from Limerick Junction to the outskirts of Portlaoise Station without incident. He stopped the locomotive on the Up Main at signal CY105 (see Figure 7), prior to attempting to manoeuvre into Portlaoise Rail Depot (see Figure 7 for the intended route of the locomotive, which required the Train Driver to cross onto the Down Main and then onto the Portlaoise Loop, stop temporarily on the Portlaoise Loop in order to set the ground frame and travel into Portlaoise Rail Depot).

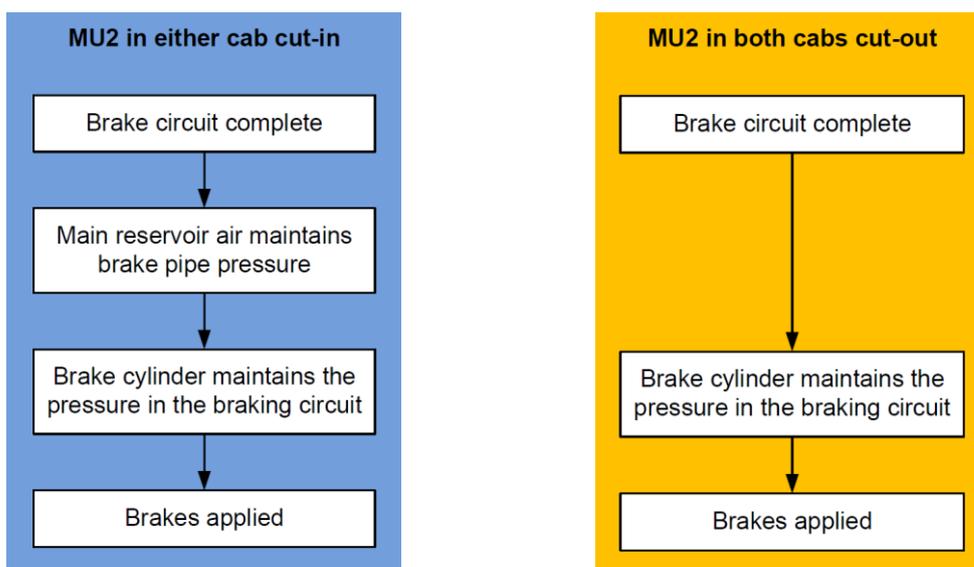
Figure 9 – Illustrating what would occur with either or no MU2 valve cut-in (and no leak)

48 As the locomotive was being driven from the cab facing towards Dublin, the Train Driver was required to switch ends (from Cab No.2 to Cab No.1) in order to manoeuvre the locomotive into Portlaoise Rail Depot. This required him to follow the procedures set out in Section 4.4.A & 4.4B of the IÉ's Drivers' Manual for 071 class locomotives (outlined in paragraph 37 and 38) in relation to vacating and occupying cabs. This would have resulted in brakes being applied to the full service position, therefore completing the brake circuits, when the MU2 valve in Cab 2 was cut-out (when vacated) and the MU2 valve in Cab 1 cut-in (when occupied); and would not have been affected by any brake leaks. Figure 9, shows what would occur with the MU2 valve cut-out in Cab 2 & cut-in in Cab 1, as procedure dictates (in blue) or having MU2 valve cut-out in both cabs, as occurred on the day of accident (in orange). It should be noted that the figure has had its functionality simplified and is for illustrative purposes only.

50 In relation to 'cab being occupied', the Train Driver did not cut-in the MU2 valve, and only placed his equipment in Cab 1, see Figure 11. However, cutting-in the MU2 valve in Cab 1 would still have resulted in the brakes applying, see Figure 9.
