Railway Accident Investigation Unit

INVESTIGATION REPORT **Rock fall at Plunkett Station, Waterford,** **31st December 2013** RAIU Report No: R2014 – 006 Published: 18/12/2014

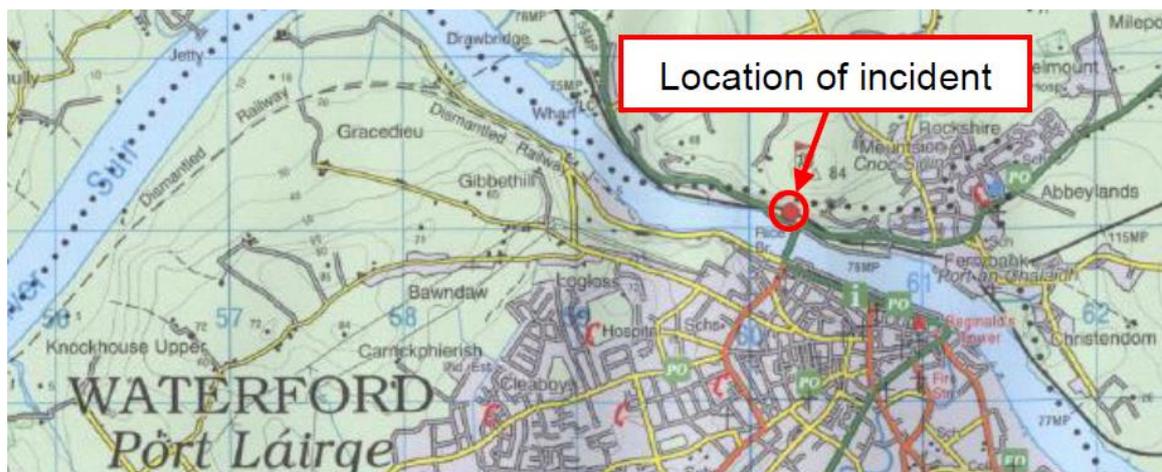
- 1 At approximately 18:45 hrs on Tuesday 31st December 2013 the Signaller at Signal Cabin, at Plunkett Station (Waterford) heard a loud rumble from outside, see Figure 1 for the location of the incident.

Figure 1 – Location of incident

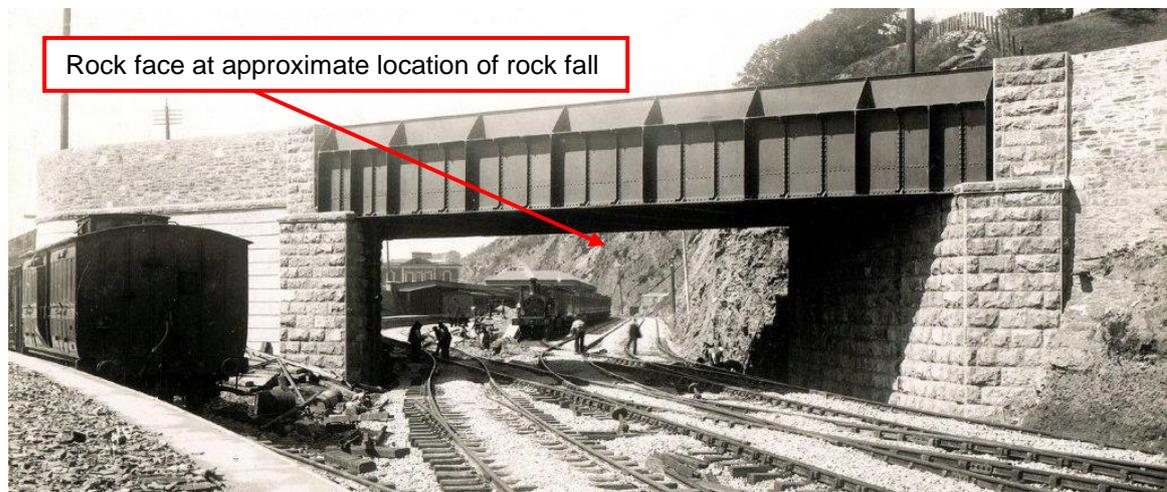
- 7 Plunkett Station, Waterford, is located at the 75 $\frac{3}{4}$ milepost (MP), measured from Mallow via Fermoy, on the Mallow to Rosslare Line on the banks of the River Suir. The station consists of four tracks running through the station and four platforms (3,4,5 & 6), with the Signal Cabin situated at the Dublin end of Platform 4.
- 8 In 1864, to facilitate the building of Plunkett Station, rock from the Mount Misery rockface was excavated. In 1905 further excavation was carried out to facilitate the Plunkett Station extension works and additional Fishguard & Rosslare Railways and Harbours Line, see Figure 3.

Figure 3 – 1905 photograph of Plunkett Station, including Mount Misery
