**Railway Accident
Investigation Unit**

INVESTIGATION REPORT
Vehicle struck by train at Corraun level
crossing, XX024, Co. Mayo,
12th February 2014
RAIU Report No: R2015-001
Published: 30/04/2015

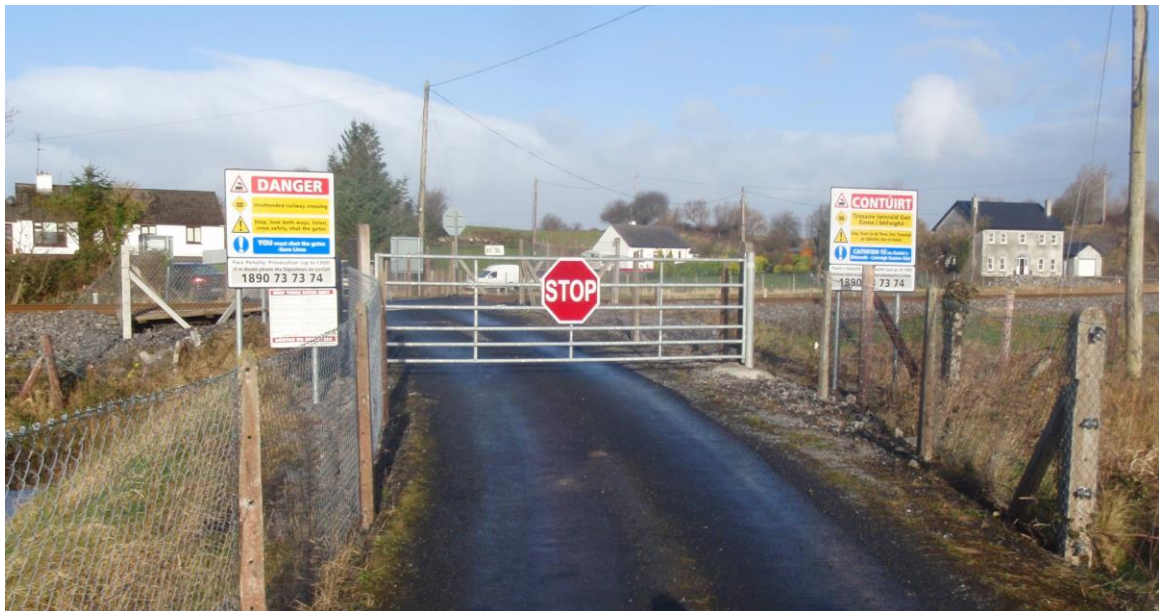
Figure 3 – Corraun Level Crossing, XX024

- 8 The Level Crossing is accessed from an unrestricted private road, 75m from a third class regional road (L57721), located off the N5 (Castlebar – Swinford) adjacent to Ballyvary, to which the public have unrestricted access, see Figure 3. The third class regional road has a speed limit of 80 kilometres per hour (km/h).

- 9 IÉ have designated the level crossing as an 'Occupational Crossing' (O) type crossing and is identified by IÉ as asset number XX024. 'O' Type crossings are unattended level crossings, on private roads, where the level crossing gates are normally closed to road traffic. They require the user to open and close the level crossing gates in order to cross the railway.

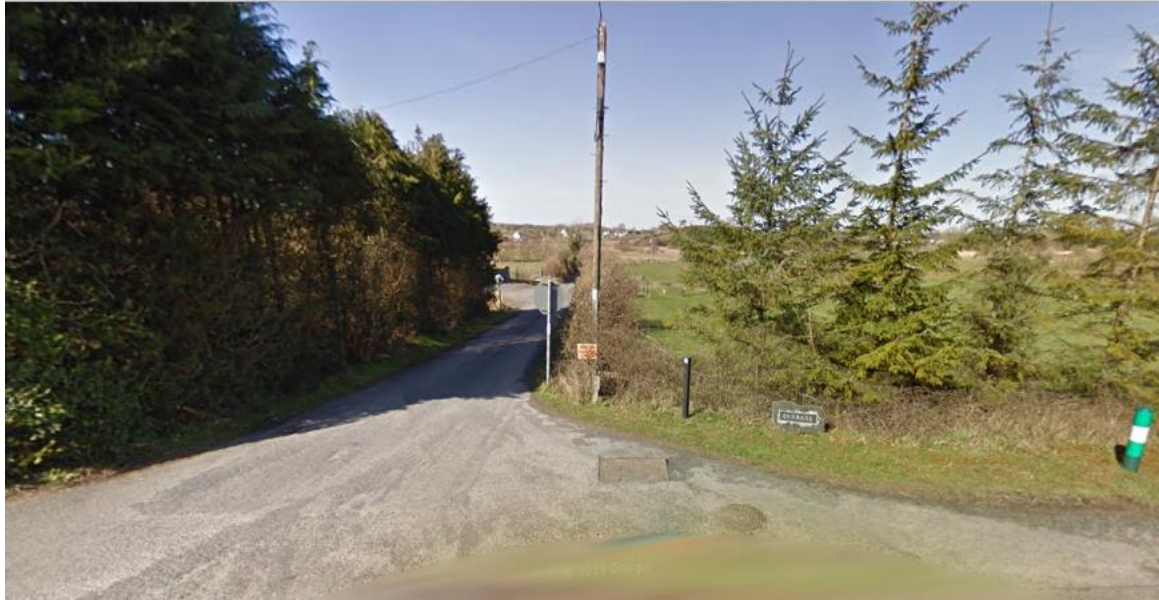
Figure 8 – View from National Road (N5) onto Third Class Public Road (Public Road)

- 44 The third class public road L57721 (identified as 'Public Road' in Figure 7) is accessed from the N5 National Road and runs a distance of 375 m to the access point of the private road (identified as 'Private Road' in Figure 7), see Figure 9.

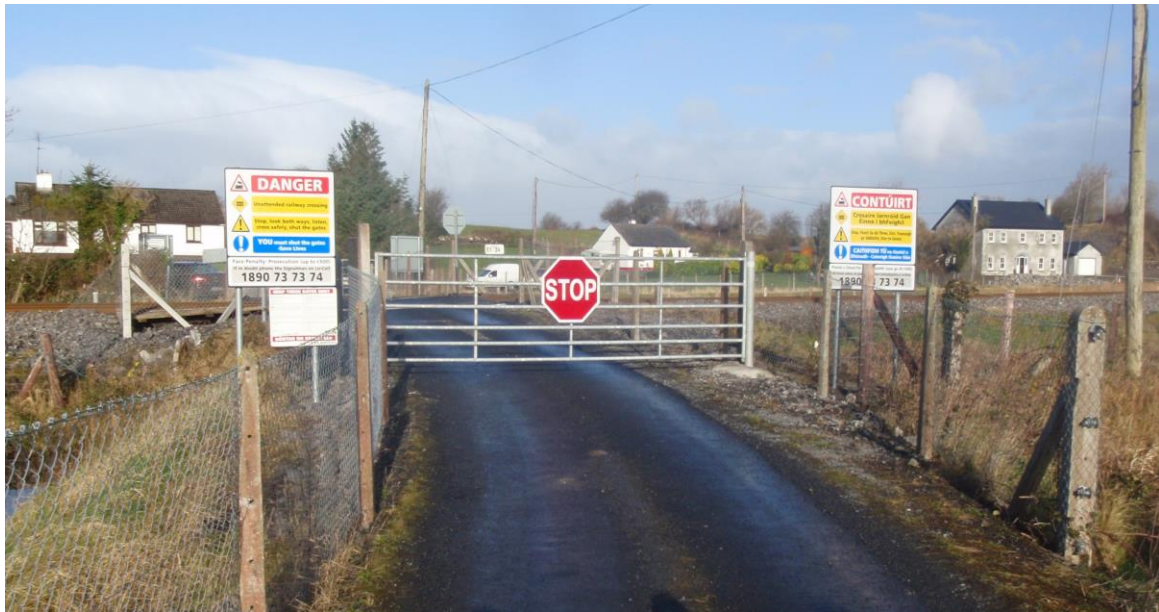
Figure 10 – The Level Crossing

52 The signage on the Level Crossing was replaced by IÉ in January 2013, see Figure 10.

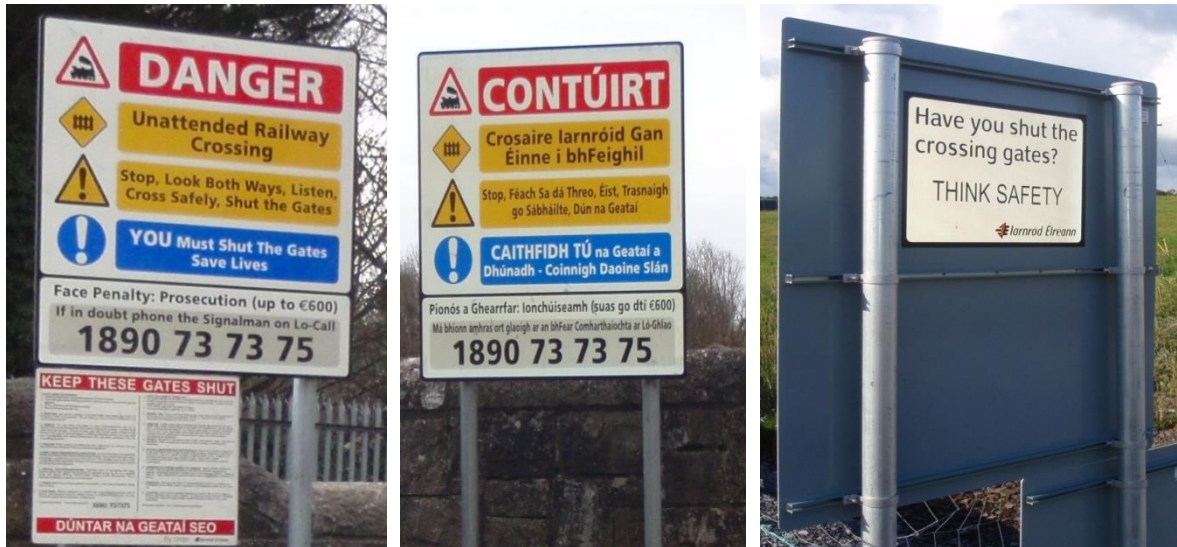
Figure 11 – Examples of signage at the level crossing

- 'Stop' signs located within the railway boundary, on poles to the driver's nearside behind the gates. These stop signs are to the same specification as required on public roads by Section 6 of the Road Signs Manual (Department of Transport, 2010);
- 'Stop' signs located on the centre of the metal gates, with the same specification set out above;
- IÉ 'Danger' sign, in the English language, including the statements: "unattended railway crossing"; "stop, look both ways, listen, cross safely, shut the gates"; "you must shut the gates – save lives" and penalty notice, see Figure 11 (left);
- IÉ 'Danger' sign in the Irish language, including the above statements in Irish, see Figure 11 (centre);
- IÉ 'Keep these gates shut' sign which includes requirements related to closure of the gates and penalty notices associated with the failure to close gates, see Figure 11 (left).

- IÉ “Have you shut the crossing gates?” signage, which is located on the rear of the IÉ “Danger” signage, see Figure 11 (right).

- The words on these signs are helpful to users, and clearly indicate danger. However, there is no mention that the user is at a railway crossing or that trains are very fast and quiet;
- These signs are considered to be “busy and confusing” for the following reasons:
 - The use of multiple colours is distracting and tends to lead to a focus on the colour rather than the words;
 - Several fonts are in use;
 - The pictograms tend to distract from the key messages;
 - Reservations that the Puffing Billy depicts a slow moving heritage railway or other leisure activity, a steam train associated with fun, children’s books and cartoon entertainment, and a train will approach from the right;
 - The exclamation marks are displayed in two contrasting styles and backgrounds.

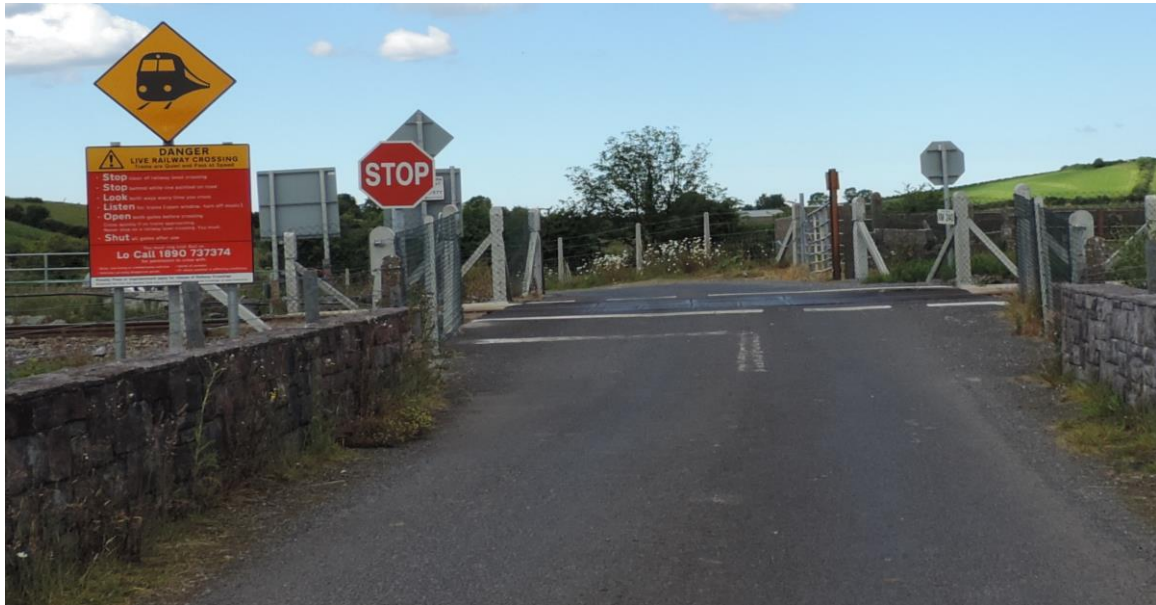
Figure 13 – New signage on trial at Level Crossing XM240

- 60 It can be seen that only the new signage and Stop sign is now present at the new type level crossings, see Figure 13.

- 61 As this signage is still undergoing its trial stage, the RAIU safety recommendation remains open by the Railway Safety Commission pending the outcome and assessment of the trial programme.

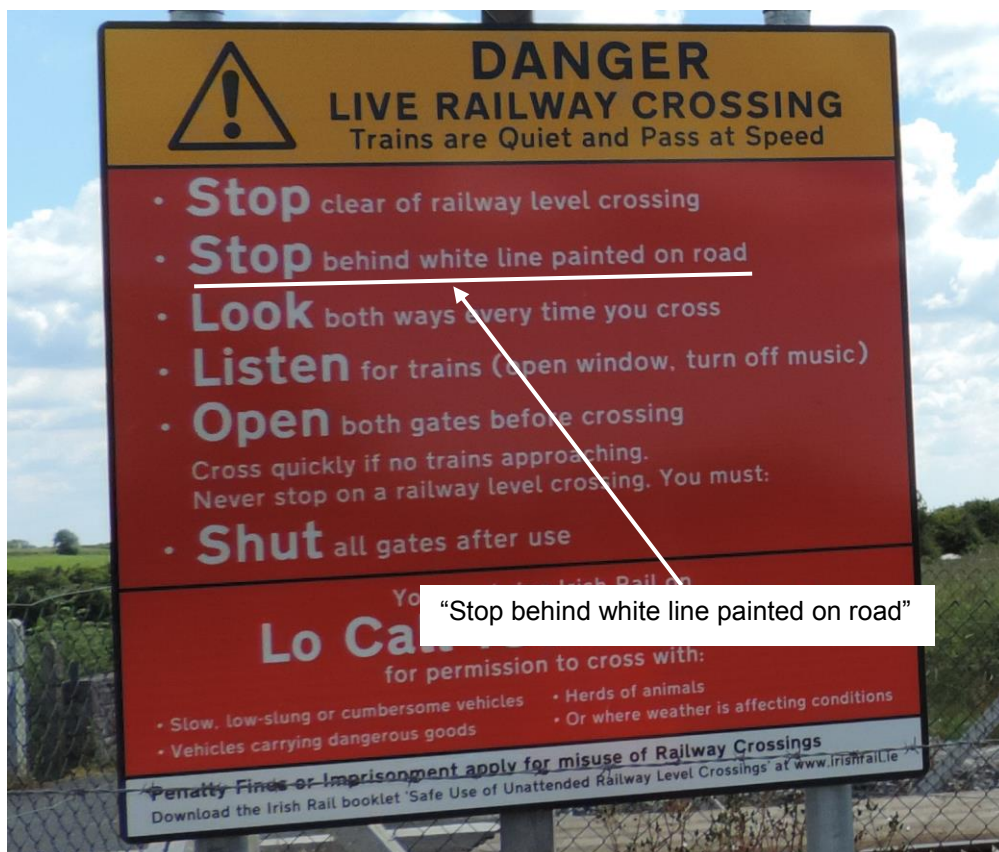
Figure 15 – New type signage “Stop behind white line painted on road”

- 70 There is no other signage or road markings associated with this Decision Line to convey its meaning, i.e. that is the Decision Lines are to indicate, to the level crossing user, the safe distance that a vehicle user can stop without the vehicle encroaching onto the path of trains. However, it should be noted, that the new type signage states “Stop behind white line painted on road”, see Figure 15. To date, it has not been established how effective this new signage is in conveying a message to the road user, as the trial period is still ongoing.
