**Railway Accident
Investigation Unit
Ireland**

INVESTIGATION REPORT

**Road Rail Vehicle occurrences on Iarnród Éireann Network
from 2015 to 2018**

RAIU Report No: 2019 – R004

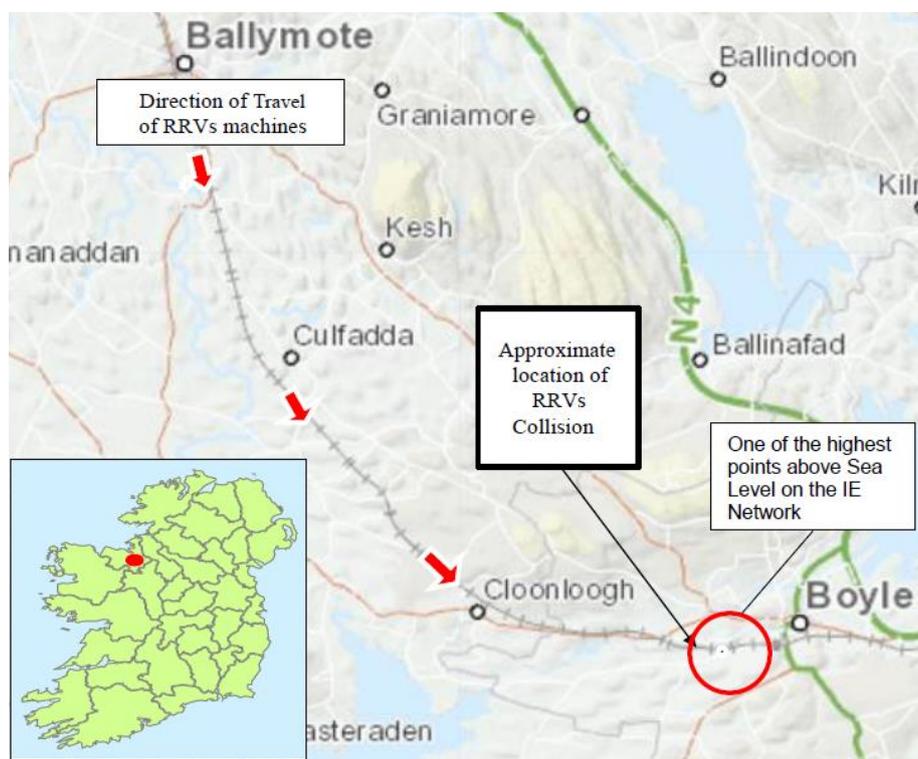
Figure 11 – Location of the accident

181 On the night of the 17th/18th November 2016, four members of IÉ-IM staff along with four contractor staff reported as a group at Ballymote Station for planned night work, see Figure 11. The planned works for the night entailed the distribution and sweeping of ballast at various locations along the section between Ballymote and Boyle Stations on the Sligo Line. A site safety and method statement briefing for the works was conducted by the TSC. The possession arrangements were organised by the PICOP and Controlling Signalman.

186 It is noted, that the location at which the accident occurred is close to one of the highest points above sea level on the IÉ network, see Figure 11.

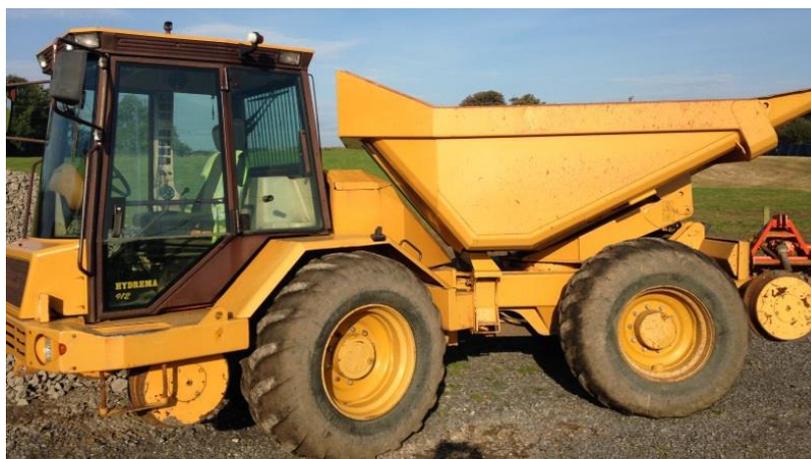
Figure 20 – RRV Dumper similar to RRV involved in the accident

229 The works were to utilise four RRV Dumpers (two mounted on the Down Line and two RRV Excavators mounted on the Up Line, see Figure 20 for RRV similar to those involved in accident. The RRVs and the RRVOs were supplied by two different contractors.

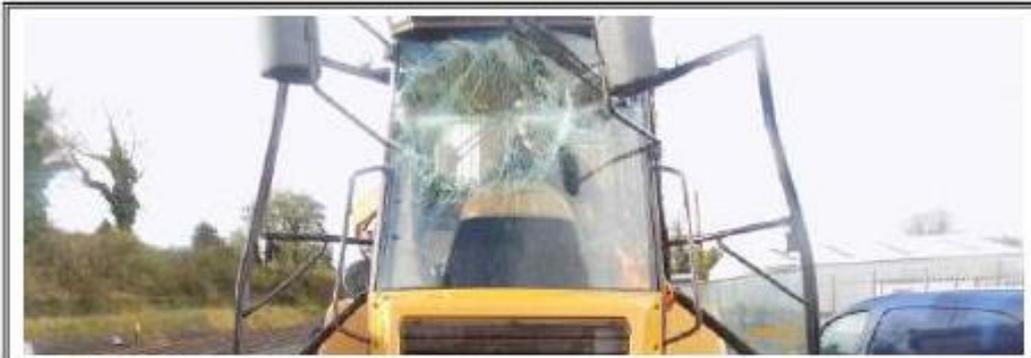
The main issues relating to the cause of these incidents include:

- Speed of the RRVs
- Inadequate distance between RRVs travelling in convoy
- Lack of proper co-ordination of RRVs travelling in convoy

INSTRUCTION – PENDING INVESTIGATION FINDINGS:

- RRVs travelling in convoy to a work location must keep a minimum distance of 100 mtrs from the RRV in front.
- RRVOs must pay particular attention to the RRV in front to watch for it either slowing or stopping as most RRVs are not equipped with brake lights while in Rail Mode.

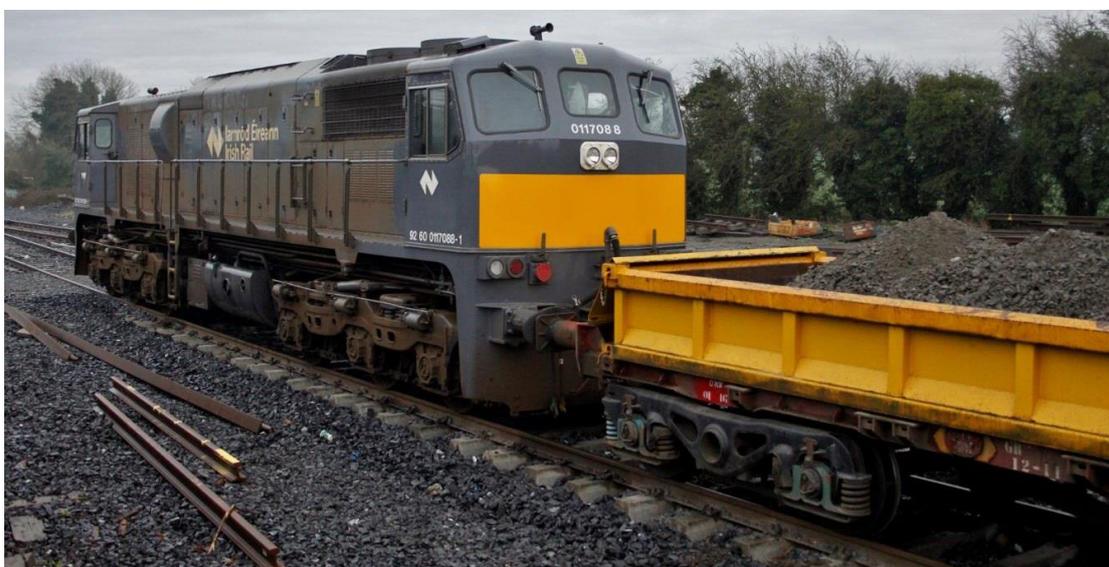
Figure 27 – Locomotive with Spoil Wagons

300 On Thursday morning 25th February 2016 the ES/TSC (who was acting as the ES and TSC) gave a site safety briefing to the relevant staff who would be working at the worksite on the Dublin to Cork line; the work planned for this worksite was the loading of spoil onto the Spoil Train (which consisted of seven spoil wagons and locomotive 071 (see Figure 27 for a similar type locomotive).

301 As part of the briefing the RRV operators were instructed by the ES/TSC to load the spoil train from the middle of the train out. This arrangement was in place as a result of a previous collision between two RRVs that were loading rails onto a rail train, on the 24th September 2015 (see paragraphs 167 - 180). These new arrangements mitigated against the likelihood of the RRVs colliding during the loading of the spoil wagons, however, there was no reference to RRVs operating in close proximity to the locomotive.

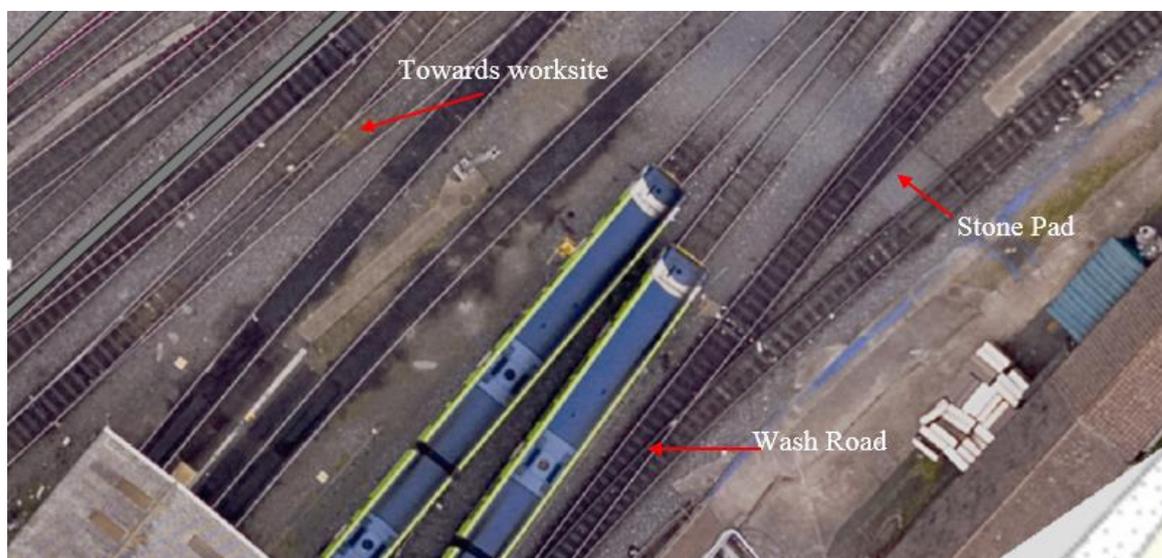
Figure 29 – Manoeuvre locations at Connolly

330 The T3 possession and T4 protections were granted at 02:14 hrs; and the RRVC commenced on-tracking the RRVs on Road No. 16; Once on-tracked the RRVs travelled on to the Wash Road and towards the stone pad. The RRVs upon arrival at the stone pad off-tracked from the Wash Road and drove across the stone pad, before on-tracking on the Down Belfast line and driving towards Platform 4 to the worksite at CY133 points, see Figure 29.

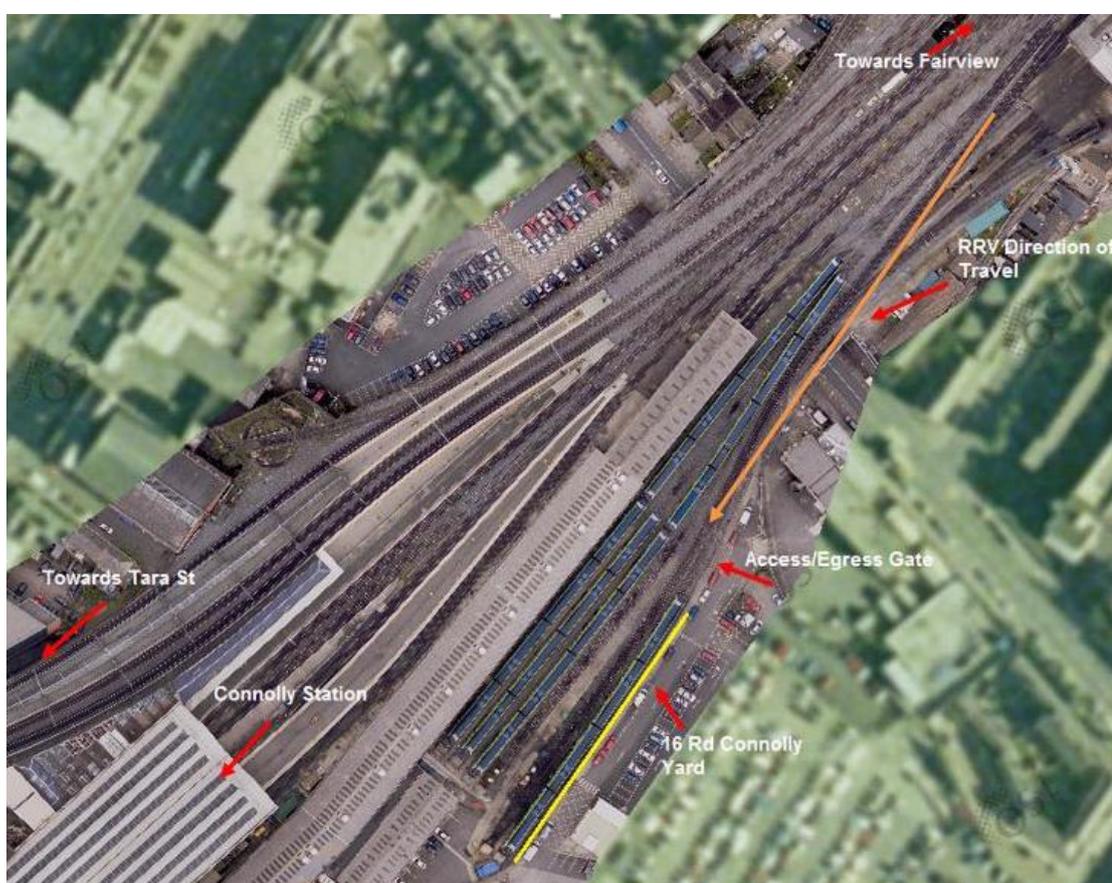
Figure 30 – Off-tracking manoeuvres for the RRVs

331 At approximately 04:00 hrs, upon completion of their work at the worksite, the PICOP/PIC gave permission to the RRVC for the three RRVs to leave the worksite at CY133 points to off-track at Road No.16. The RRVC informed the RRVOs that he would walk ahead of them as far as the stone pad, and upon arrival there he would get them to drive across the stone pad to on-track again on the Wash Road (see Figure 30). Upon arrival at the stone pad the RRVC brought the RRV Dumper across first and then proceeded to bring across the two RRV Excavators. Whilst the RRVC was in the process of bringing the final RRV across the stone pad, the RRV Dumper left the stone pad and began moving down the Wash Road towards the Road No.16 off-tracking location, which was located approximately twenty metres from the stabled 29000 DMU (see Figure 30).

332 On approach to the off-tracking point, approximately twenty feet from the stabled 29000 DMU, the RRVO of the RRV Dumper applied the brakes but was unable to stop; and, collided with the 29000 DMU, resulting in damage to unit 29109 (windscreen, wiper and some other superficial damage); there was no reported damage caused to the RRV Dumper.

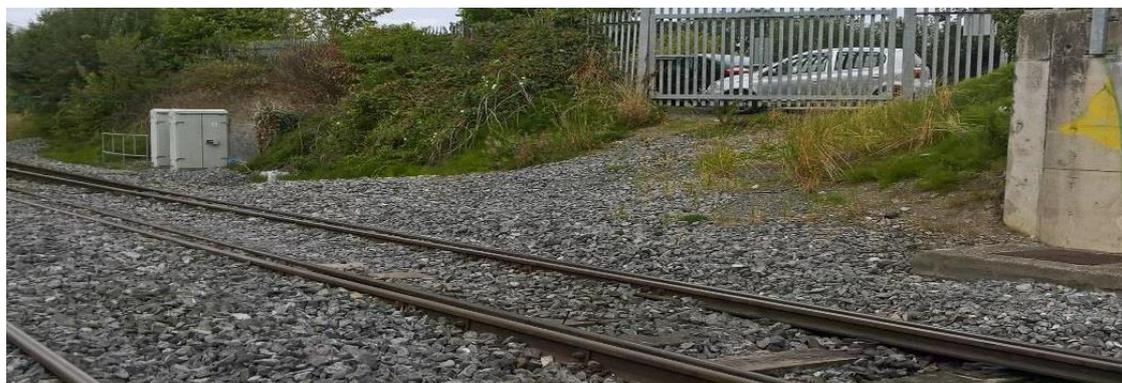
Figure 33 – Ballast Pad (for on-tracking & off-tracking RRVs)

357 The RRVs were to be on-tracked at the ballast pad (see Figure 33) adjacent to the track access gate in Maynooth Yard which is the designated on-tracking point for RRVs.

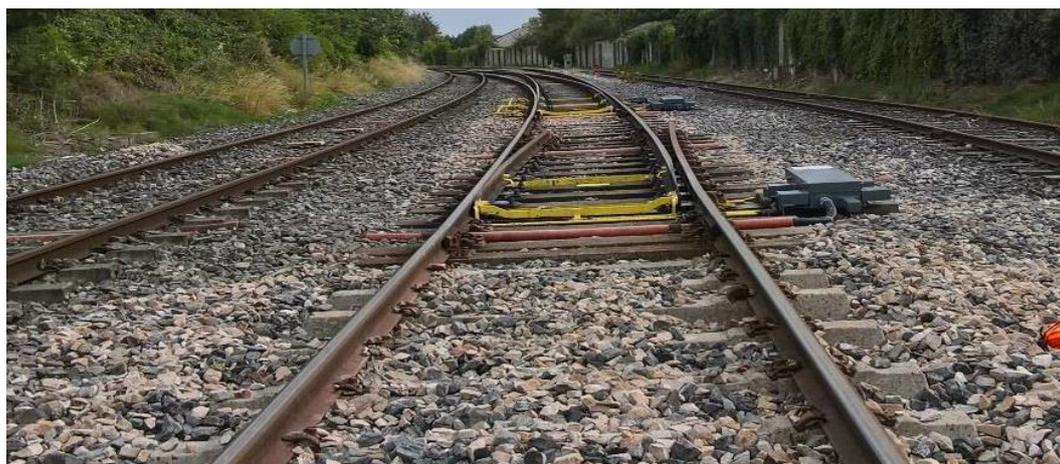
Figure 35 – Point MN266

361 Prior to the works commencing, the RRV Dumper unloaded a rail grab attachment and placed in the six-foot area between the machinery siding and the Long Siding, close to Trap Points MN266. The RRVs proceeded into the Long Siding at Maynooth Station to carry out the ballasting works controlled by the PICOP/ES/PIC. The ballasting works around Trap Points MN266 (see Figure 35) works were undertaken and completed.

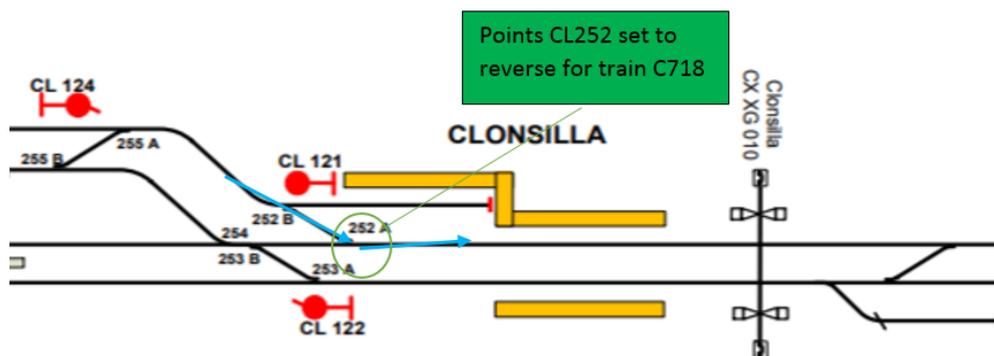
Figure 39 – Points CL252 in reverse (figure taken from IÉ-IM report)

388 At 23:24 hrs the Clonsilla Signalman set and cleared the route for the departure of an empty train from Clonsilla for Connolly Station (train identification C718 to be referred to as Train C718 for this section of the report); this train movement required Points CL252 to be set to the reverse position (Figure 39) in order for the train to transverse from the M3 Parkway Branch onto the Up Main (Sligo to Dublin) at Clonsilla Junction. Train C718 was the last train that was required to clear the section on the night; however, it is noted that Train C718 usually departs ahead of the train departing Maynooth towards Connolly (Train C710).

390 At 00:23 hrs the PICOP contacted the Clonsilla Signalman, the T3 Possession arrangements were made and granted; during the set-up process the PICOP queried the Clonsilla Signalman on the positioning of the points in the possession which the Clonsilla Signalman said they were all in the normal position (however Points CL252 remained in the reverse position for the earlier train movement, Figure 39).

removed from the line. The SET Department were contacted to attend and carry out the necessary repairs, they reported a substantial amount of damage to the switch blades and its operating mechanisms; which was repaired later that day.

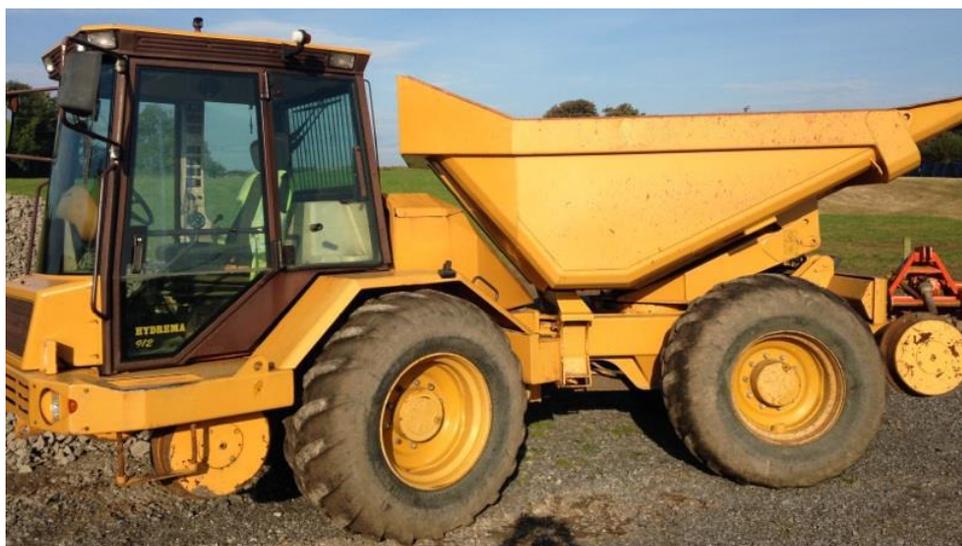
Figure 40 – RRV dumper similar to one used in accident

389 Track maintenance works were to be conducted during the T3 Possession, which involved four RRVs (two excavators and two dumpers). At Foley's Yard access point, close to Barberstown Level Crossing (Clonsilla) the PIC, who was in charge of an RRV dumper was undergoing a competency assessment in the role of PIC; this assessment was being carried out by an IM Competency Assessor (IMCA). The PIC carried out a briefing on the works with all RRV operators present.

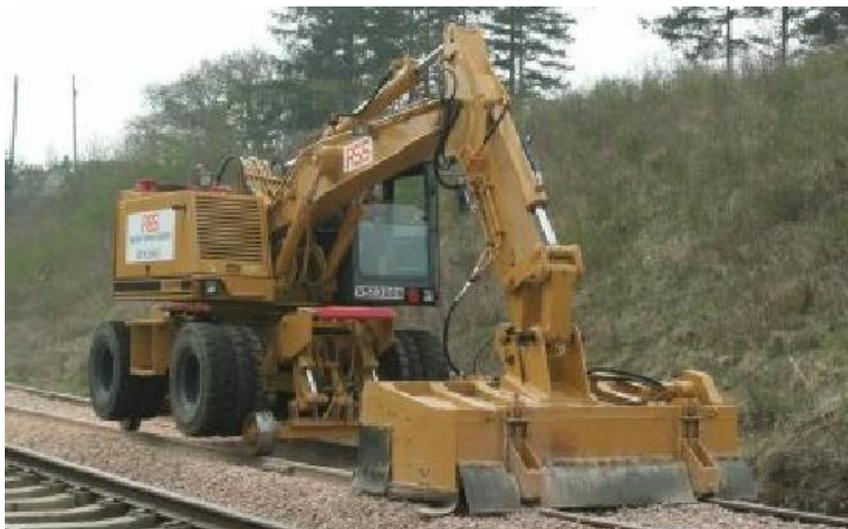
Figure 43 – RRV with brushbox (similar to RRV involved in accident)

403 The worksites north of Lisduff involved an OTM for a ballast cleaning site on the Down line and an RRV (fitted with a brush box), see Figure 43, for the ballast brushing on the Up line; the OTM and RRV were to access the possession from Lisduff Yard.

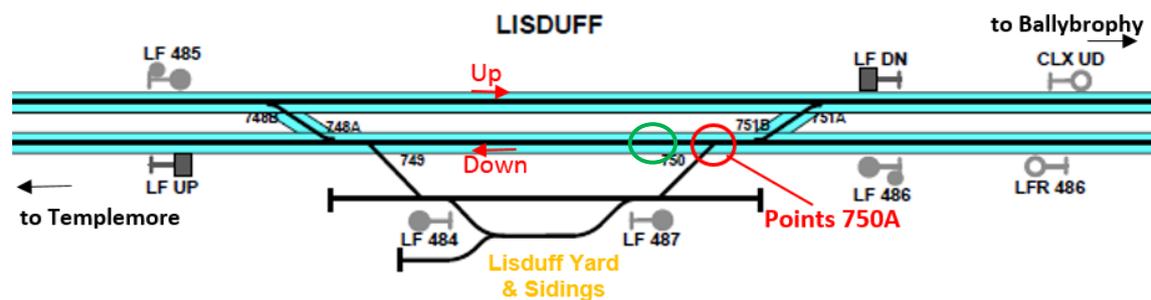
Figure 44 – Layout at Lisduff

406 When the T3 was granted (without issue) by the Signaller, the PICOP contacted the ES/PIC at Lisduff to advise, firstly, that the possession was taken and secondly that the OTM in Lisduff Sidings was to on-track first at Lisduff Yard, traverse on to the Up line, via Points 750, and travel north towards Ballybrophy; while the RRV was to on-track at Lisduff Yard and travel to a worksite on the Down line, also north towards Ballybrophy (see Figure 44). The PICOP and ES/PIC did not discuss the RRV on-tracking or the setting of the points to reverse or normal at this stage.

409 Approximately twenty minutes after the OTM departed, the RRVO then on-tracked the RRV onto the Down line (see green circle for location in Figure 44) under the instruction of the ES/PIC; and the ES/PIC then boarded the RRV and instructed the RRVO to continue on the Down line (in the Up direction) to the worksite, see Figure 44.

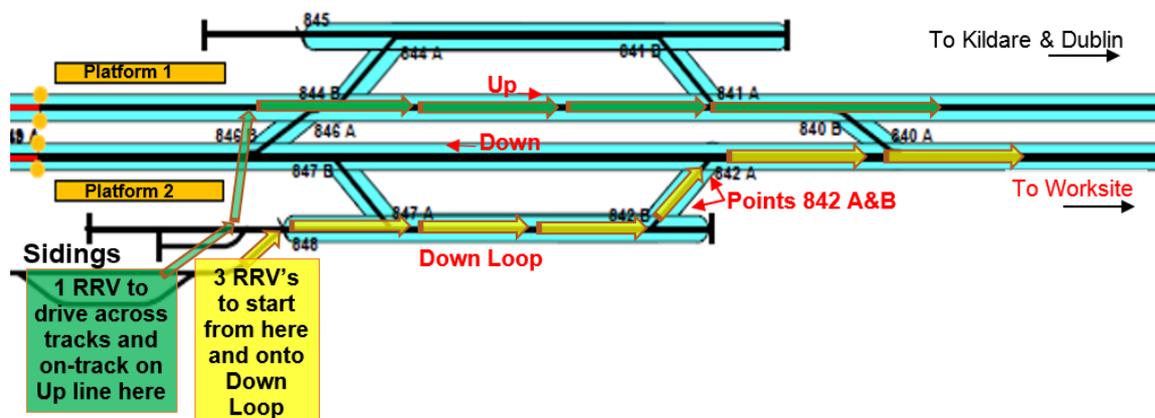
Figure 46 – Planned on-tracking of RRVs

Points run-through at Points 750 (Lisduff, Co. Laois) on the 26th June 2018

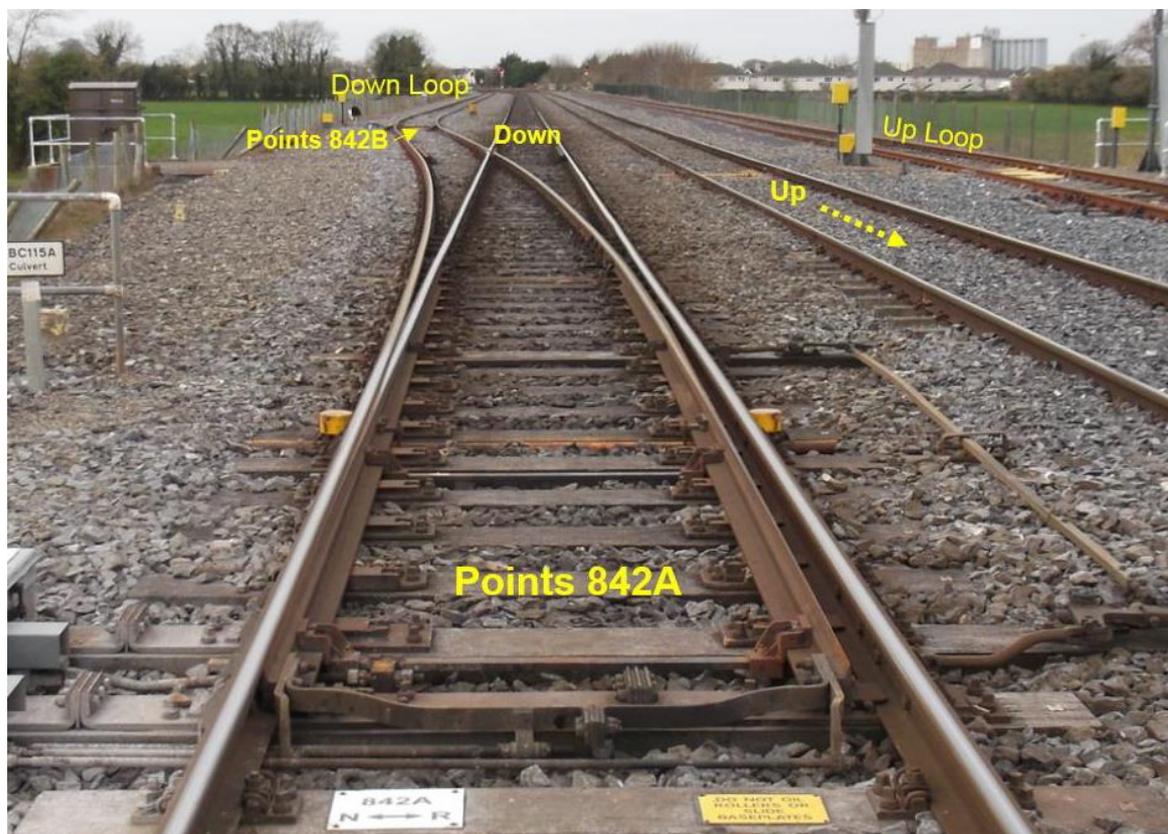
Figure 47 – Points at Portarlinton

422 The PICOP contacted the ES/PIC to advise him that the T3 Possession was granted and that the points were sets for the three RRVs to leave the siding onto the Down Loop and exit the loop at the Dublin end (via Points 842) and travel onto the Down Line; the PICOP also requested that the RRV Digger be on-tracked directly onto the Up Line (see Figure 47).
