**Railway Accident
Investigation Unit
Ireland**

INVESTIGATION REPORT

Luas isolation irregularity, Kylemore to Suir Road,

RAIU Investigation Report No: 2021 – R007

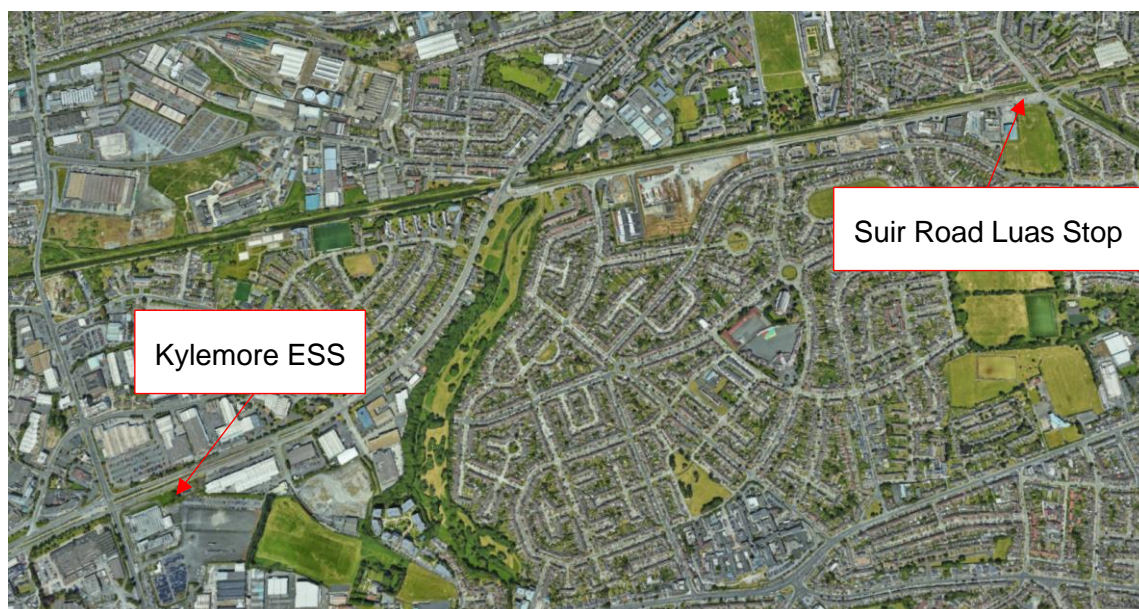
Figure 12 – Location of Tram 4010 in relation to Kylemore ESS

- 89 At this time, the Authorised Person and some of the team were located at Kylemore ESS and some of the team were on route to Suir Road, see Figure 12.
