**Railway Accident  
Investigation Unit  
Ireland**

# **INVESTIGATION REPORT**

**Luas pantograph collision with railway bridge,  
Beresford Place,**

RAIU Investigation Report No: 2022 – R001

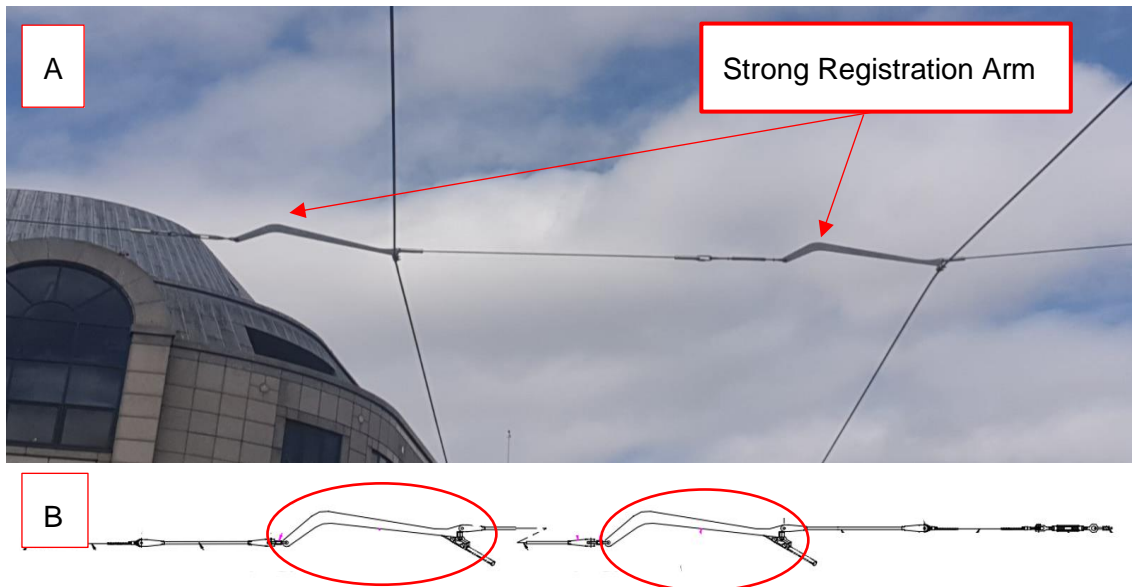
Figure 7 – Strong Registration Arm (encircled)

64 The Strong Registration Arm is an OCS component which attaches at one end to the bracket arm and to the contact wire at the other (see Figure 7 (A)); which allows the wire to lift under the force of a pantograph whilst maintaining it in the correct register. It is similar to the cross-span arrangement illustrated in Figure 7 (B).

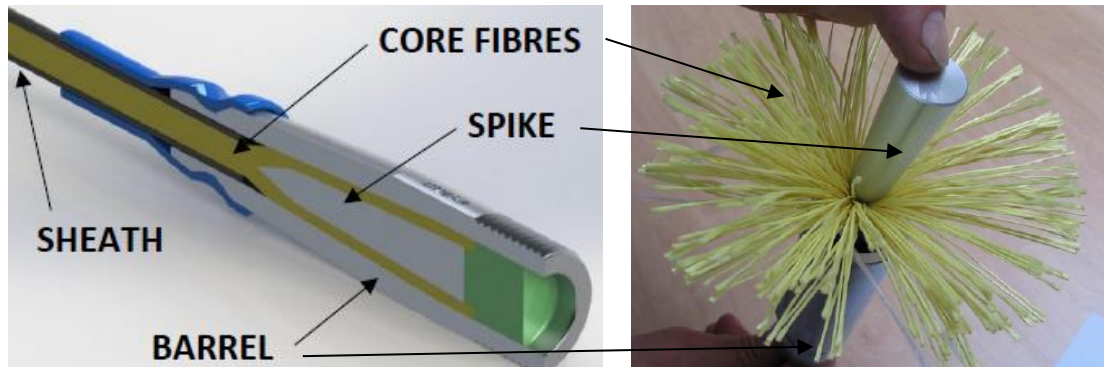
Figure 9 – Parafil termination (barrel and spike)

66 Parafil termination end fittings consist of a barrel and a spike (see Figure 9). The rope core fibres are placed through the barrel before the spike is inserted compressing the fibres securely against the barrel wall.

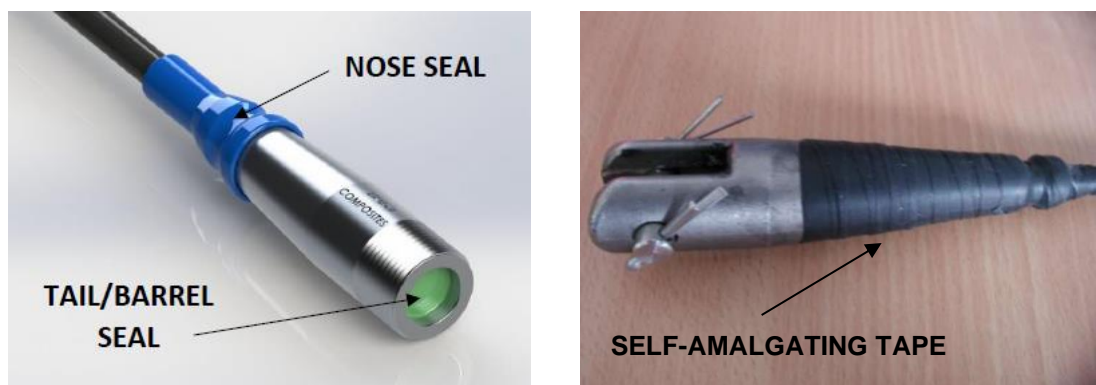
Figure 10 – Sealing arrangement

67 LCL state that “it is good practice to take steps to prevent ingress of water into terminations used on aramid<sup>5</sup> fibre Parafil ropes. The sealing is applied to two regions the junction between the ‘nose’ of the termination and the rope and into the ‘tail’ end of the barrel (left image of Figure 10). The nose seal is made of two components, a short length of silicone rubber which is over-wrapped by self-amalgamating tape while the tail seal is typically formed using a proprietary silicone mastic compound (see right image, Figure 10). The Luas terminations did not have silicone rubber sleeves fitted and relied on self-amalgamating tape to prevent water ingress at the nose end (see Figure 10).
