**Railway Accident
Investigation Unit
Ireland**

INVESTIGATION REPORT

**Collision with track equipment between Newbridge
and Kildare,**

RAIU Report No: 2023 – R002

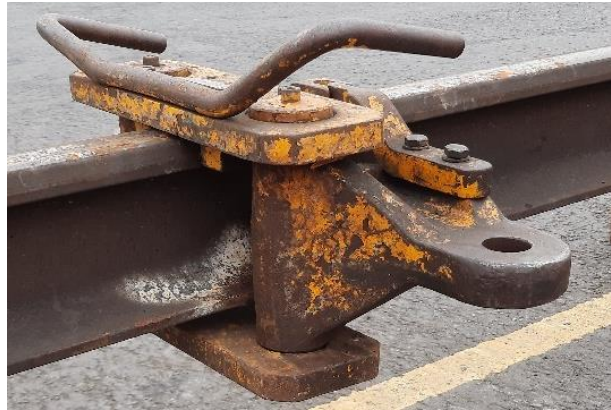
Figure 2 – Clamp fixed to rail

26 At the same time, one of the contracted welders started digging the ballast out from around where the clamp⁶ was to be placed, whilst the two other contracted welders started to attach the clamp to the Down Leg of the Up Line. Figure 2 illustrates how the clamp would be fixed to the rail during the works.

- 27 The contractor that was digging the *ballast*, turned to put down his shovel, when he saw the lights of an approaching train and shouted “train on” and all staff quickly moved to a *position of safety*.
- 28 Train J283 struck the clamp, which at the time of collision, was clamped onto the rail, see Figure 2.
- 29 Driver J283 brought Train J283 to a stop and contacted the Mainline Signaller to report that Train J283 had struck something on the line as the train approached the Curragh; and, that he saw members of staff on the Up Line who had moved off the line as Train J283 approached.
- 30 There were issues with the reporting of the accident by the ES and other members of staff, which initially “downplayed” the accident, with inference given that a small bolt had struck Train J283 and not that a piece of equipment that had been clamped to the rail.
