**Railway Accident
Investigation Unit
Ireland**

INVESTIGATION REPORT

**Dangerous occurrence involving a Double SPAD at
Clontarf Road Station,**

RAIU Investigation Report No: 2023-R001

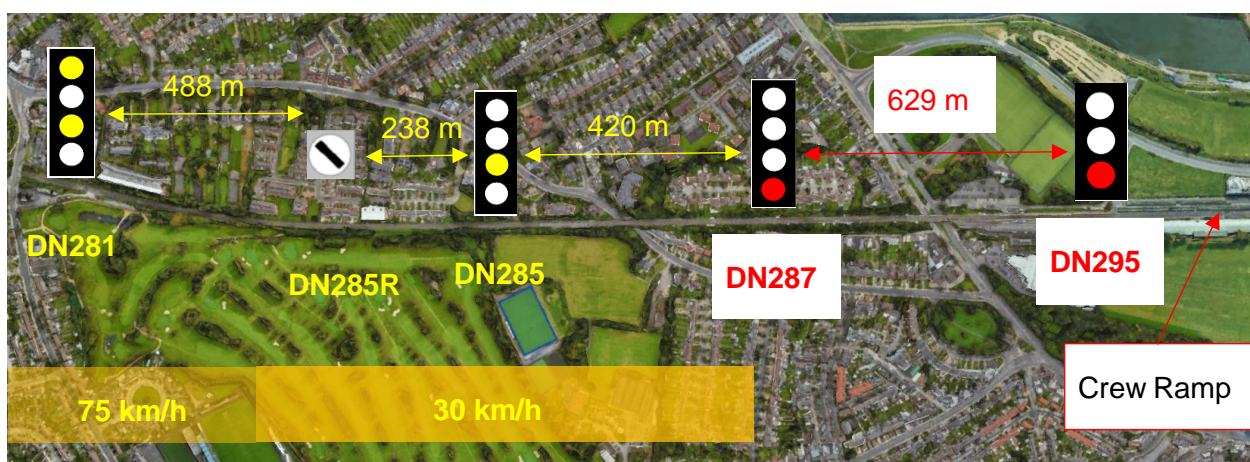
Figure 9 – Signal and speed locations

- 64 The DCCR layout change resulted in a reduction of 0.596 km in the position of the first cautionary aspect (Signal DN281) protecting a train stopped at Fairview Ramp and trains would now be permitted to travel at 75 km/h on a Double Yellow leaving Killester, compared to the previous 50 km/h for a single Yellow⁶ (see Figure 9).

- 65 The speed downgrade from 75 km/h to 30 km/h on approach to Signal DN285R (see Figure 9) complies with IÉ standards, I-SIG 2145, Calculation of Signal Spacing Distance, Issue 1, published in 2006).

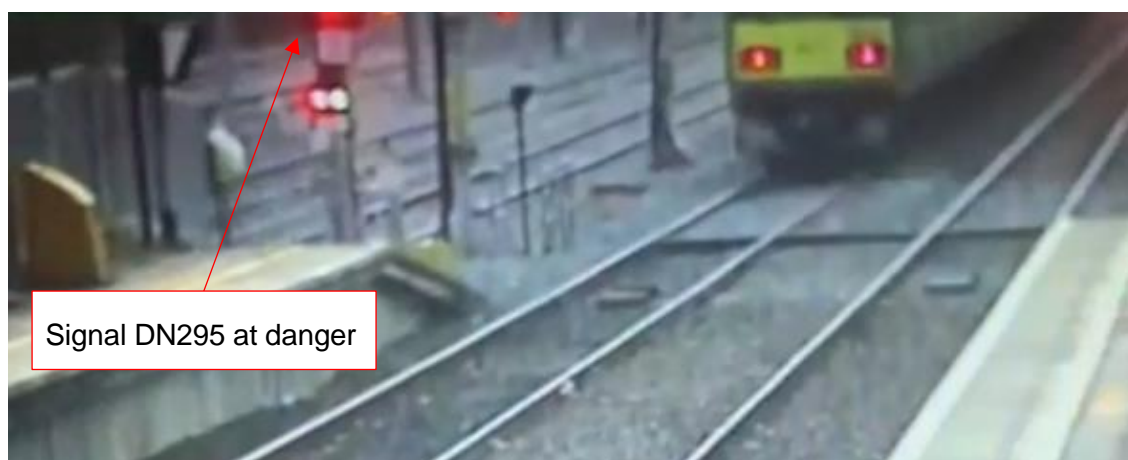
Figure 18 – Train E120 stationary at the Crew Ramp, Fairview

- 152 At 16:03 hrs Train E240 passed Signal DN287 at danger.
- 153 At 16:03 hrs, Train E120 was stopped at the Crew Ramp at Fairview (see Figure 18, the following figures are taken from Clontarf Road Station CCTV). Note Signal DN295 displaying at red aspect to protect Train E120.

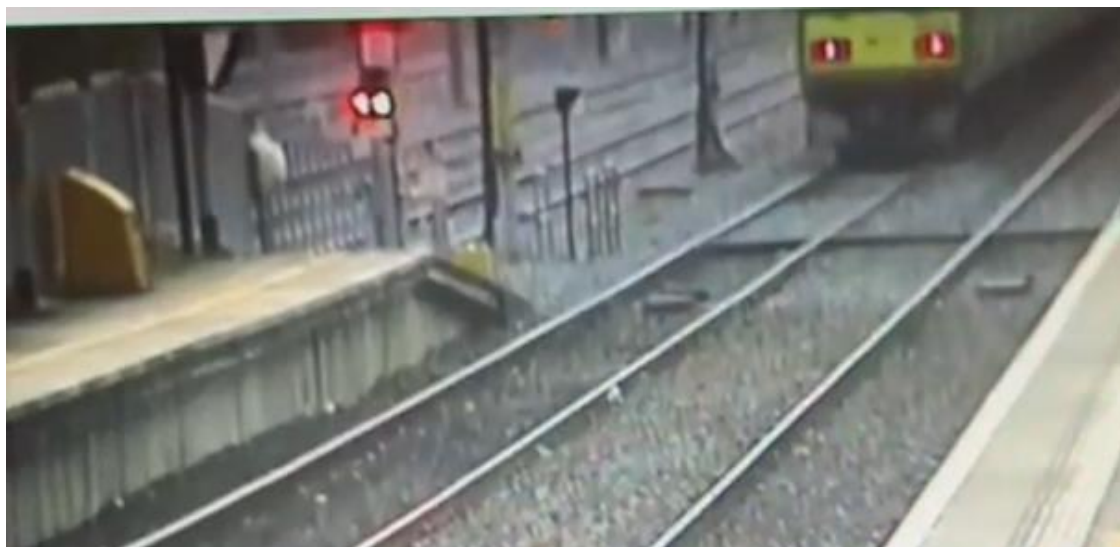
Figure 19 – Train E120 began to move away from Crew Ramp

154 Within the minute (16:03 hrs) Train E120 began to move away from Crew Ramp, see Figure 19.
