**Railway Accident  
Investigation Unit  
Ireland**

## **INVESTIGATION REPORT**

**Collision of an RRV Dumper with a member of  
Iarnród Éireann infrastructure maintenance staff,  
Tivoli, Cork, 6<sup>th</sup> July 2022**

RAIU Investigation Report No: 2023-R003

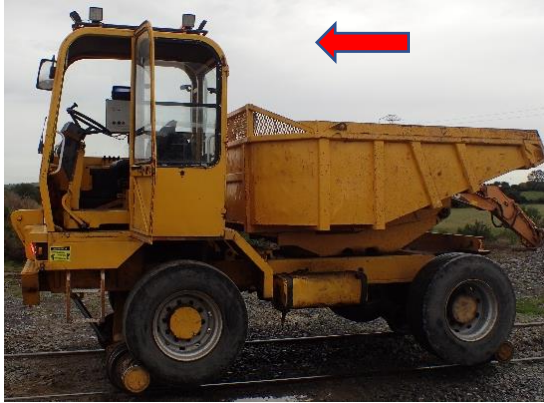
Figure 2 – Forward driving configuration

49 The driving seat, steering wheel, brake, and accelerator pedals can be rotated 180° to facilitate the driver facing the direction of travel for forward (Figure 2) and reverse movements (Figure 3).

104 When driving a RRV Dumper in the forward direction a clear view through the windscreen is available as there is no obstructions (Figure 2 and Figure 7). However, the view when driving in reverse, through the rear windscreen is obstructed low down, by the bucket (Figure 3) and can become further obstructed when laden (Figure 9, in the case of the re-enactment, this was 15 m). To address this, RRV Dumpers are fitted with reversing cameras (Figure 4 and limited to 120° rather than 180°) and in-cab monitor on the RRVO's right-hand-side (Figure 5). However, the position of the reversing monitor, is such, that the RRVO must turn his head away from the direction of travel to view it.

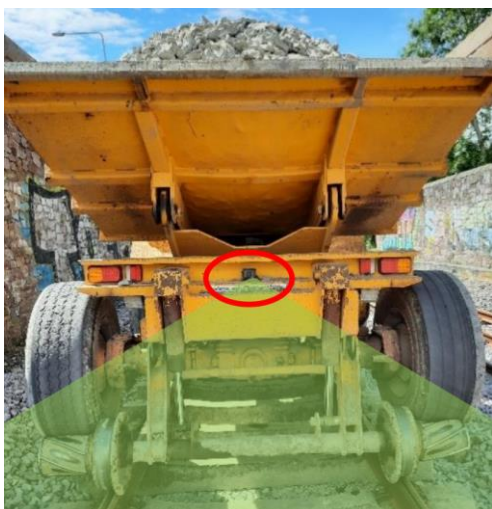
Figure 4 – Reversing camera

50 Note how the view from the rear windscreen could become obstructed when the dumper is laden with materials in Figure 3. To compensate for this, there is a 120° angle camera (circled in Figure 4). The 120° angle (highlighted green in Figure 4) gives a 30° blind spot on both sides. The camera images are projected to a monitor situated at 90° to the RRVO's right-hand-side seated position while in reverse mode (circled and inset in Figure 5), the camera images only show live images and does not record i.e. the RRVO has to look to his right-hand-side to view the monitor.

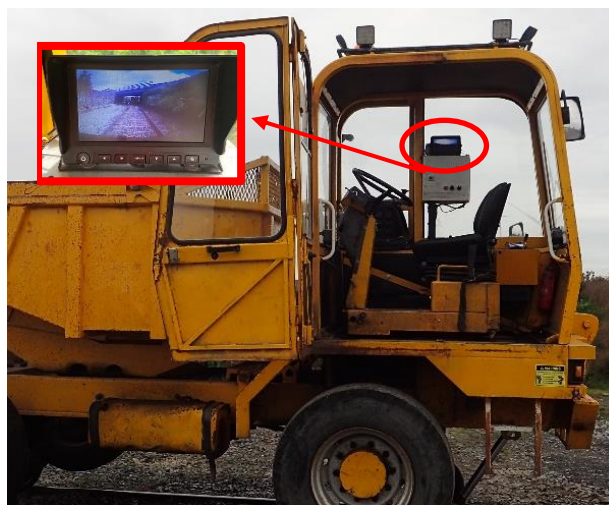
Figure 5 - Camera monitor

56 The inspection also found the monitor to be working. The monitor gives a clear view of the five foot ahead of the RRV Dumper, while working in reverse.

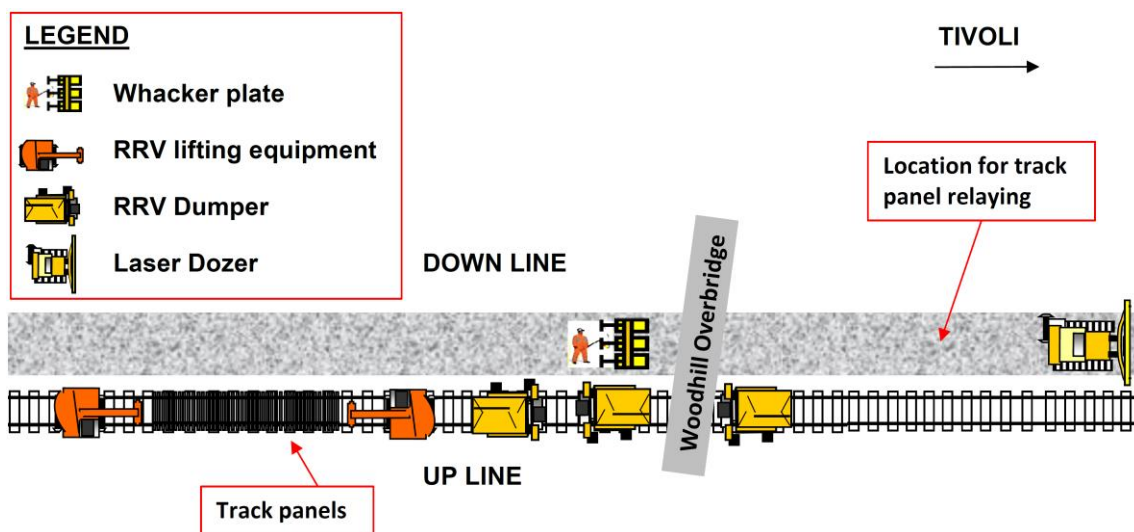
Figure 11 – RRV Dumpers stationary adjacent to Woodhill OB

79 Shortly after 13:00 hrs, two RRV Dumpers, after loading at Tivoli, travelled along the Up Line towards Cork under the control of the PIC-RRVs. The RRV Dumpers stopped under Woodhill OBC411 (see Figure 11).

80 While stationary, the cab seats and headlights and tail lights (directional lights) were reconfigured by the RRVOs in anticipation of a request from the PIC-RRV to move back towards Tivoli and distribute the stone as required for the track panel relaying on the Down Line (see Figure 11)<sup>8</sup>.

<sup>8</sup> The directional lights should not have been configured for movement at this stage as when an RRV is stationary it must display red lights at both ends of the vehicle, so they always remain visible (paragraph 53). The RAIU consider this to be an additional observation, AO-02 (paragraph 116), which requires a safety recommendation, 2023002-02 (paragraph 128).

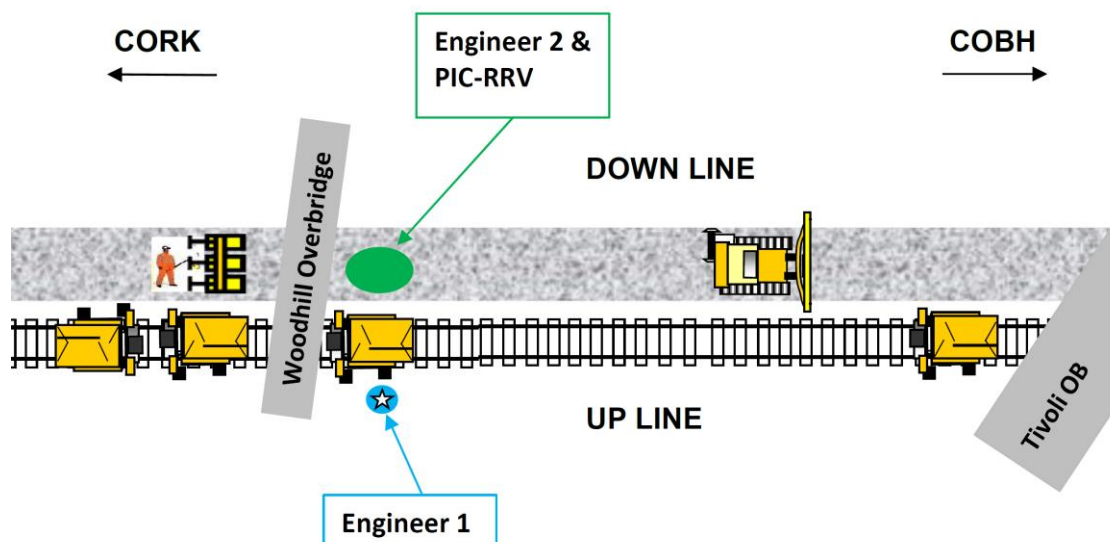
Figure 12 – Approximate locations of members of staff

- 81 Engineer 1 had two work related missed calls on his company issued mobile phone and while waiting for the Regional Manager moved to a position of safety from the Down Side to the Up Side cess and beside one of the laden RRV Dumpers (see Figure 12) to return the calls<sup>9</sup>.
- 82 Engineer 2 identified that the panel lifting equipment machinery (orange machinery in Figure 11) was required to be moved in the direction of Cobh (“Location for track panel relaying”, Figure 11) in order to place a track panel on the Down Line. However this was blocked by RRV Dumpers, which were required to move in the direction of Cobh to clear the location.
- 83 Engineer 2 approached the PIC-RRV who was near the leading RRV Dumper (Figure 12) and made a request for the RRV Dumpers to move forward towards Cobh to facilitate the placement of track panels.

- 85 Engineer 1, (Figure 12), in Up Side cess, in a position of safety, made two return phone calls, commencing at 13:18 hrs and finishing at 13:23 hrs.

- 88 Engineer 1, having completed two work related work calls, decided to return to speak with Engineer 2 on the Down Line (Figure 12).
- 89 Engineer 1 walked in the cess for approximately three metres, in the direction of Cobh, taking him past the stationary RRV Dumper before looking at the RRV Dumper and observing the head of the RRVO but did not make eye contact or gesture to the RRVO. Engineer 1 did not observe the illuminated head lights on the RRV Dumper.
- 90 At the same time, the RRVO of the leading RRV Dumper, viewed his in-cab monitor (located to his right-hand side) and as it was clear; the RRVO then looked forward, through the windscreen (illustrated in Figure 9), over the ballast and again, his view was clear.
