**Railway Accident
Investigation Unit
Ireland**

INVESTIGATION REPORT

Self-detrainment of passengers between Shankill & Bray,

RAIU Investigation Report No: 2023-R005

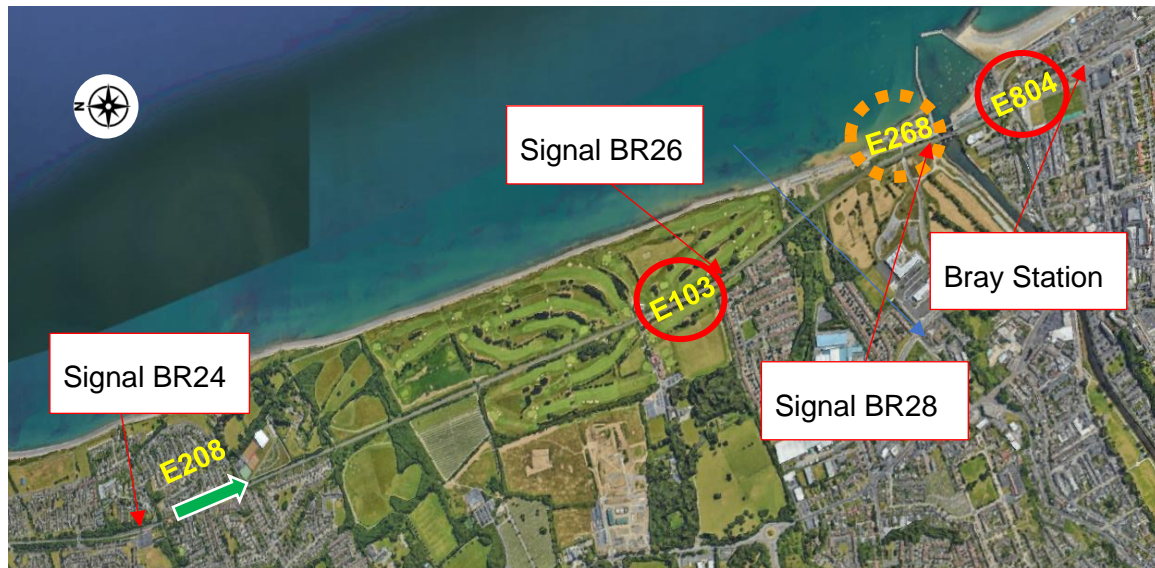
Figure 11 – Signal locations and status of trains at 14:57 hrs

- 213 At the point of self-detrainment of Train E268 at 14:55 hrs, Train E103 was travelling from Shankill towards Bray.
- 214 At 14:57:08 hrs, as a result of Train E268 being stopped at Signal BR28, Train E103 was stopped at Signal BR26 (Figure 11). Driver E103 immediately made an announcement, followed by a number of other announcements in relation to the delay.

- 215 As a result of Train E103 being stationary, there is now no forced ventilation on the train, and insufficient passive ventilation through the windows resulting in the conditions onboard becoming increasingly uncomfortable.

- 216 Figure 11 illustrates the status of the trains at 14:57 hrs, whereby passengers are self-detraining Train E268 at Signal E268 (dashed circle), Train E103 is stopped at Signal BR26 (circled); Train E208 is departing Shankill Station and Train E804 is stopped on request of the Controlling Signalman (explained in paragraphs 248).

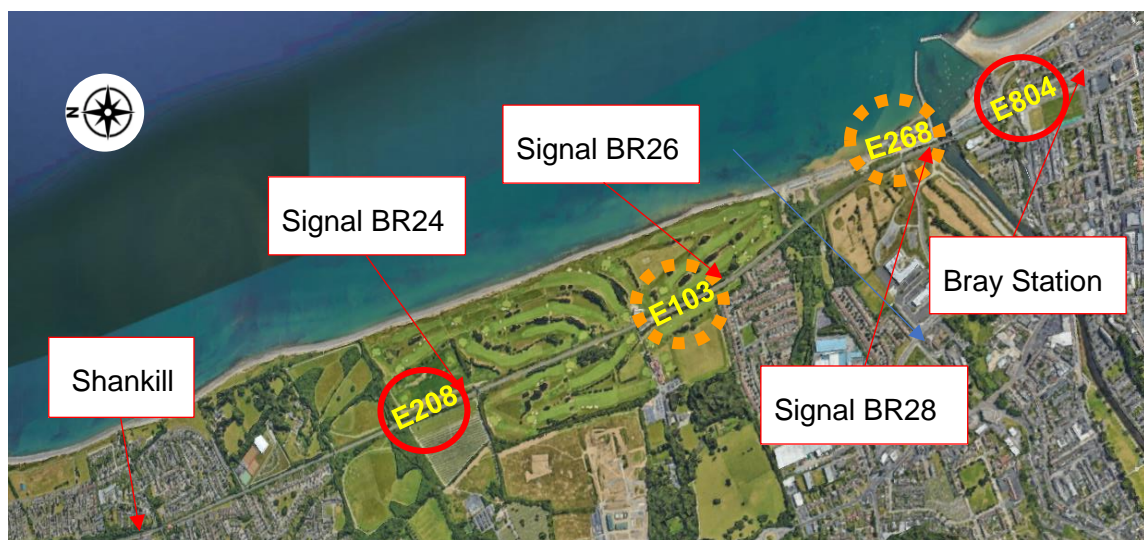
Figure 12 – Signal locations and status of trains at 15:00 hrs

229 At the time of Train E208's departure from Shankill, passengers from Train E268 were self-detraining (which commenced at 14:55 hrs) and Train E103 was stopped at Signal BR26 (see Figure 11).

230 At 15:00:45 hrs, Train E208 is stopped at Signal BR24. Driver E208 makes a number of announcements about the delay.

231 Figure 12 illustrates the signal and station locations and the status of the trains at 15:10 hrs, when Train E208 has been stopped for ten minutes with passengers on Train E268 and Train E103 self-detraining.

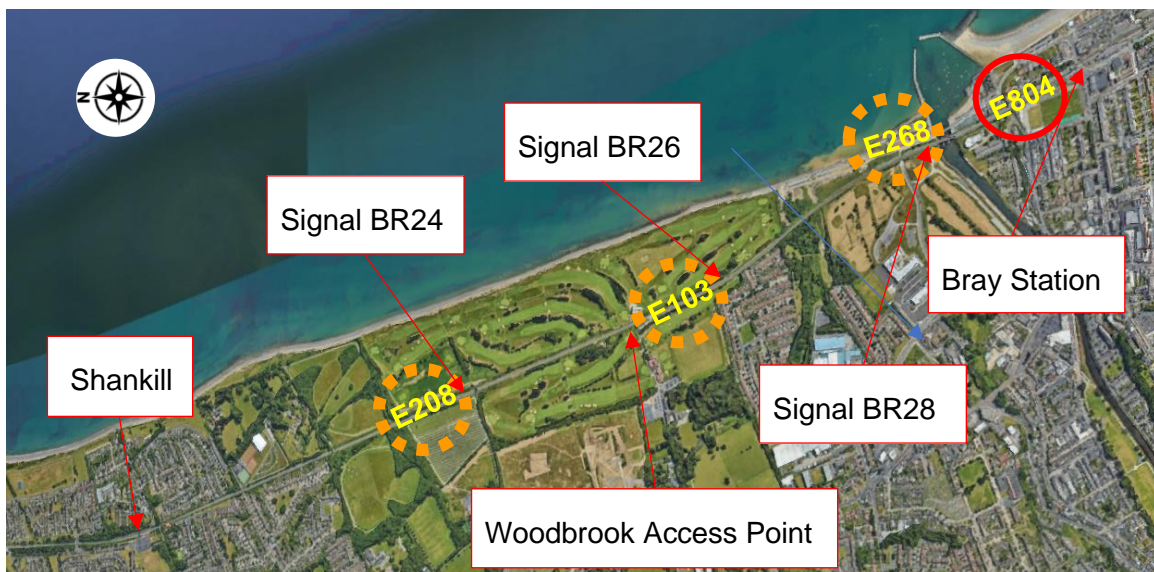
Figure 13 – Signal locations and status of trains at 15:00 hrs

238 Figure 13 illustrates that three trains now have passengers self-detraining, and one train remained stopped.

239 At 15:45 hrs, the Acting Station Manager Bray contacts Suburban Regulator to advise that he is making his way up to Train E208 and intends to initiate a controlled evacuation and to divert people from the train via Woodbrook Access Point and through Woodbrook Golf Club (Figure 13) to get them off the line.

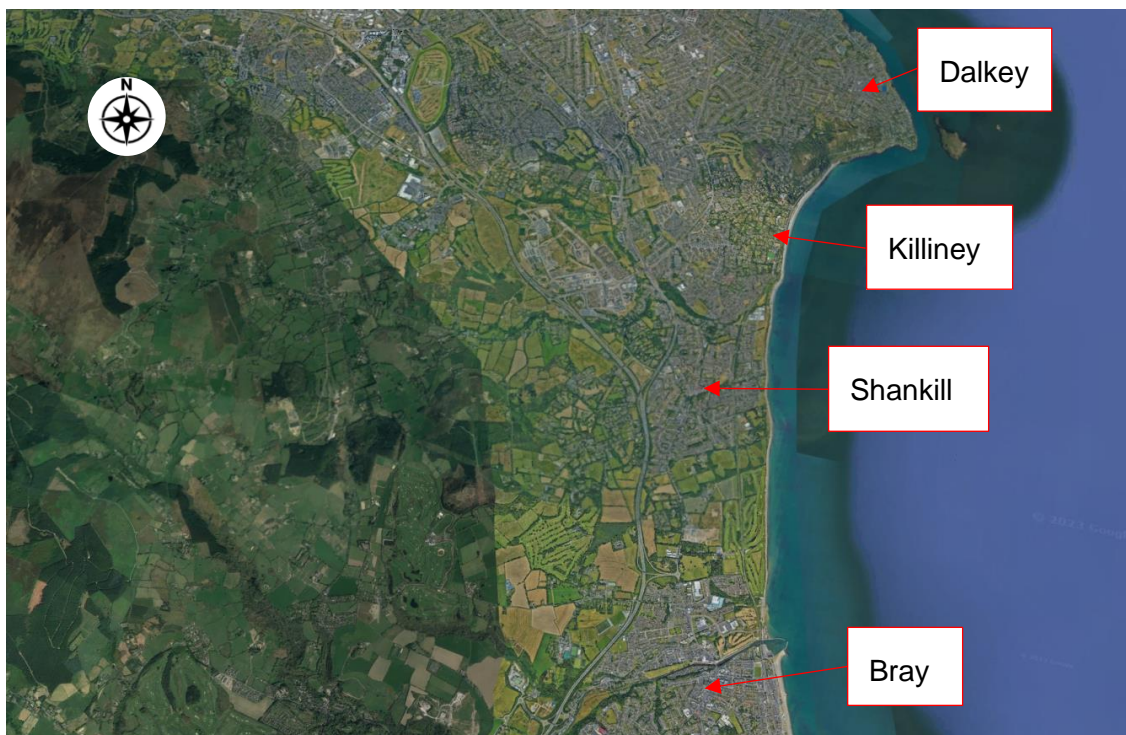
Figure 14 – Extent of the incident locations

261 At approximately 15:50 hrs, the driver of a train stopped at Platform 2 at Dalkey Station reported that passengers had left his train and began to get down onto the railway line and were walking towards Bray (see Figure 14).

262 At the same time, the driver of a train stopped at Platform 2 at Killiney Station reported that passengers had left his train and began to get down onto the railway line and were walking towards Bray (see Figure 14).

263 It was reported by Garda Control (Bray) that at approximately 16:30 hrs, about forty passengers on Shankill Station, got down from the platform, and started walking towards north and south of the station (see Figure 14).
