**Railway Accident
Investigation Unit
Ireland**

**Failure of a Current Return Cable on a Luas Tram,
Connolly Stop,
25th October 2022**

RAIU Investigation Report No: 2023-R004

Published: 13th October 2023

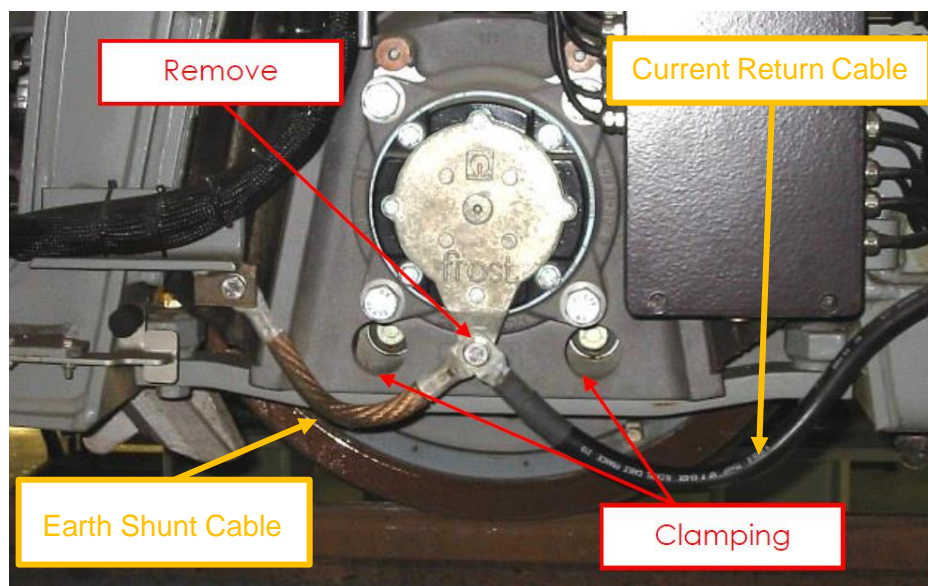
Figure 7 – Figure taken from WI-00814

- 51 Also relevant to the incident is TDLR-LUAS-WI-00814 Preparation before and after wheel turning (2019).
- 52 Section 9 of WI-00814 outlines the procedures before and after wheel turning. Step 7 (before wheel turning) requires the disconnection of the earth return and shunt cables by unscrewing and removing the fixing screws and placing the cables away from the clamping holes; which is illustrated Figure 7 (the RAIU have added the orange text for ease of understanding).

- 53 Step 14 (after wheel turning) of WI-00814 states, “Check the ends of the earth cables and report any corrosion to your team leader.
- 54 Coat the contact surfaces of the earthing cables with a small amount of contactal paste (which provides protection against corrosion, external pollutants; and resistance to oxidation).
- 55 Attach the earthing cables on each high floor bogie and tighten to a torque of 45 Nm. In terms of the torque wrench, Section 7, Materials and Specials Tools, requires the 45 Nm torque wrench, to have the asset number recorded and be “tested” before use. The importance of fitting the earth cables correctly is highlighted in Section 4 of WI-00814, Safety Critical Working, which states: “If the side skirts, or earth cables are not fitted correctly they could become detached.” The text is coloured red on the document to further emphasise the importance of the task.

- Safety Recommendation 2023004-01 – TDLR should develop supporting guidance documentation to WI-00814, Preparation before and after wheel turning, to include information on possible defects e.g. photographs of unacceptable levels of corrosion on the Current Return and Earth Shunt cable Lugs;

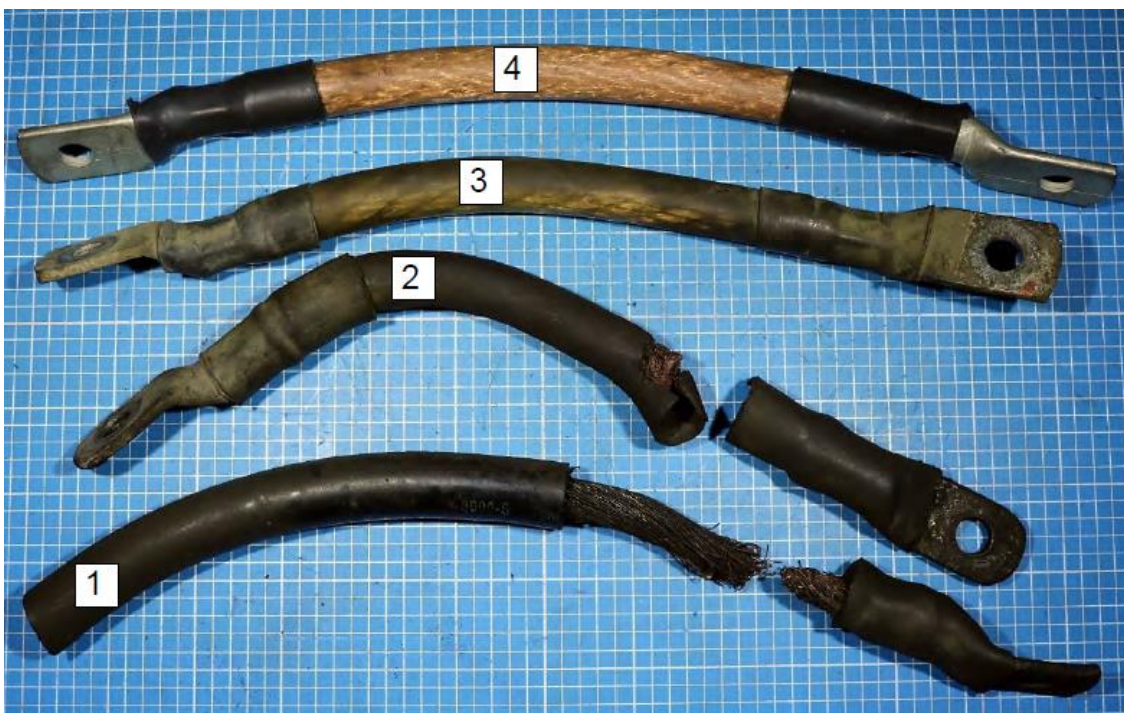
Figure 11 – Cables delivered to the RAIU metallurgical specialist

- Item 1 – The failed S1 Current Return Cable;
- Item 2 – The failed S3 Earth Shunt Cable;
- Item 3 – An exemplar of a service run, but not failed, Earth Shunt Cable;
- Item 4 – An exemplar of an unused Earth Shunt Cable.

- 72 The failure surface on S1 Current Return Cable occurred approximately 30 mm from the cable Lug (see Figure 6 for location of the Lug), but when the individual cable strands were straightened (for examination) it was apparent that the cable strands failed at lengths from a few mm up to 60 mm from the Lug. The cable strands were blackened by *thermal oxidation* in service but there was no significant evidence of *aqueous corrosion*.
