**Railway Accident
Investigation Unit
Ireland**

INVESTIGATION REPORT

**Broken Rail near Emly,
County Tipperary, 22nd February 2023**

RAIU Investigation Report No: 2024-R002

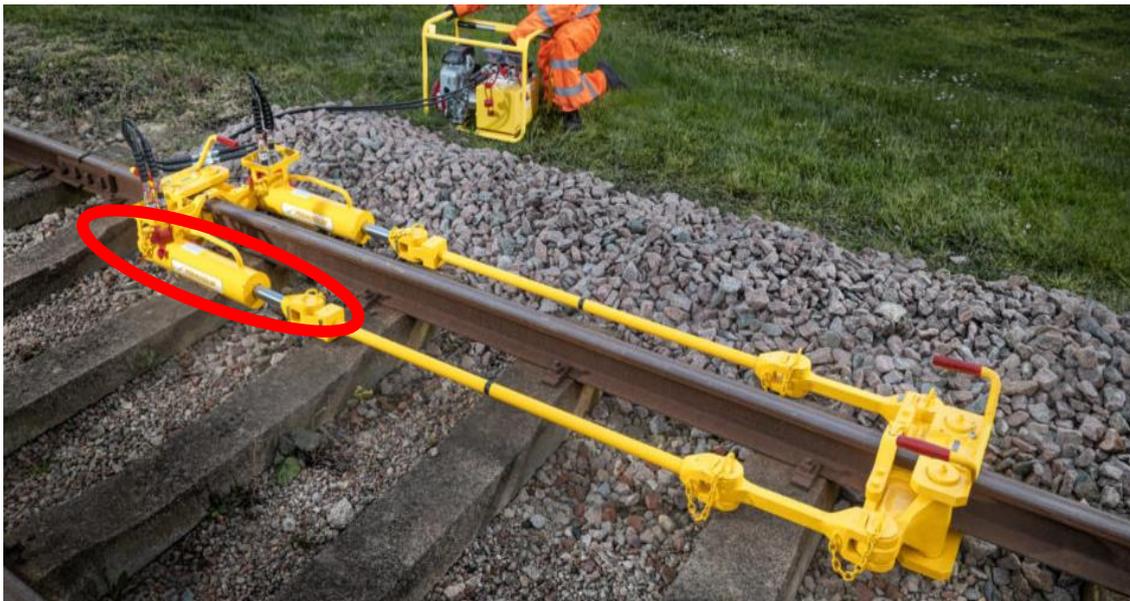
Figure 5 – Rail Tensors attached to rail

67 Using the Rail Tensors, both rails are stretched (i.e. stressed) using hydraulic rams (circled Figure 5) and *anchored* at the same time to ensure the equal *Stress Free Temperature* (SFT) in both rails (the permitted SFT in CWR is between 23°C and 27°C, with three rail thermometers placed on the rail to monitor temperature. This is to ensure that the temperature is not below the absolute minimum rail temperature for stressing which is -7 °C. In addition, both rails must be stressed during the same shift to ensure that the forces remain balanced in both rails.

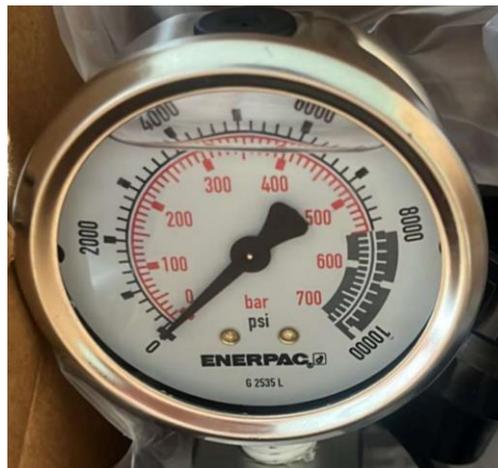
68 The Rail Tensors are checked for slippage of the clamps or for defects in the pressure gauge dial (see Figure 6 example of a pressure gauge). There is a *valve* on the hydraulic pump that is used to close off the flow of hydraulic fluid (oil) when the rails have been pulled to the required welders gap; this is to safeguard against rail movement.

Figure 6 – Pressure gauge

69 Pulling force is then applied by the Rail Tensors, which is displayed on the pressure gauge (displayed as pound-force per square inch (psi))³. The pressure gauge is monitored by the Person in Charge of Stressing during tensioning to ensure no loss of force occurs. CCE-TMS-323 states that the maximum pulling force applied by the Rail Tensors shall not exceed 6553 psi.
