Railway Accident Investigation Unit Ireland

INVESTIGATION REPORT

Collision between a car and a train at Level Crossing XM190, Mayo, 9th September 2023

RAIU Investigation Report No: 2024-R003 Published: 12/12/2024

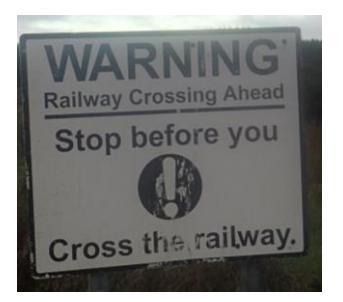
Figure 15 – Old signage

- 71 The Stop Line has been present at LC XM190 since March 2012 and the signage was last updated in April 2019, to meet the requirements of CCE-TMS-380 (see Figure 13).
- 72 Although no longer a requirement in CCE-SMS-380, additional, "Stop before you Cross the railway" signs, remain in place on the approaches to LC XM190 as an additional advance warning sign, see Figure 15.

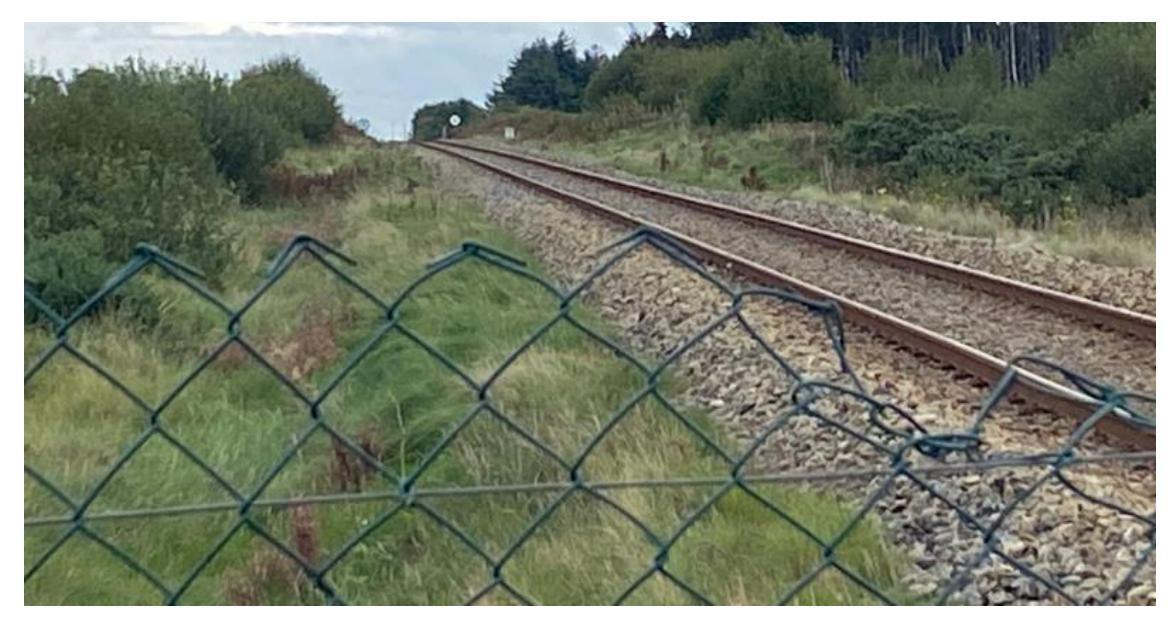
Figure 19 – V boards on the up side, looking in the up direction

- 91 In accordance with CCE-TMS-380, the minimum viewing distance for LC XM190 is 350 m in both directions, as it is a single line with a maximum train speed limit of 70 mph (110 km/h).
- 92 The actual viewing distances for LC XM190 (up side), in place at the time of the accident, are recorded as 600 m in the up direction and 1,000 m in the down direction; in excess to the requirements set in CCE-TMS-380. See Figure 19, for a photograph taken from the viewing point on the day of the accident, of the V boards, confirming the minimum viewing distances in the direction from which Train A804 approached LC XM190¹⁸.

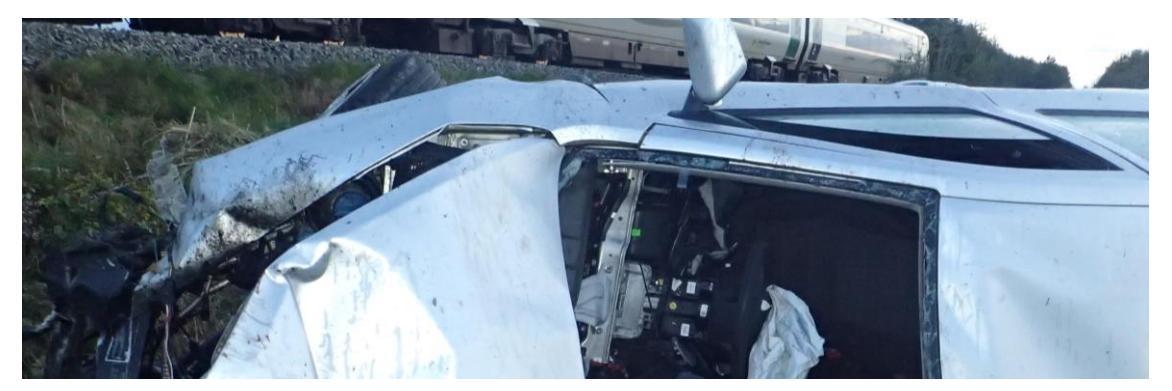
111 An inspection of the car, on site, after the accident, shows that the window on the car driver's side was half lowered (see Figure 20). The damage is outlined in paragraph 23.

- 211 The Car Driver does not remember the accident; however, it is possible the Car Driver heard the train horn in the final seconds before impact as the driver side window was half open (Figure 20) and the car slowed and came to a standstill on the tracks moments before impact (paragraph 129).

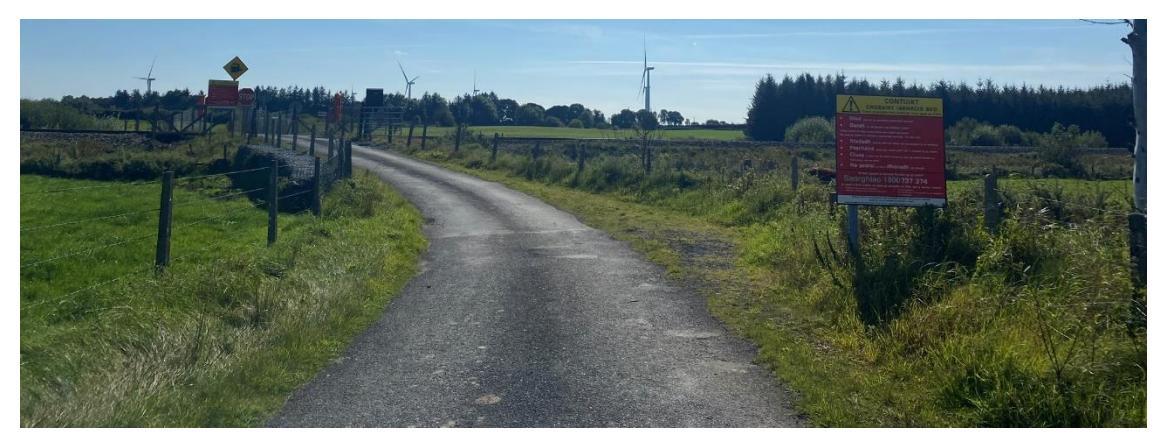
Figure 25 – Photograph with the gates open (not taken on the day of the accident)

Department of Transport

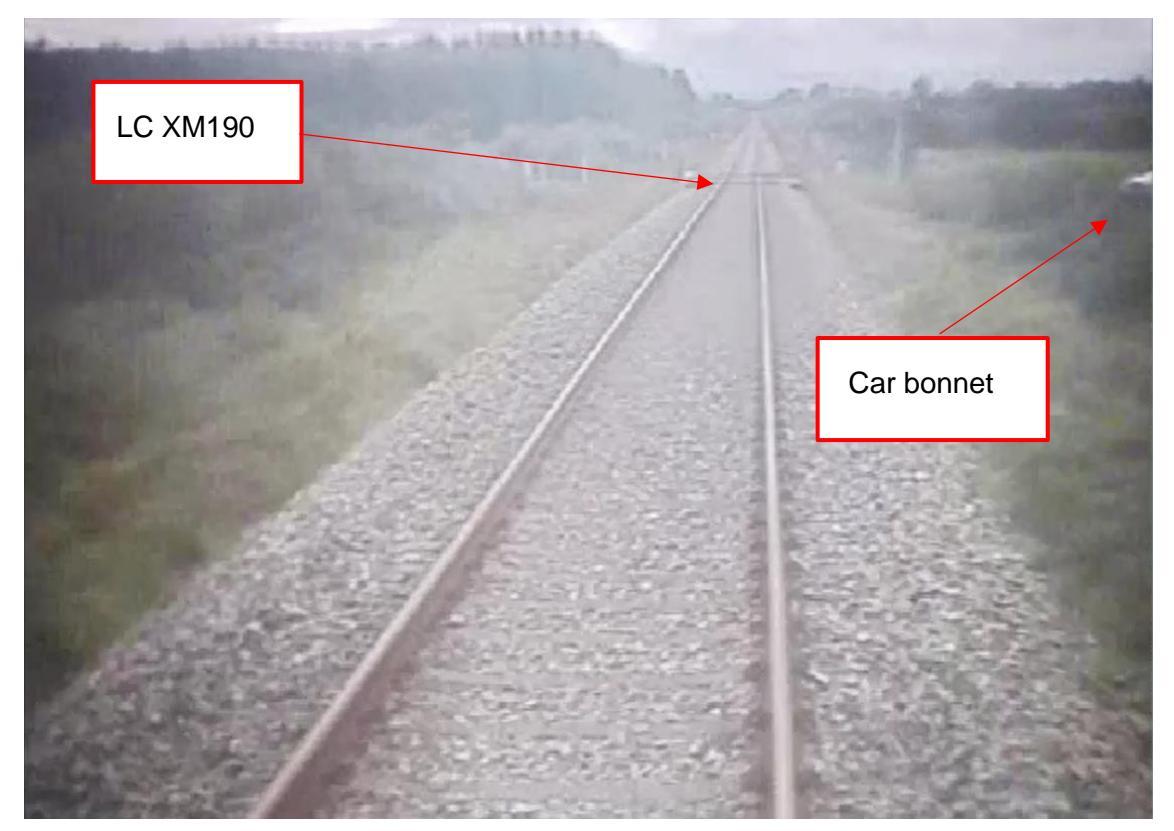
Figure 27 – Car bonnet on approach to LC XM190

126 At 15:15:03 hrs, when Driver A804 saw the bonnet of the silver Skoda Octavia (see Figure 27 (images taken from FFCCTV of Train A804)) approaching LC XM190, Driver A804 sounded the horn in case the Car Driver did not see the train. The front of Train A804 was 156 m from LC XM190³¹ (the train horn was sounded continuously until 15:15:10 hrs (after the collision)).

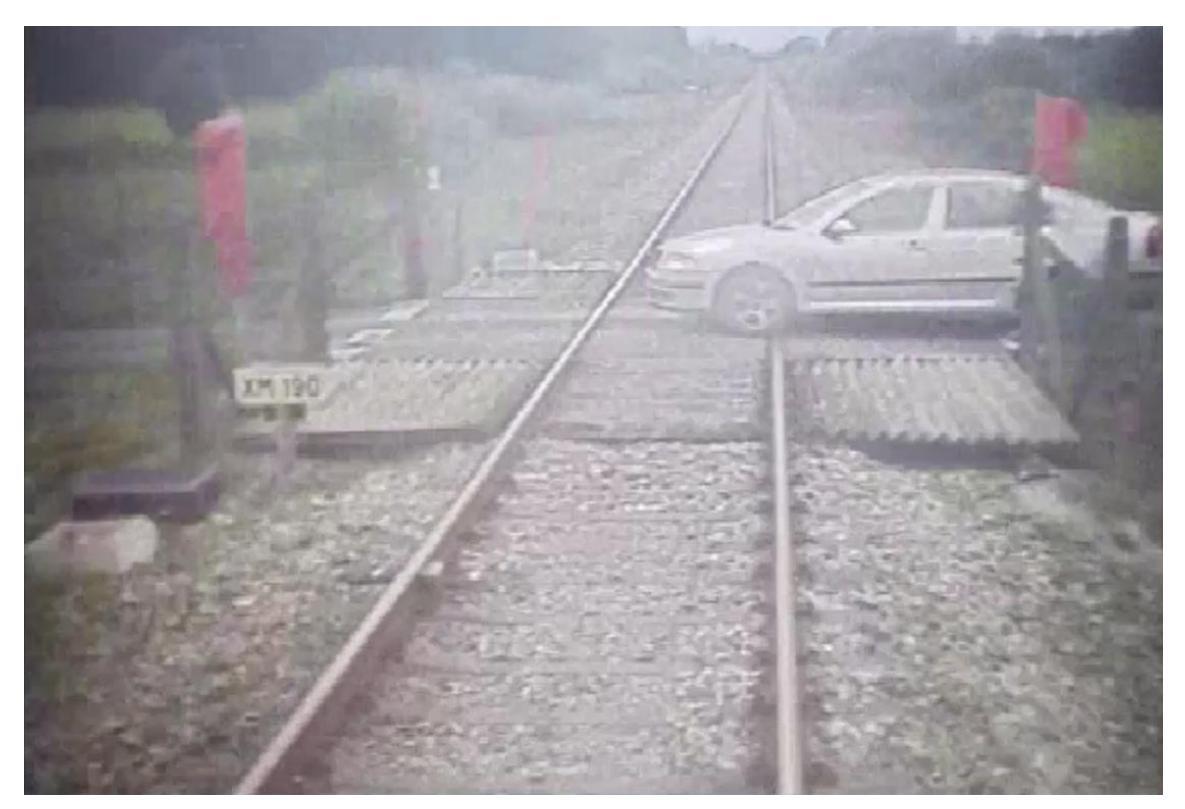
Figure 28 - Car slowing on the LC XM190

- 128 At 15:15:06 hrs, on realising that the car was not going to stop clear of LC XM190, Driver A804 made an emergency brake application³⁴. Train A804 was travelling 68 mph (109 km/h) and the front of Train A804 was 68 m from LC XM190.
- 129 As Train A804 slowed, Driver A804 saw that the car was also slowing while crossing LC XM190 (see Figure 28). Driver A804 stated "the car slowed to the point that it came to a standstill on the line directly in front of the train".

- At LC XM190, the gates were left open by a previous user (paragraph 125), and the car continued onto the level crossing without looking for approaching trains (see Figure 28). It should be noted that the actions of the Car Driver were unintended, and the Car Driver mistakenly drove onto LC XM190.

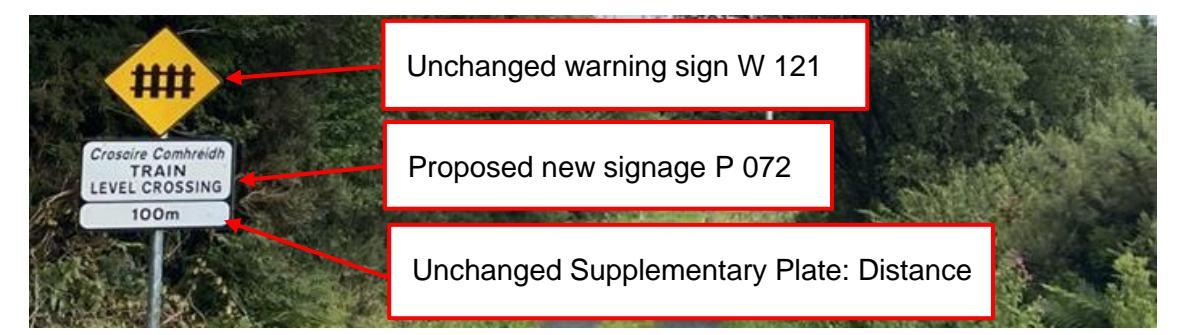
Figure 30 – Proposed new signage arrangement

- 161 Numerous options for alterations to advance warning sign, Sign W 121, were considered and discussed by the LC Working Group. It was decided, however, to retain the existing "picket fence", see Figure 30. The reason being that the format of existing Sign W 121 was considered as being internationally recognised through its inclusion in the Vienna Convention for Signs (of which Ireland is not a signatory). However, the application of Sign W 121 at UWLCs, in Ireland, is incorrect; Ireland is the only country to use the "picket fence" at OP Type level crossings, other countries use the "picket fence" for protected automatic half and full barriers (this is further discussed in paragraphs 177 to 187).

- 162 In addition, the LC Working Group noted that the existing sign was recognised and understood by over 70% of driver theory test candidates (the multiple choice question options are: "private grounds no entry", "farm machinery crossing ahead", "road fencing ahead", "level crossing ahead guards by gates or barriers"). To assist the 30 % of the driving population who had difficulty in understanding the meaning of Sign W 121, a new signage information plate, P 072, was proposed which states "Crosaire Comhréidh" (Irish for level crossing) and "TRAIN LEVEL CROSSING", see Figure 30.

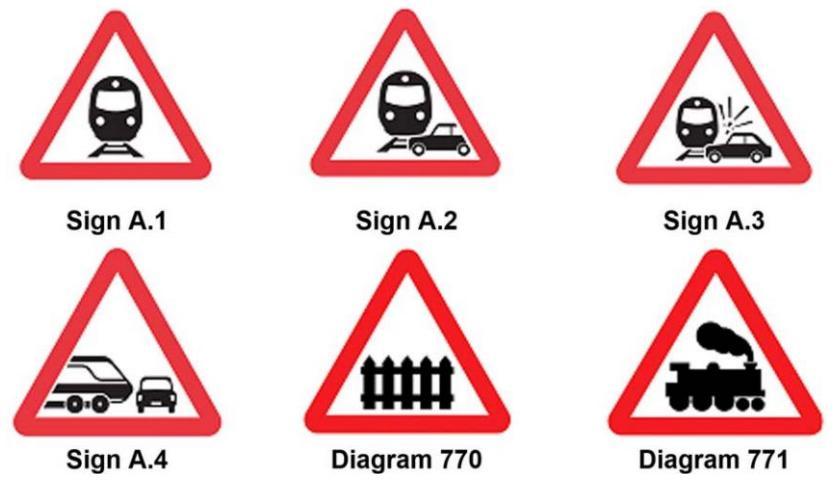
Figure 49 – Signs included in the comprehension survey

- 192 The designs of the proposed signs were evaluated using focus groups, road user comprehension survey, static image trials and virtual reality. Four new signs and two existing advance level crossing warning signs, Diagrams 770 and 771, (see Figure 49) were included in the comprehension survey.

- 193 The results of the comprehension survey were:
 - Sign A.1 For participants who associated the designs with the presence or possible presence of a level crossing ahead, there was little difference between the six signs in the frequency of responses that reported the presence of light signals or barriers (except Diagram 770 which performed badly);

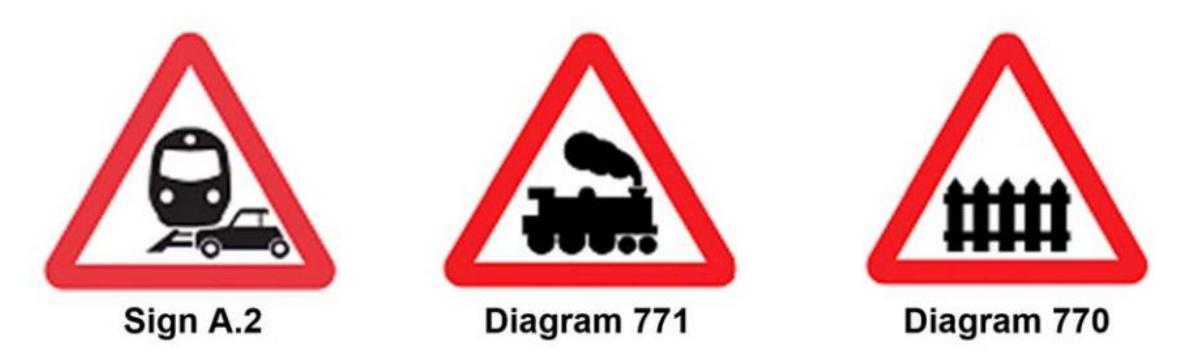
Figure 50 – Advance warning signs included in the static image test

195 In terms of the static testing, the three signs brought forward are shown in Figure 50. Initial inspection of the different accuracy levels produced by the three signs tested showed that Diagram 770 was identified the least accurately.

- As part of the research a comprehensive study, using six variations of signs, found that the "picket fence" symbol was the: least understood; received low ratings for associated risk; ranked as the least clear and understandable design; and for those who associated the design with the presence or possible presence of a level crossing ahead, the "picket fence" was more likely to be associated with level crossings protected by barriers (bullet 5, paragraph 193). Similarly, a static test found the "picket fence" sign was identified the least accurately (paragraph 195).

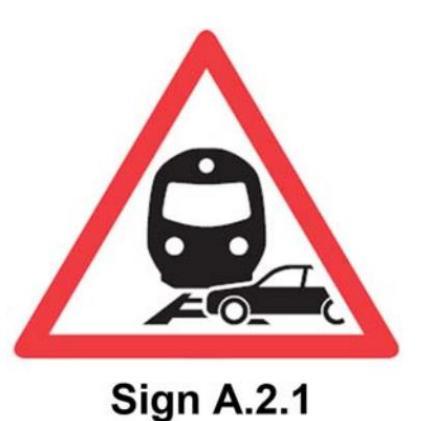
Figure 51 – Sign A.2.1

196 In terms of the virtual reality trial, the new design for the universal advance warning sign was altered slightly to make the car depicted in the image look more like a modern vehicle, see Sign A.2.1³⁹ (Figure 51). Participants' situation awareness and comprehension of Sign A.2.1 was high, particularly in the third and fourth video presentations. The key findings from the VR trial were:

After the second video presentation, 61% of participants recalled the presence of Sign A.2.1

A note of the safety recommendation: Serious consideration should be given to a sign design similar to Sign A.2.1 (train and a car) as opposed to Sign A.1.1 (train and gate) given the high level of misuse and abuse at UWLCs with gates being left open.

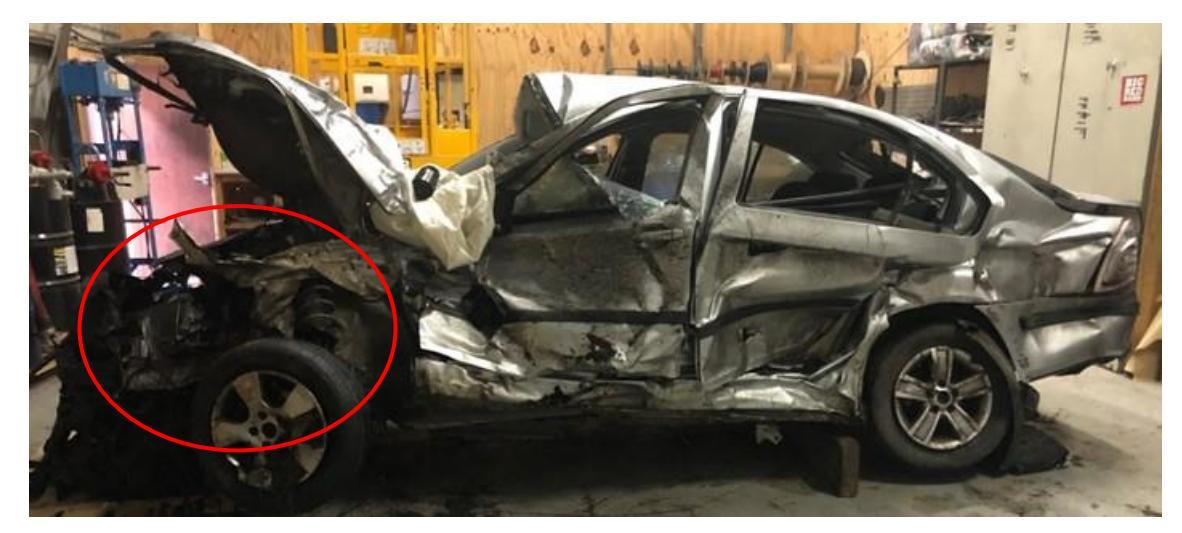
The coupler (which was extended) was the first part of Train 804 to strike the car. The area of impact of the coupler was in front of the passenger tyre near the front of the wing (see circled in Figure 55); damage outlined in paragraph 23.

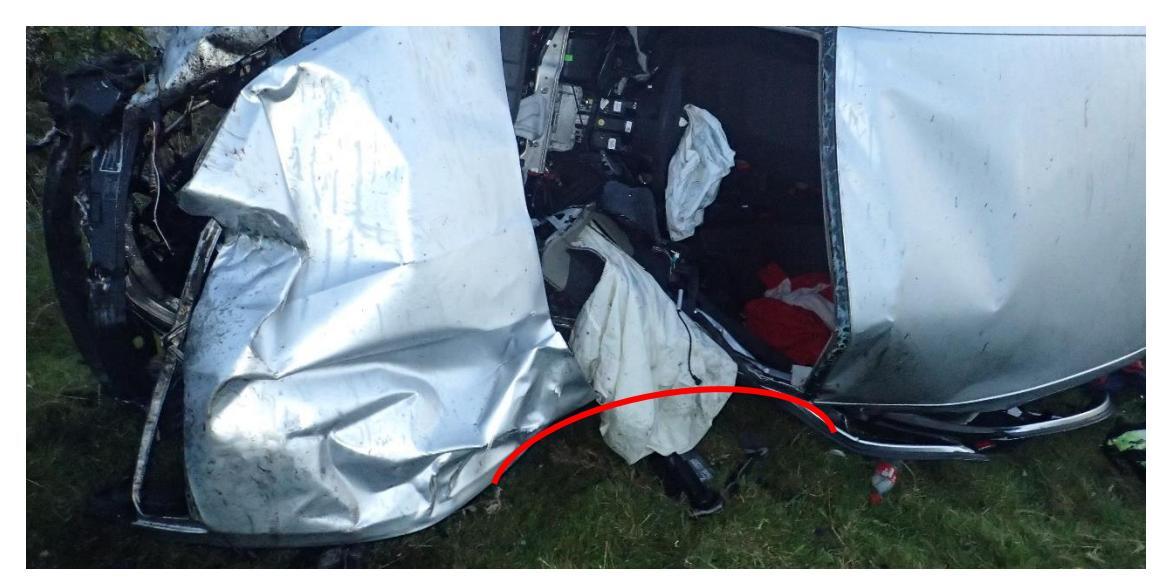
Figure 56 – Bowing effect from wrapping

215 The impact caused the front of the car (which was stationary) to rotate in a clockwise motion. The area behind the front passenger wheel and the front passenger door wrapped around the front right-hand corner of Train A804 (see Figure 56); (the reason there wasn't more of a bow further forward of the front passenger door ("A" pillar) was because the car's front wheel and engine would have absorbed some of the impact and thus resisting the bowing effect that was evident behind the passenger side front wheel, see Figure 56).

- The damage at the leading edge of the rear passenger door ("B" pillar) back to the rear quarter panel is consistent with the car having rotated into the right-hand side of the train (this is also evidenced from the imprints on the rear door area being consistent with some of the pipes and castings on the side of the train). The car was then spun out into the field by the forward motion of the train.
- 217 Had the coupler been retracted, it would likely have reduced the rate of rotation of the car from the initial impact and may have reduced the damage sustained by the car and in turn, the injuries to the occupants. However, it cannot be determined, what damage the car would have sustained had the coupler been retracted (i.e. there could have been potentially worse damage; and in addition, there could have been other unwanted consequences).

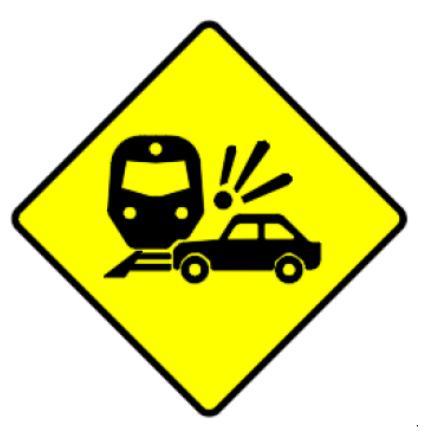
Figure 57 – Sign W126

- 247 The LC Working Group reconvened in October 2024 and a new sign was designed (with proposed number W126).
- 248 This signs is 600 mm x 600 mm in size and includes a train, car (as proposed by the RSSB Research, paragraphs 188 to 202) and "collision" element (see Figure 57).

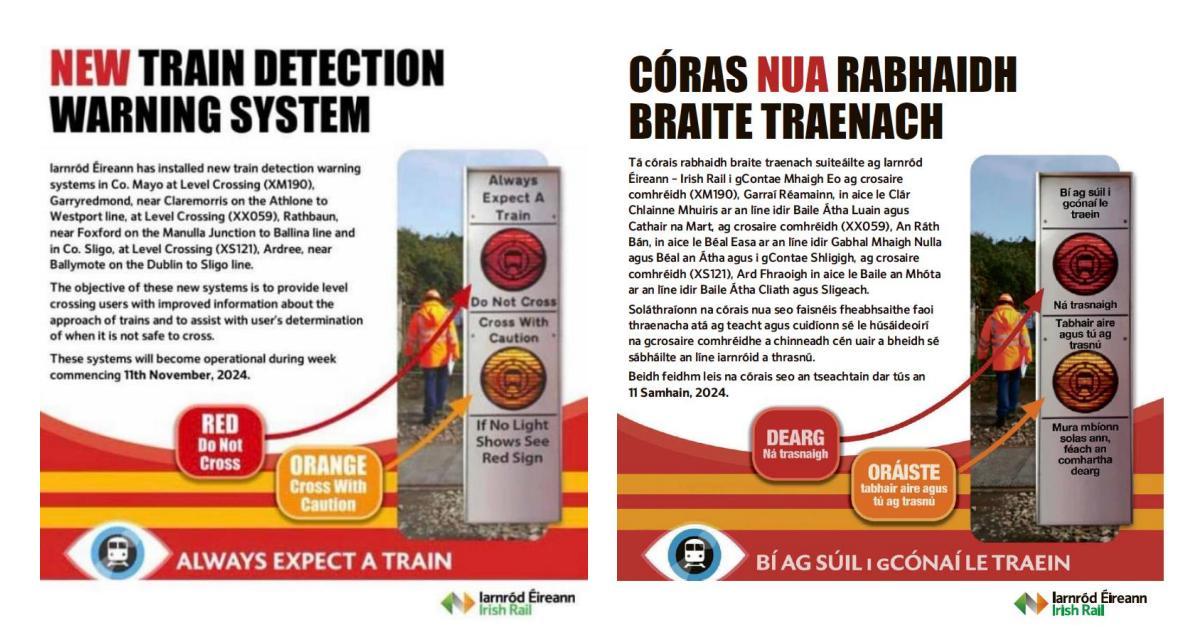
252 The DSS at LC XM190 was commissioned on the 11th November 2024⁴⁹ which provides improved information on the approach of trains at LC XM190. As part of the commissioning process, IÉ-IM have an associated advertising campaign to highlight, to users, the information that is displayed at the level crossings, the campaigns are in the English and Irish language (see Figure 58).

Figure 58 – Advertisement for DSS

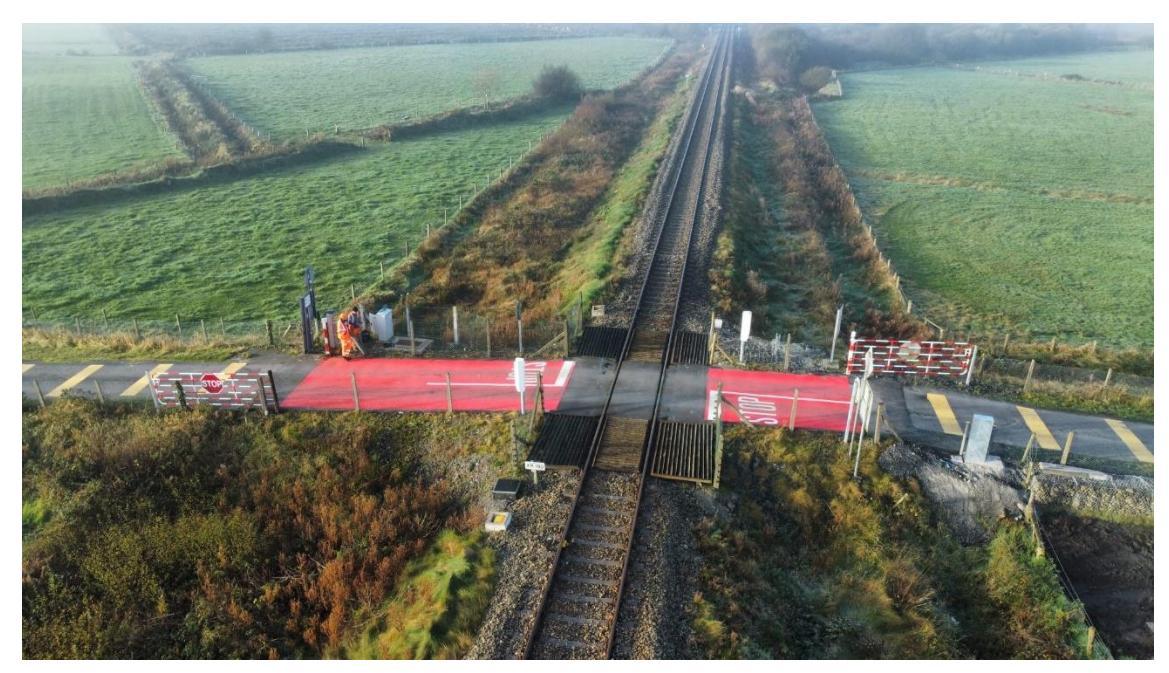
Figure 59 – LC XM190 with road markings and painted gates

254 The painting has greatly improved the visibility of the level crossing.

253 In terms of LC XM190, the painting of the gates (red and white) and the roads (part covering in red paint and yellow bar marks) was completed in October 2024, see Figure 59.

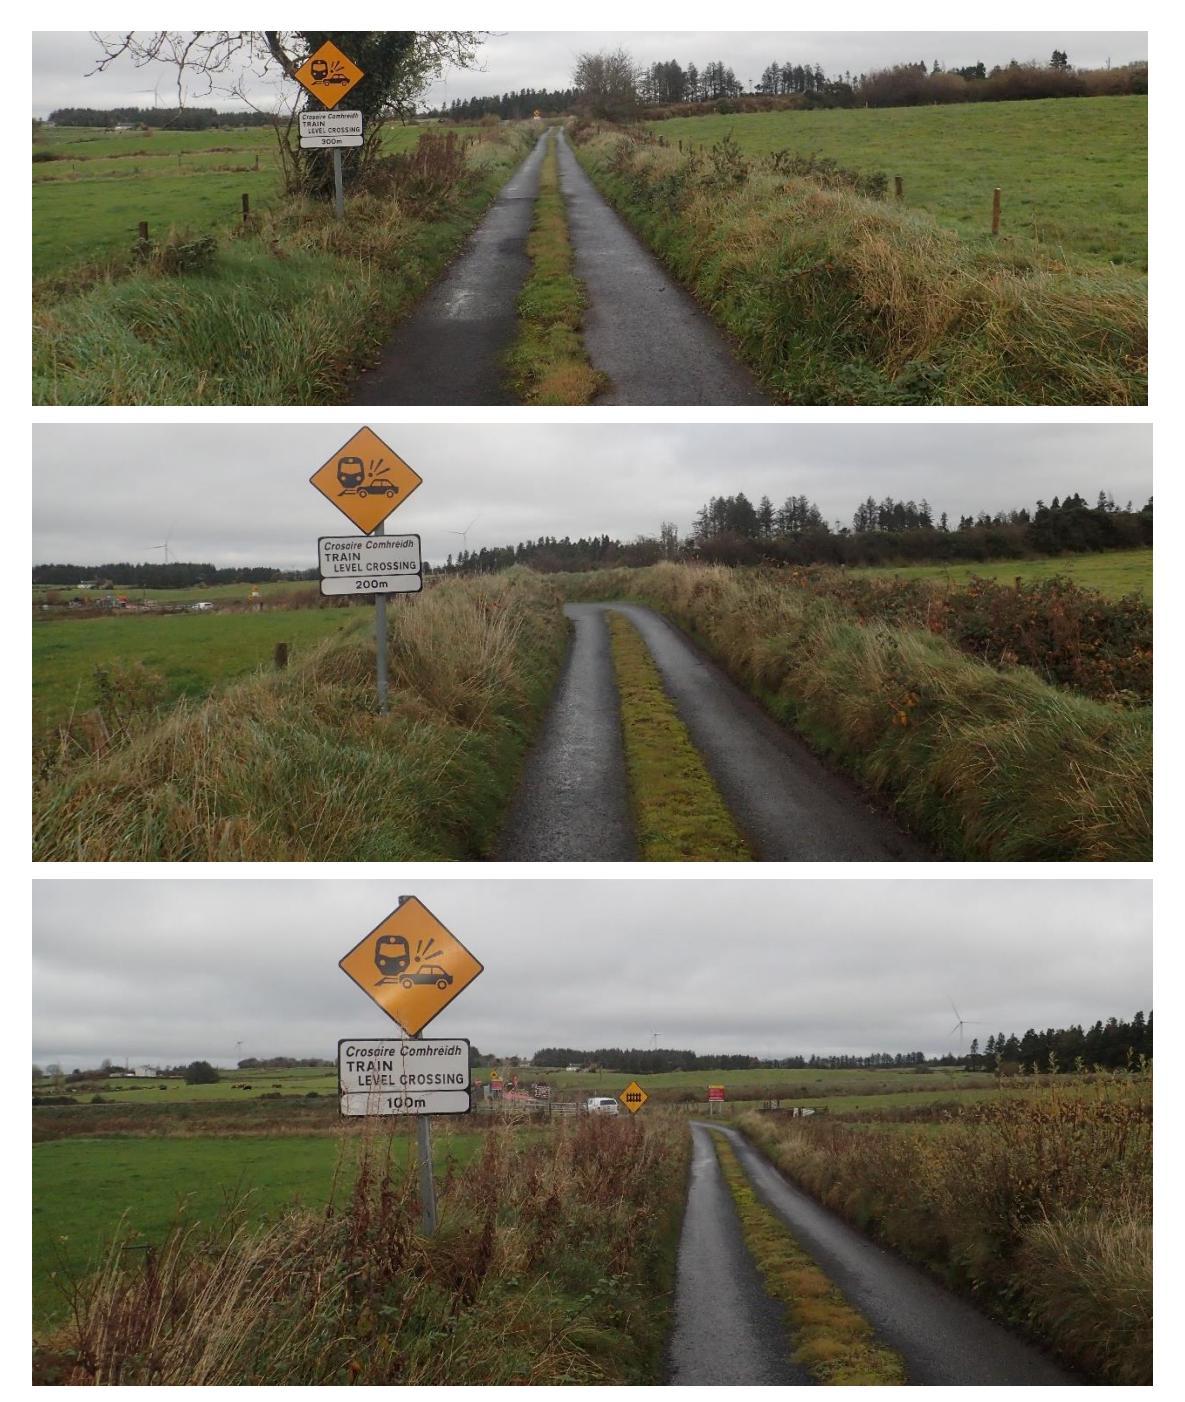
Figure 60 - New trial signage, Sign W126, at LC XM190

- 257 Initial feedback from users is positive and users have indicated a preference for the new sign, W126, over the older "picket fence" sign, Sign W121.
- 258 However, the IÉ-IM "Warning Trains" (Diamond Type), sign remains at the level crossing the location of the risk⁵⁰, noting that this is an IÉ-IM sign (complaint with CCE-TMS-380 (paragraph 67)).

- The new trial signage, Sign W126 (paragraphs 247 to 251), has been erected at LC XM190, see Figure 60 for signage at locations 300 m, 200 m and 100 m in advance of LC XM190.
- 256 These new design signs give road users clear information on the hazard they are approaching, irrespective of whether they are familiar or unfamiliar with UWLCs.

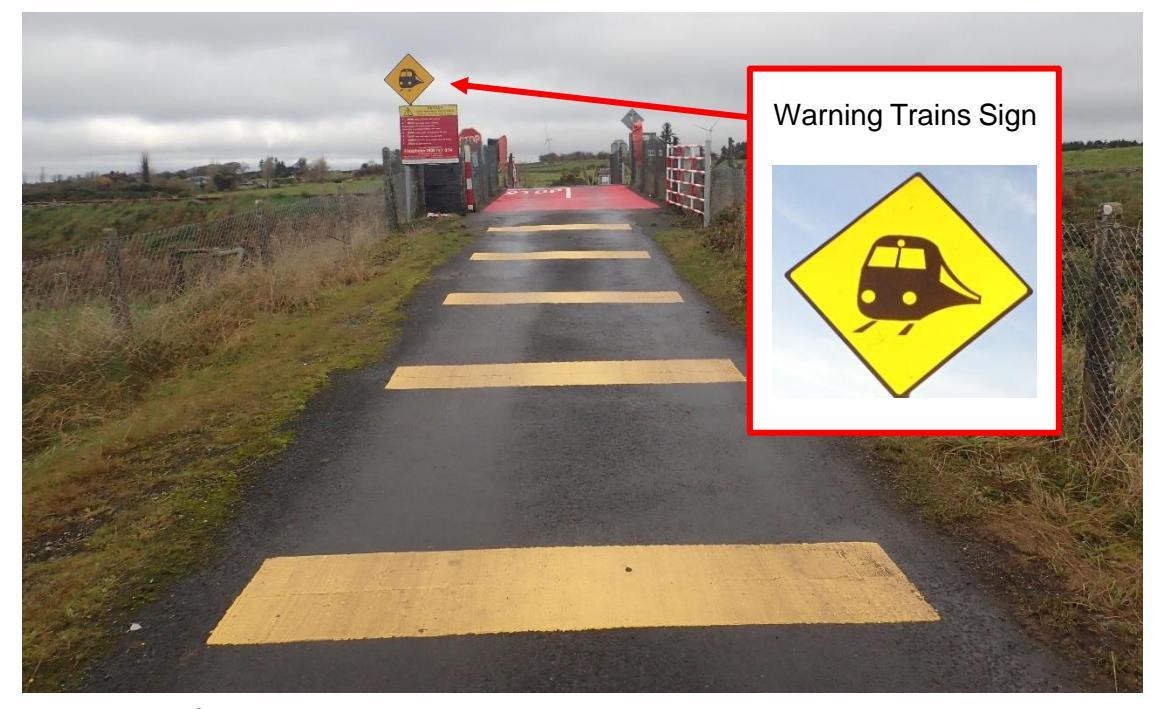
Figure 61 – IÉ-IM's "Warning Trains" sign

⁵⁰ The RAIU considers that there should be consistency in terms of the signage on the approaches to and at the level crossing and consider that a safety recommendation is warranted, Safety Recommendation 2024003-02 (paragraph 279).
