**Railway Accident
Investigation Unit
Ireland**

INVESTIGATION REPORT

Operational Irregularity, Clontarf Road, 1st May 2024

RAIU Investigation Report No: 2025-R001

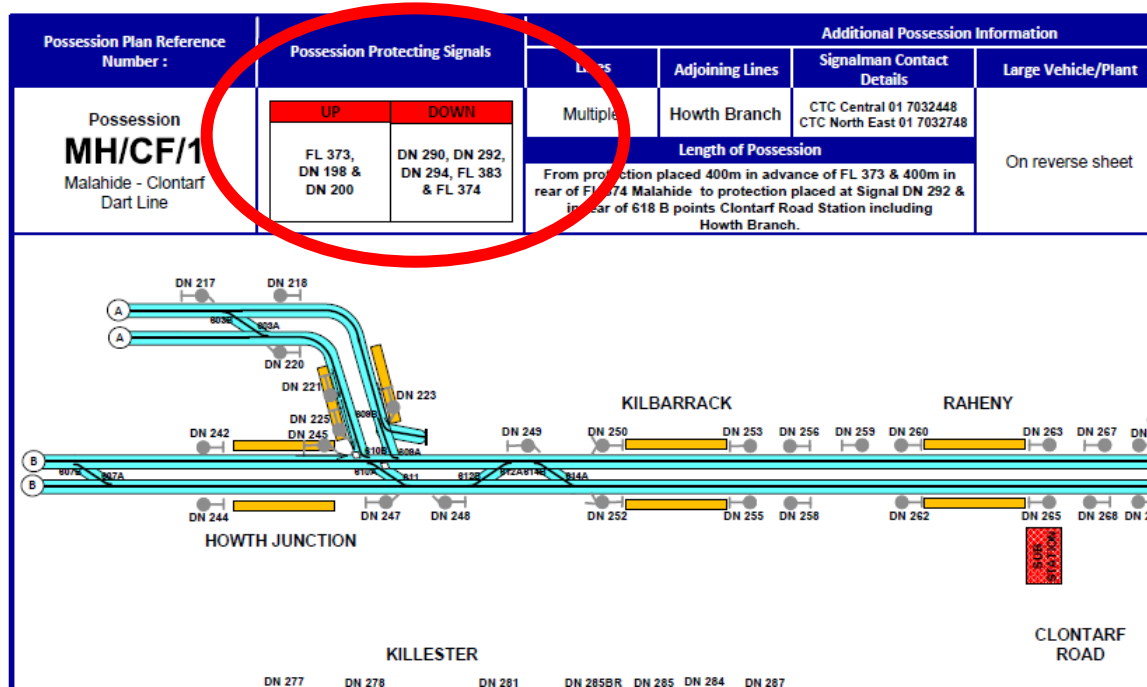
Figure 9 – Protecting signals for PPRN MH/CF/1

52 To provide signal protection, the signalman must place the relevant possession protecting signals at danger, these are included in the PPRN MH/CF/1, see circled in Figure 9.

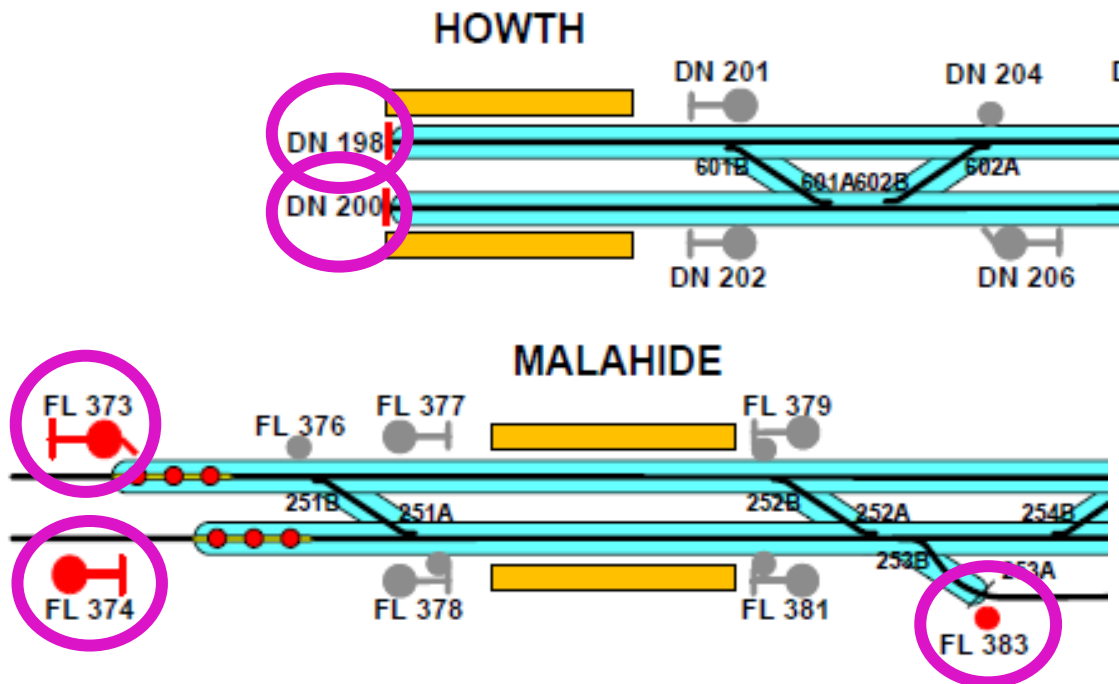
Figure 11 – Possession protecting signals North & East Workstation

106 At 00:56 hrs, the Signaller contacted the North & East Workstation at CTC to request signal protection at the northern end of T3 Possession MH/CF/1 (possession protecting signals FL373, DN198, DN200, FL383 and FL374 see Figure 10 for a section of PPRN MH/CF/1), in the Howth and Malahide areas, see pink circles in Figure 11.
