**Railway Accident
Investigation Unit
Ireland**

INVESTIGATION REPORT

Investigation into two near miss events involving track workers at Bray Tunnels

RAIU Investigation Report No: D2026-R003

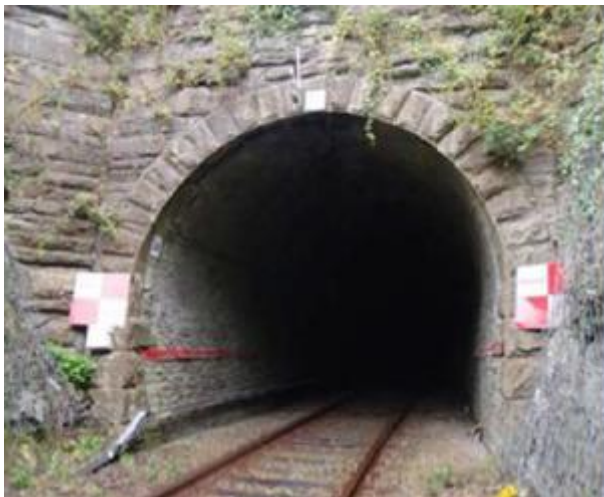
Figure 4 – Limited clearance, PTS Handbook

- 60 As mentioned previously, where the required clearances for a position of safety are not available at all locations, these are areas of limited clearance. The PTS Handbook (Section 1.7) states that “When you see the sign below it means you will not have a position of safety on that side of the railway for the length of the structure”, providing an example with the signage at the entrance of a tunnel, see Figure 4.

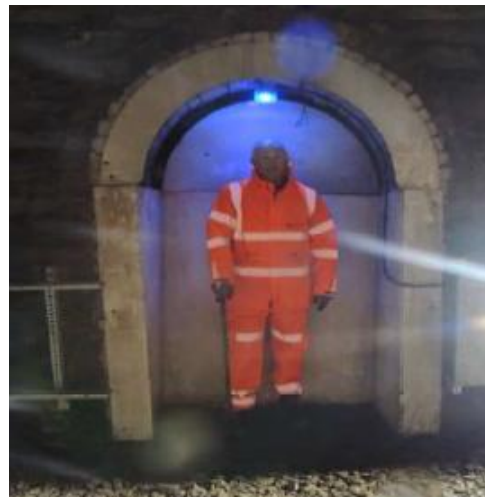
Figure 5 – Refuge

- 61 The PTS Handbook states that “Tunnels add another layer of risk to working on the railway, as a result, people are not allowed to work in tunnels while trains are running. If trains are stopped and you have received permission to enter, you still need to make sure you know where the nearest position of safety is, this will usually be in a refuge. You must have a head lamp or hand lamp with you if you are entering a tunnel”.
- 62 A refuge is a place where it is safe for you to stand when a train is passing; they can be built out over an embankment, bridge or cut into the wall of a viaduct or tunnel, see Figure 5 for example of a refuge in tunnel.
