Railway Accident Investigation Unit

Report

**Report into the Collision at Level Crossing XN 104 between
Ballybrophy and Killonan on the 28th of June, 2007**

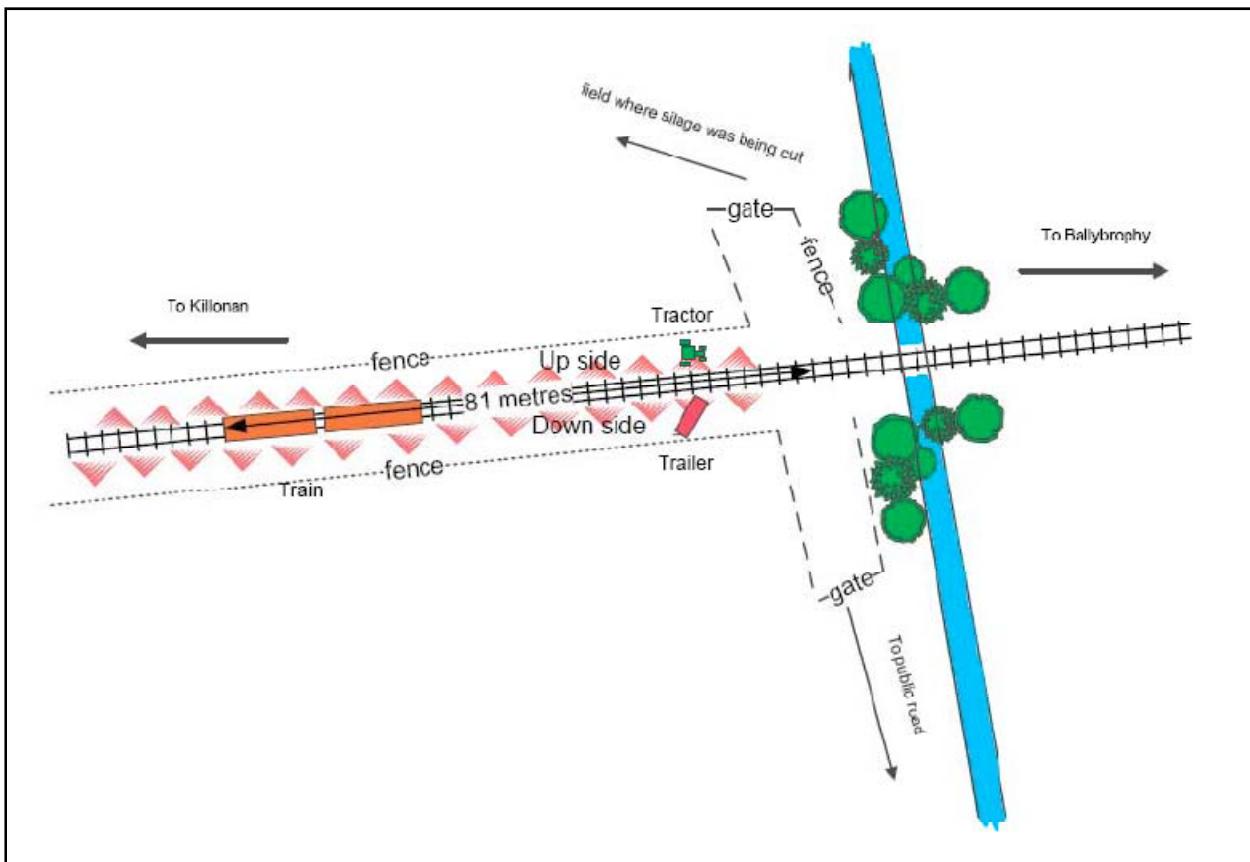
Figure 2 - Site Map

A harvester and three tractors and trailers were working across the crossing. It is not known who originally opened the crossing gates but it is clear that the tractors and trailers worked back and forth over the crossing and that the gates were left open while this happened. At approximately 20.00 hrs, having dropped off a load of silage, one of the tractors and trailers was traversing the crossing to the field when it was struck by the 18.55 hrs passenger service from Ballybrophy to Limerick, train identification A464. The site layout can be seen in figure 2.
