**Inquiry into the
Derailment of a Freight Train
at Cahir Viaduct on
7th October 2003**

Interim
Railway
Safety
Commission

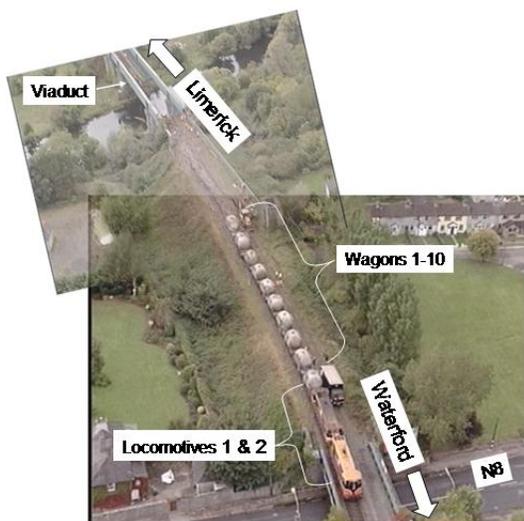
Figure 2 Aerial shot of front of train (by courtesy of Radio Teilifís Éireann)

During the course of the accident the Train, which comprised two locomotives and twenty two laden cement wagons (the wagons), divided. The locomotives and the first ten wagons crossed the viaduct, coming to a stand with the rear of wagon 10 approximately 61m beyond the Viaduct. The remaining twelve wagons fell through the deck of the viaduct coming to rest in the river or on the Waterford bank (Figures 2 and 3).

While no railway employee or other party was injured in the accident the rear twelve wagons of the Train were damaged beyond repair and the deck of the Viaduct required major reconstruction. The capital cost of this damage was in excess of €3 million. Following the accident the Limerick to Waterford railway remained closed until reconstruction work on the Viaduct was completed in September 2004.

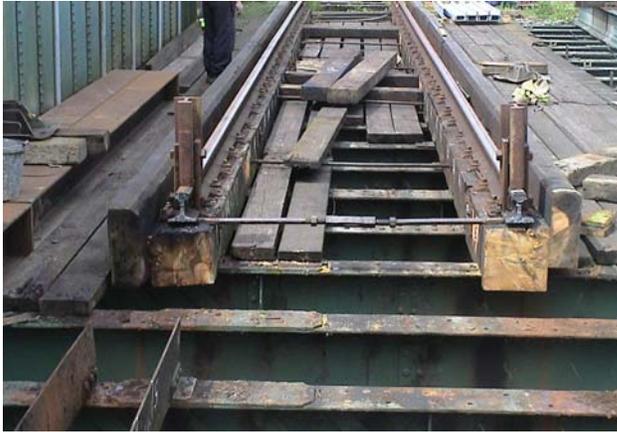
Figure 9 Way-beams over transverse girder
18

Corrosion of the ironwork has necessitated various lesser repairs principally involving the fixing of reinforcing plates or straps to the webs and flanges of the wrought iron transverse girders (see section [4.5](#), figures 9 and 10). In 1973, reinforcing plates were fixed to the top flanges of eleven transverse girders, the bottom flange of one transverse girder and two main box girders connections. Detailed examination by the Divisional Engineer and Bridge Gang Foreman in 1995 identified further corrosion damage requiring repairs to the webs of 46 transverse girders and the bottom flanges of a further 5. The dates of prior repairs are not known.

On the Up side, some of the reinforcing plates on top of the transverse girders commenced half-way across the way-beam seating, (see section 4.5, figures 9 and 10). This meant that those way-beams, in addition to requiring notching to accommodate the reinforcing plate and its rivets, also required packing^[33] to create a level seating across their whole width.

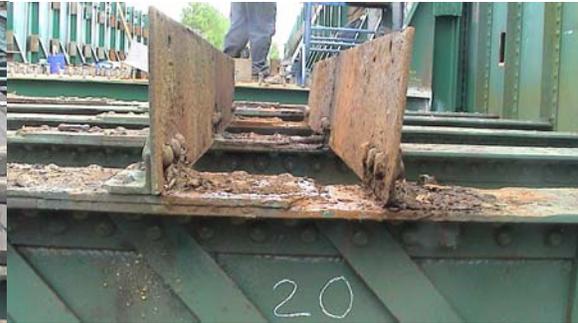
Figure 10 Flitch plate and top flange
reinforcement plate at transverse girder 20

At every second way-beam joint there were pairs of steel flitch plates ^[15] that were the same depth as the way-beams to which they were bolted on either side (Figure 10). The plates were approximately 2060mm long and spanned three transverse girders to which they were riveted. They were mounted at longitudinal intervals of 11.7m in staggered fashion, reflecting the probable original length and layout of the way-beams. The flitch plates helped to provide lateral, longitudinal and rotational fixity to the way-beams and, along with the staggered guard-beams they provided longitudinal continuity.

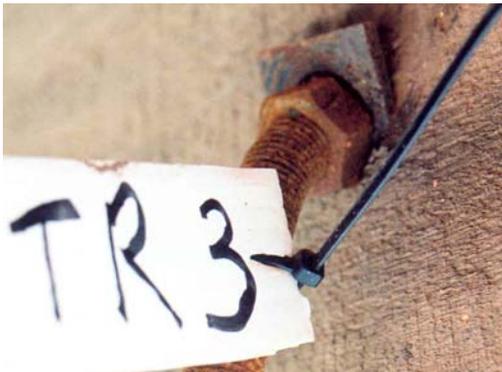
- some of the washers on the ends of the tie-rods that held the way-beam and guard-beam assembly together were in excess of 100mm square, while others were little more than the size of a standard engineering washer for that diameter rod (Figure 17);

Figure 17 Guard-beam showing tie-bar and washer.

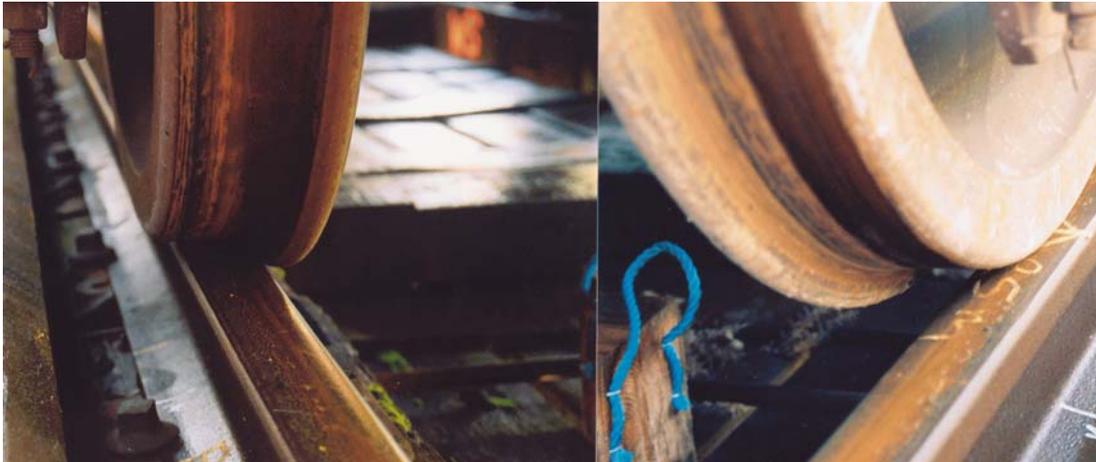
Figure 27 Opposite wheels of test train axle at Way-beams 6 and 7 respectively

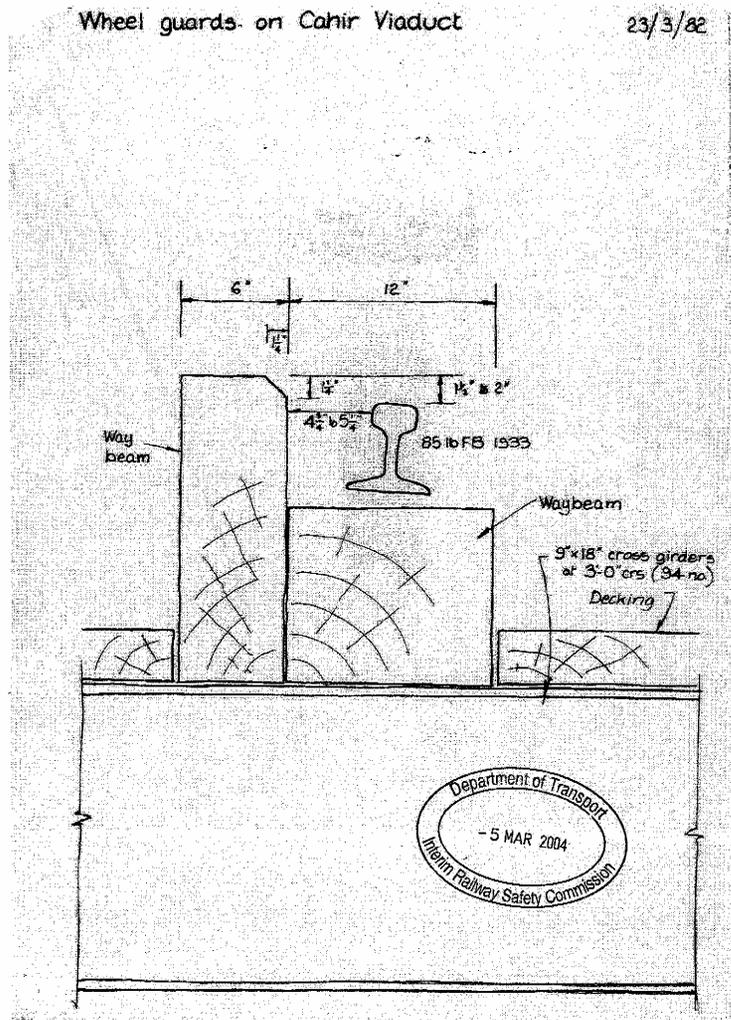
The configuration of the timbers, as indicated in a drawing of the Viaduct prepared after the accident by the Divisional Engineers, differs from that shown in the historical drawings in that the guard-beam is shown seated directly on the transverse girders as opposed to top of the walkway timbers: the same configuration was also indicated on a sketch prepared in 1982 (Figure 31 in Appendix 2).

The only available drawing relating specifically to provision of derailment protection on the Viaduct is a 1982 IÉ sketch (Appendix 2, Figure 31). This indicates the required height of the top of the guard-beam over the top of the rail to be in the range 38mm-51mm (1½”-2”) and the gap between its inner face of the guard-beam and the outer face of the rail head in the range 120mm-133mm (4¾-5¼”). In the sketch, no beam or timber dimensions are given and the guard-beam is erroneously called a way-beam. The 1982 sketch shows the guard-beam seated directly on the transverse girder rather than on top of the walkway timber. In showing an arrangement that contradicted previous drawings, this apparent error may have introduced confusion.

Figure 31 Cross-section detail of wheel guards (CIÉ Chief Civil Engineers, 1982)

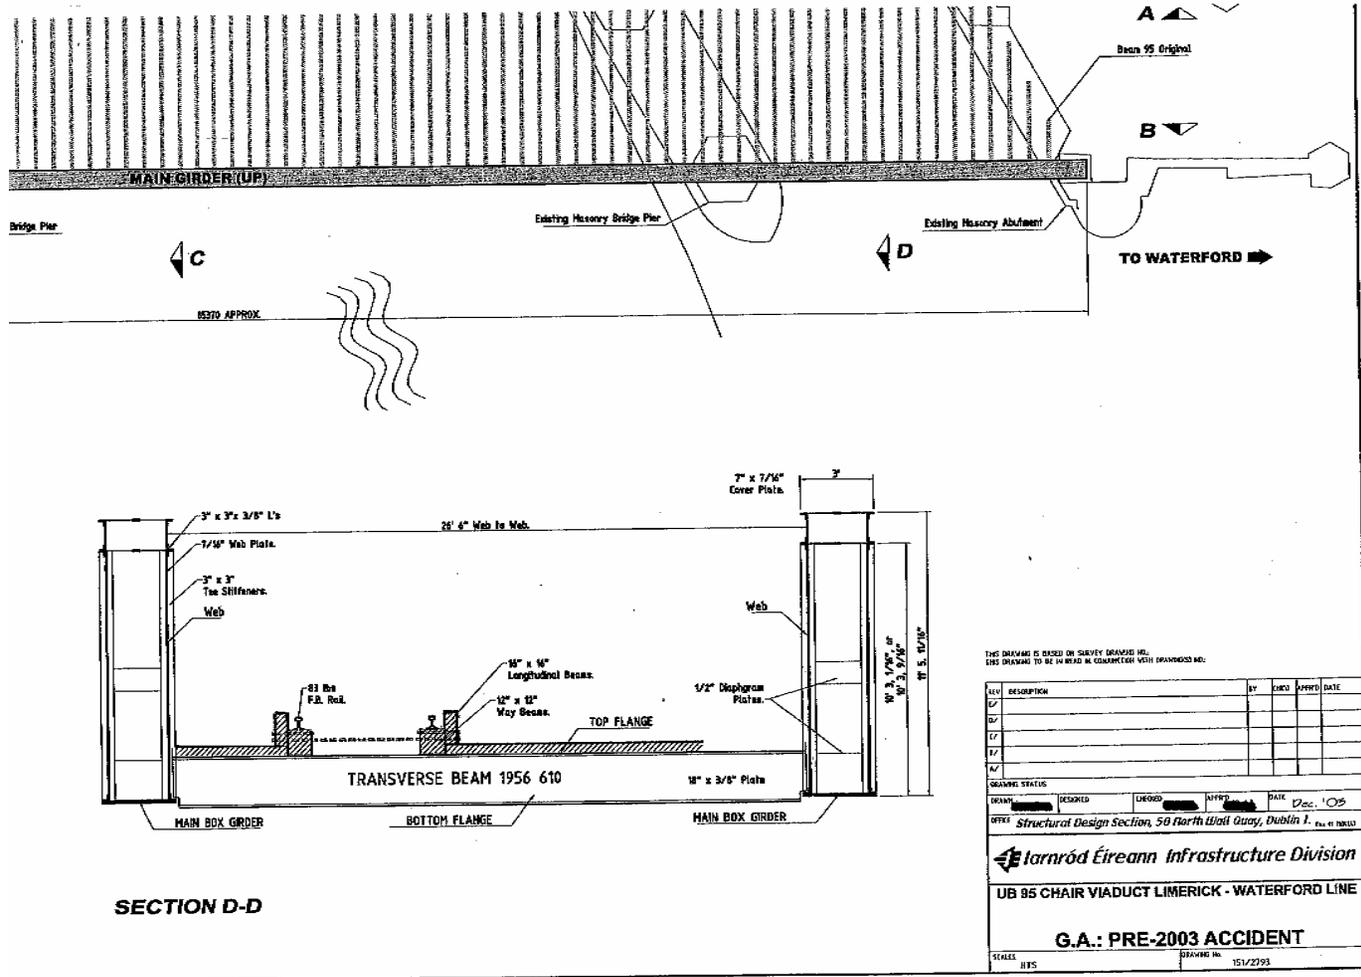
The drawing of the secondary deck prepared by IÉ in 2004 (Appendix 2, figure 32 is not compliant with the derailment protection requirements shown in its 1982 sketch and shows the rail-head higher than the top of the guard-beam. As in the 1982 sketch, the

Figure 32 Cross-section of structure pre-2003 accident (IÉ Structural Design, 2003)

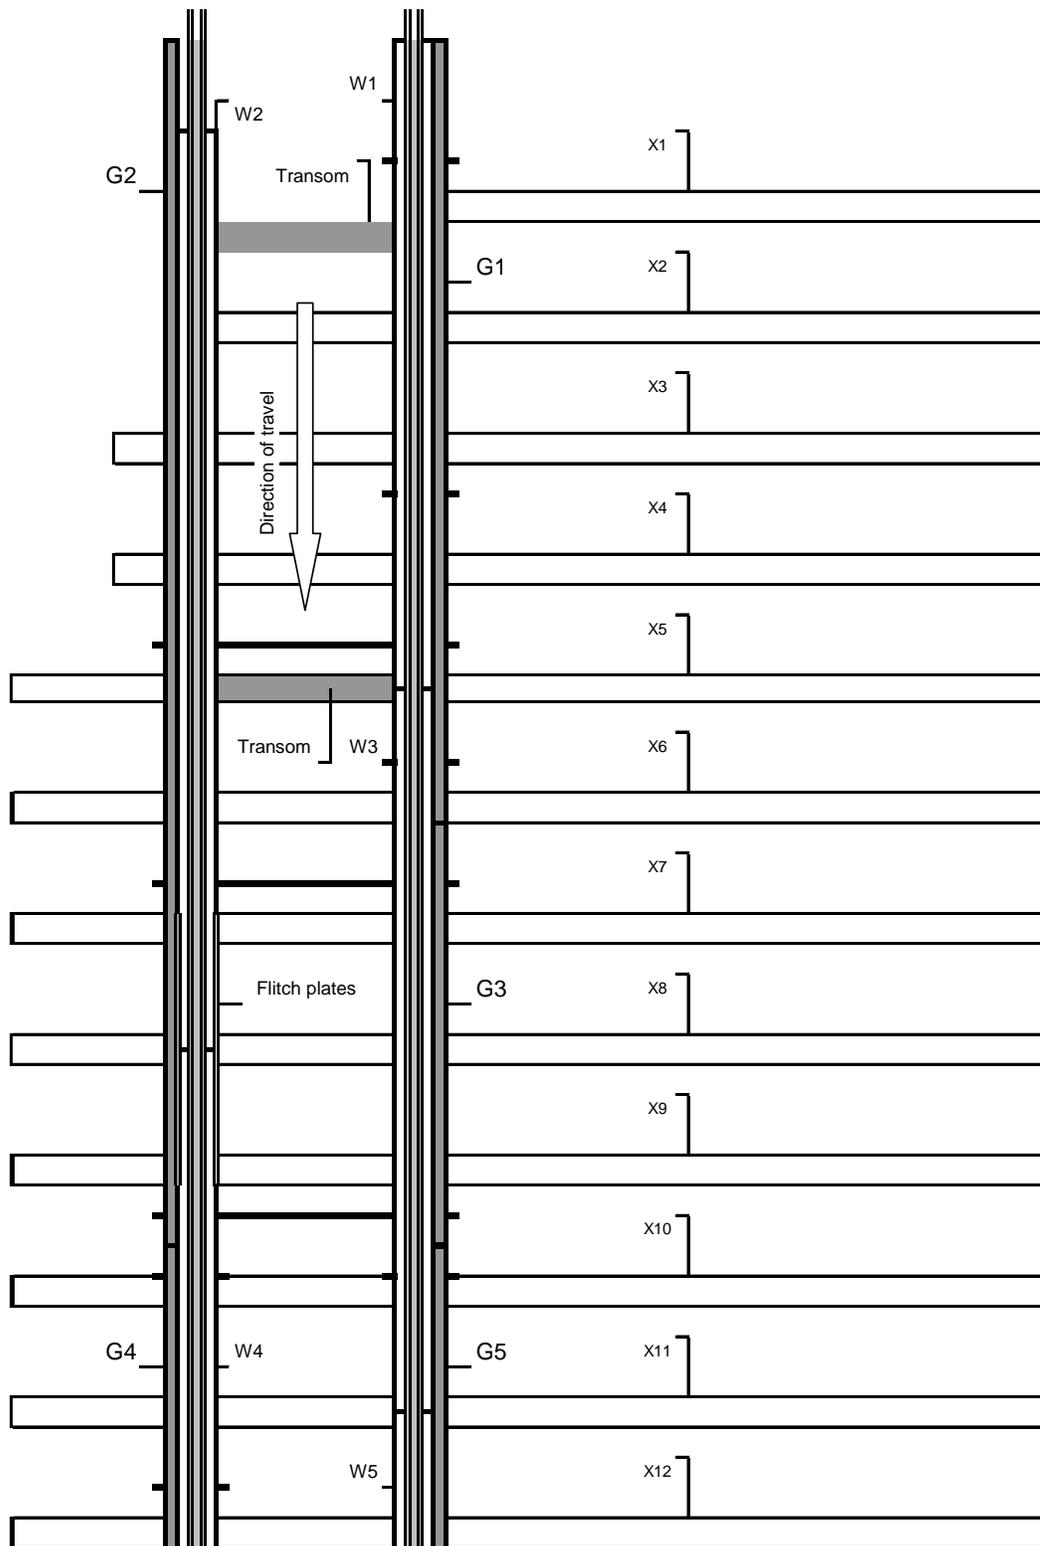
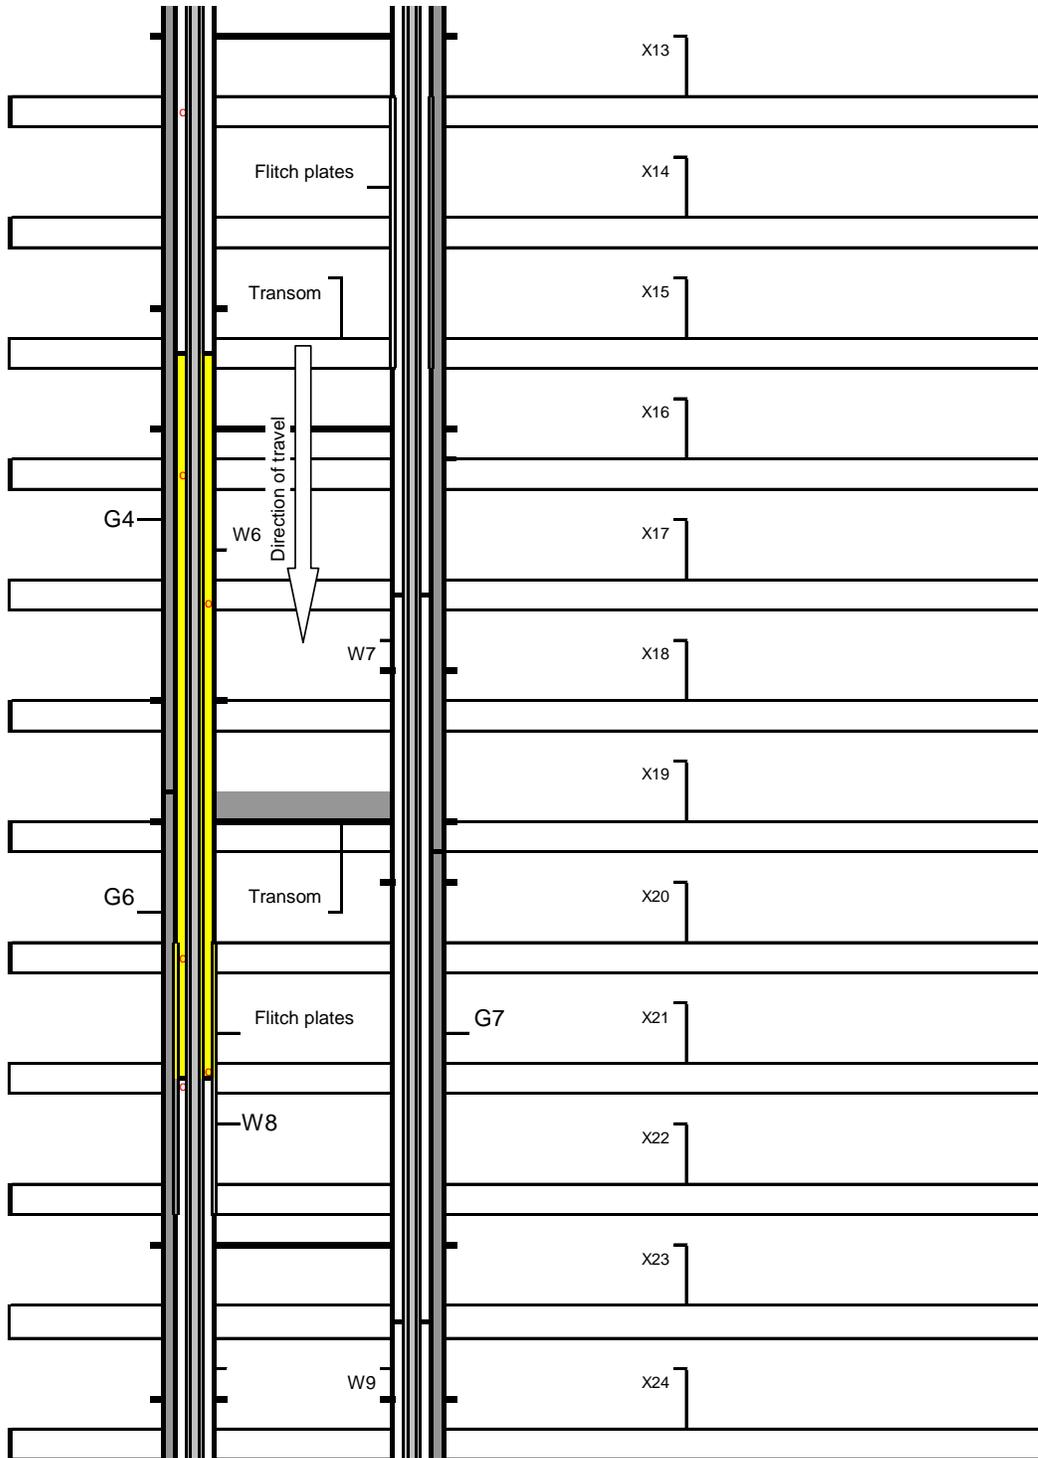
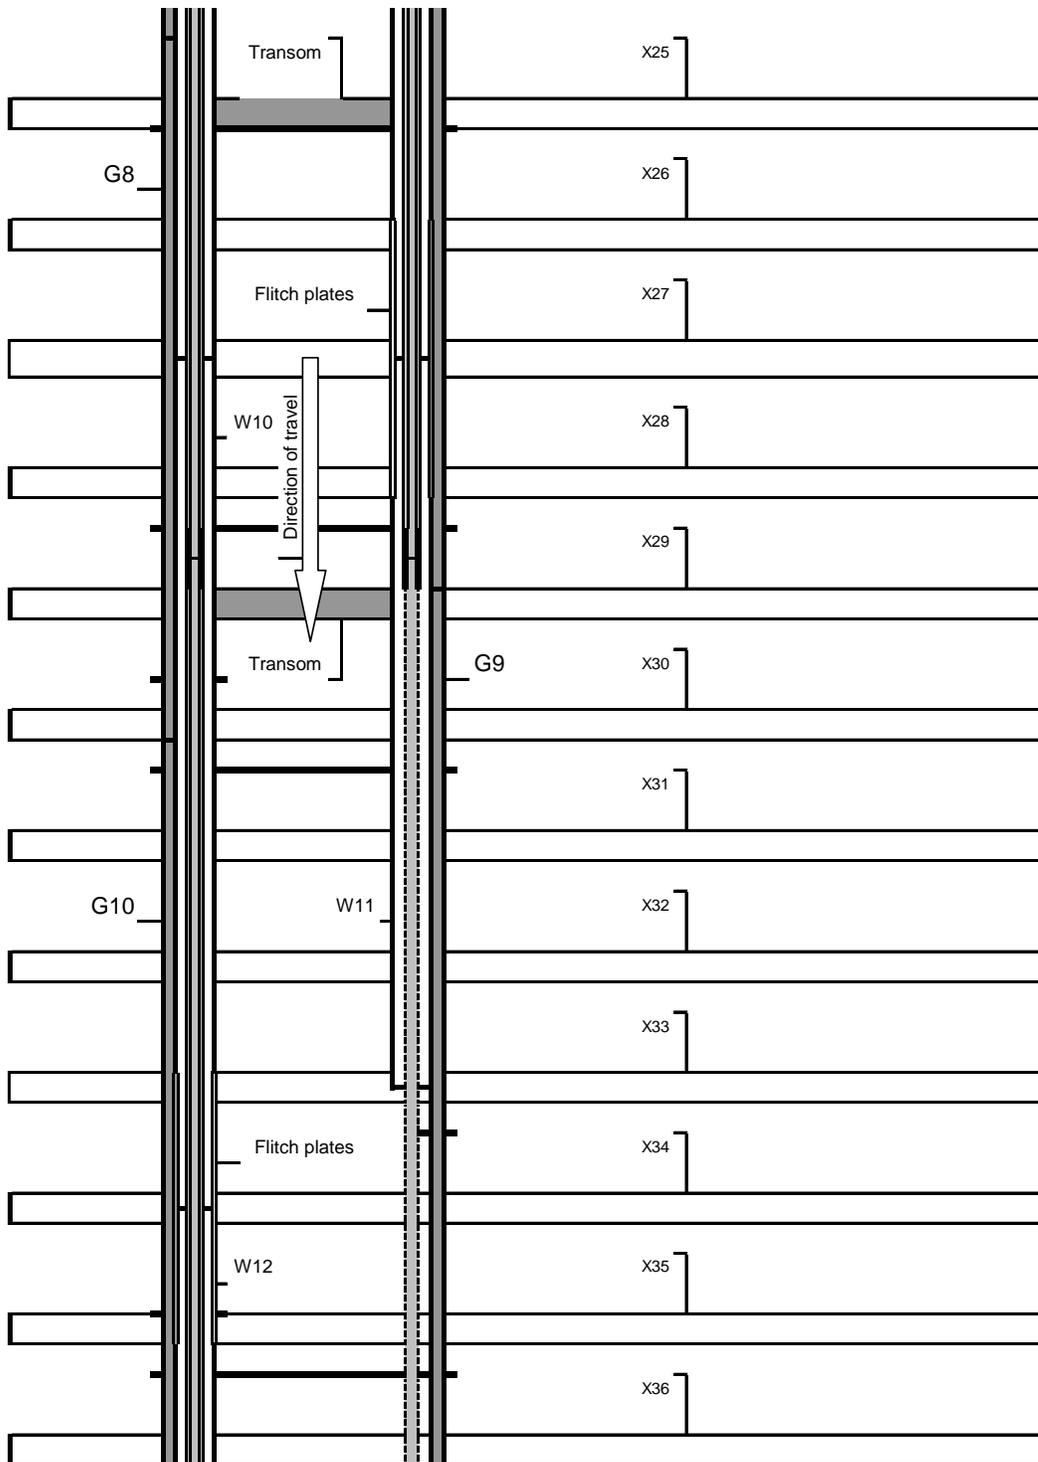
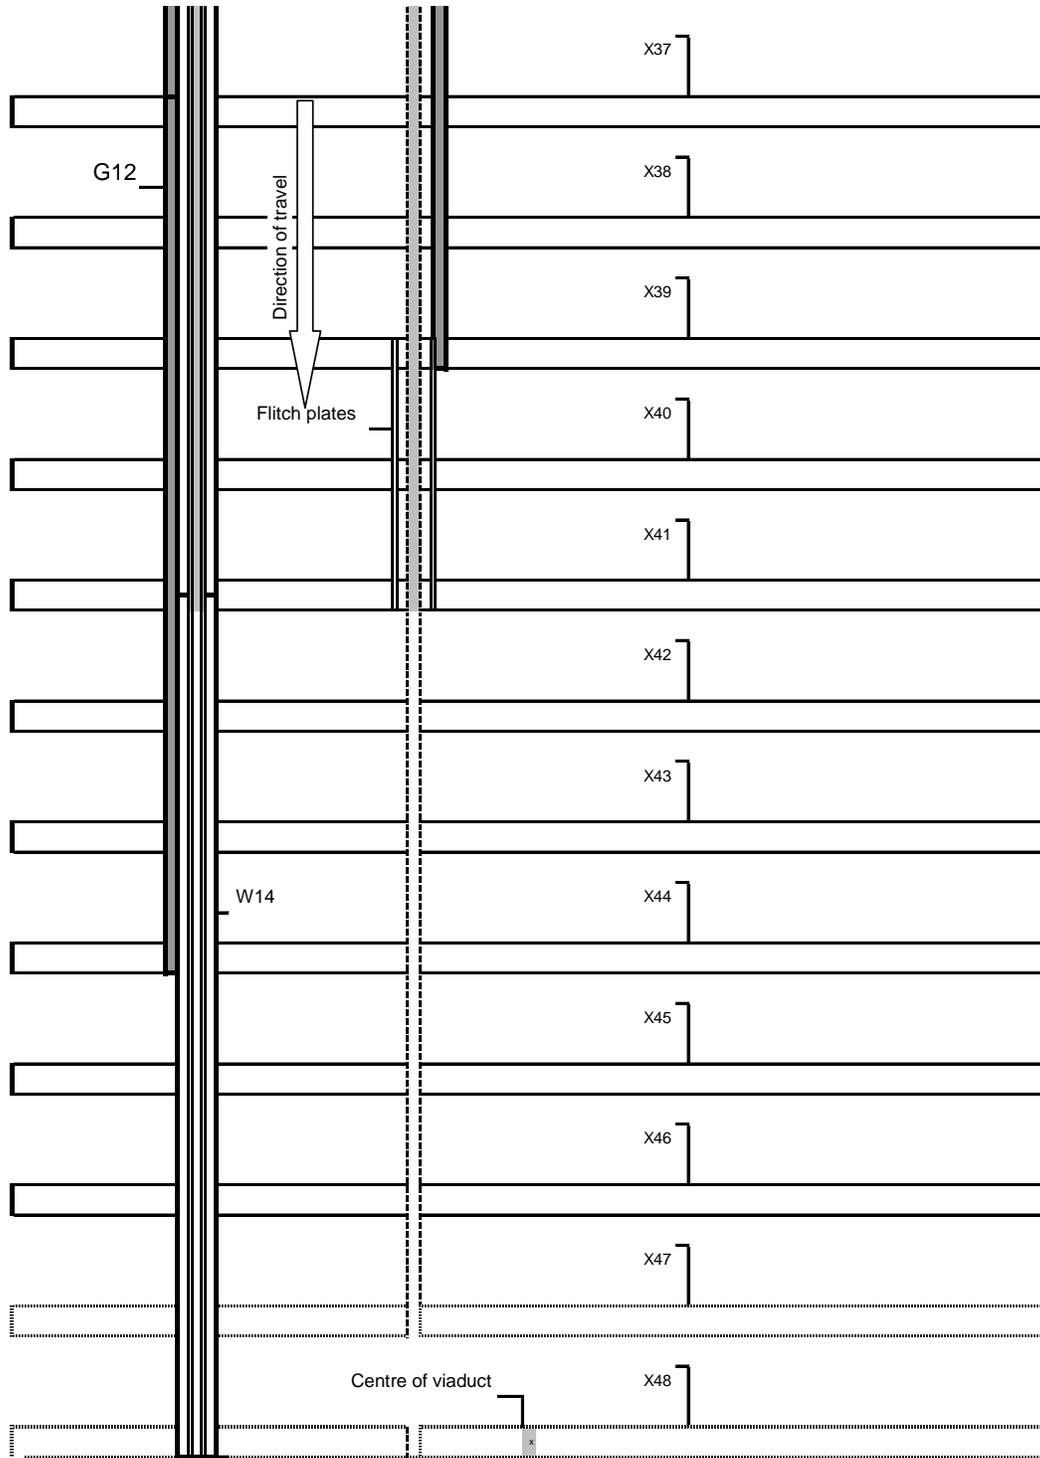
Figure 34 Plan diagram of intact bridge deck

However, since the whole Viaduct deck was subject to the same inspection and maintenance regime the condition of the approximately 40% that remained intact following the derailment may be taken as indicative of that of the remainder that was destroyed. For illustrative purposes, a sketch plan view of the intact portion of the deck is shown in Appendix 3, figure 34.
