Investigation Report 2011-R002

Secondary suspension failure on a train at Connolly Station

7th May 2010

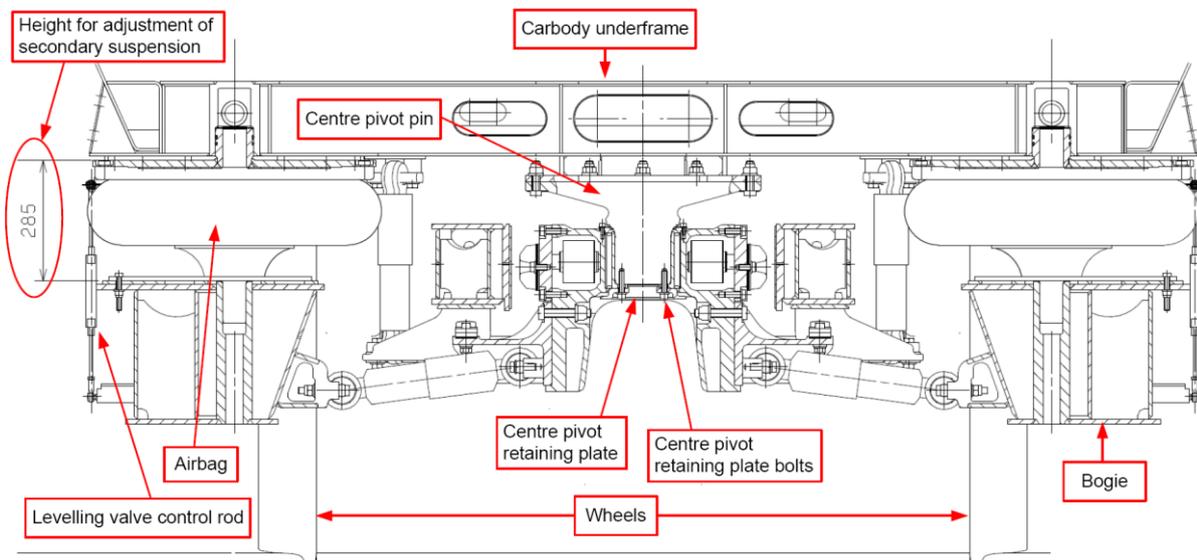
Figure 5 – Equipment between bogie and carbody (CAF, 2003a)

Each carriage on the Class 29000s has two sets of secondary suspension equipment, one mounted between each bogie and the underframe of the carriage, see Figure 5. The secondary suspension consists of two levelling valves, two levelling valve control rods, two airbags incorporating two conical springs, an average relay valve, a compensating valve and two auxiliary air reservoirs.

Air is fed from the main air reservoir on the carriage to the airbags on each bogie separately through two levelling valves. The height of the carbody is controlled by the levelling valve control rods, which maintain a gap of approximately 285 millimetres (mm) between the carbody and the bogie, see Figure 5. When the gap is less than the required height, the levelling valve control rod forces the arm of the levelling valve upwards allowing air to enter the airbag. When the gap is greater than the required height, the levelling valve control rod forces the arm of the levelling valve downwards causing the valve to vent air from the airbag. This allows the system to compensate for changing passenger loads.
