Investigation Report No. 2010 – R004

August 2010

**Malahide Viaduct Collapse on the Dublin to Belfast Line,
on the 21st August 2009**

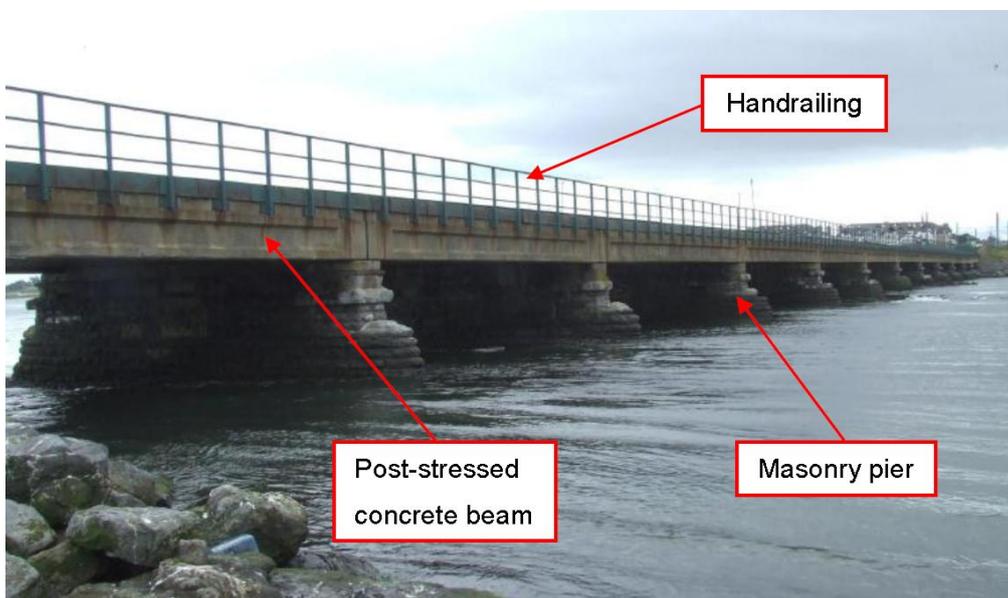
Photograph 3 – Post-stressed concrete beams on original masonry piers

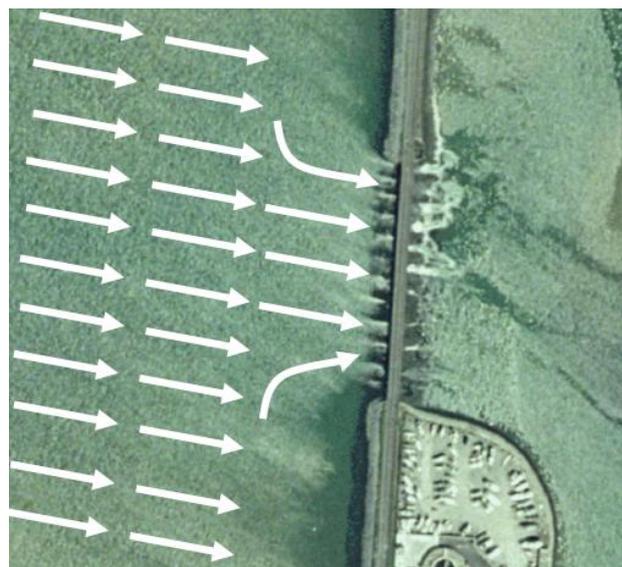
The viaduct construction allowed for even flows through all twelve spans of the viaduct (see Photograph 7).

Photograph 7 – Even flows through all twelve spans (during ebb flow)

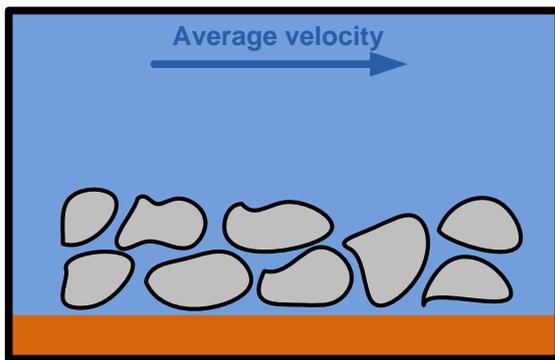
The 2-D 1:40 laboratory moveable model was created to simulate the sediment transport between the piers for the Broadmeadow estuary level (west), at 2.7m, 2.0m and 1.5m OD. Simulated 300 – 400mm stones were placed along the full length of the simulated pier. The model showed that these stones were unstable and moved even when slightly dislodged, suggesting that the stones were close to the *threshold of movement* when velocities are high, as occur during high ebb tides, Figures 10 and 11 illustrate this movement. The velocity measurements were taken from the model and scaled up to give prototype velocities ranging from 3.48m/s to 4.9m/s.

Figure 10 – Stable cobbles during average velocities

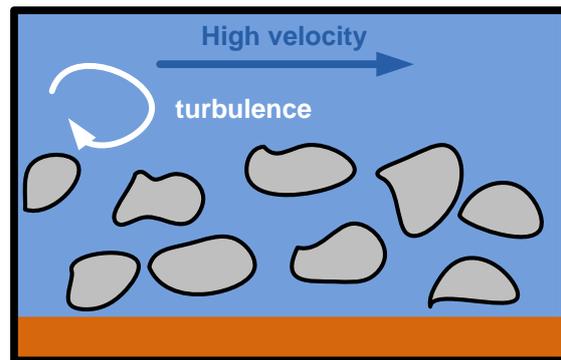
Figure 11 – Unstable and moving cobbles during turbulence caused by high velocities

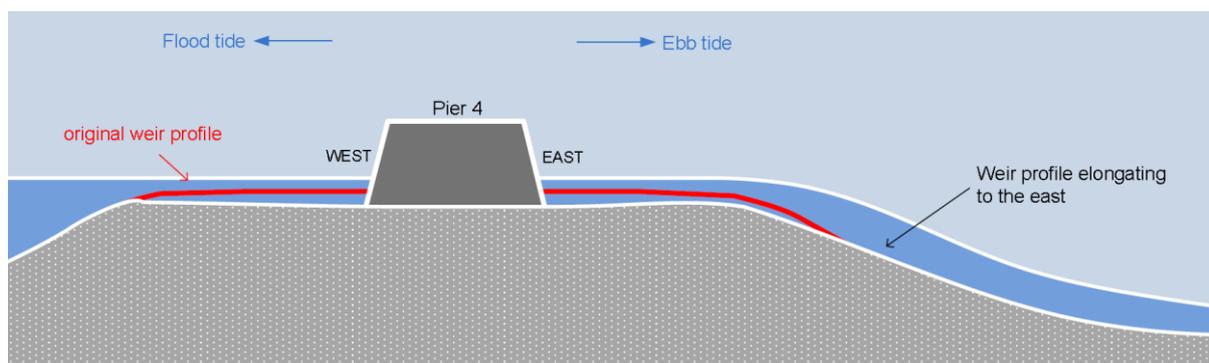
This movement of stones, simulated over a period of many years, resulted in the material being eroded from the crest of the weir; this process is generally referred to as *winnowing*. This erosion resulted in the weir's profile changing over the years from the original weir profile, illustrated in Figure 7, to a more elongated weir on the eastern side, illustrated in Figure 12.

Figure 12 – Weir elongating to the east due to erosion

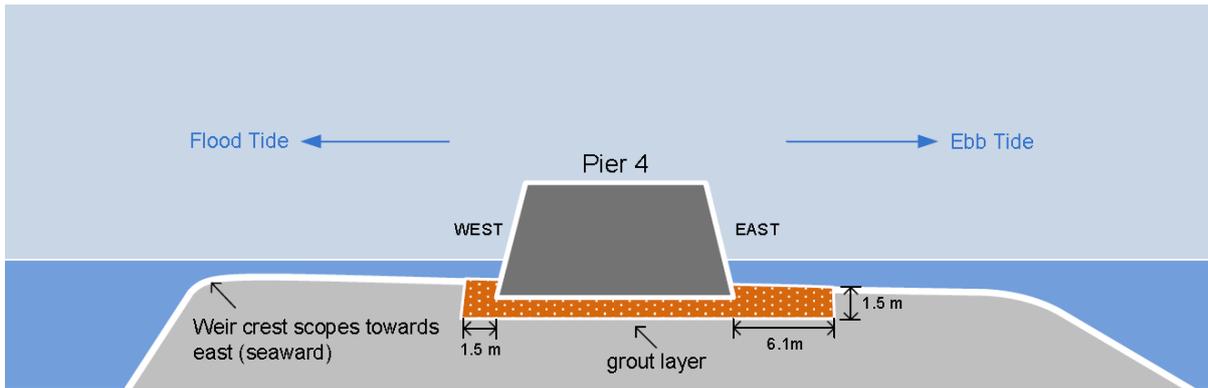
ICE Session 68-9 records that the weir crest was *grouted* in 1967 and 1968, in an attempt to stabilise for a period the weir; this formed a grouted rock armour extending approximately two metres in depth (see Figure 13). The Malahide Viaduct article in ICE Session 68-9 Volume 95, noted that “the surface of the stone ‘weir’ varied from crest level to the west side sloping steeply to about 100 feet (30m) out from the pier on the seaward side.”, (see Figure 13).

Figure 13 – Grout layer (grouted rock armour) inserted in 1967 – 1968

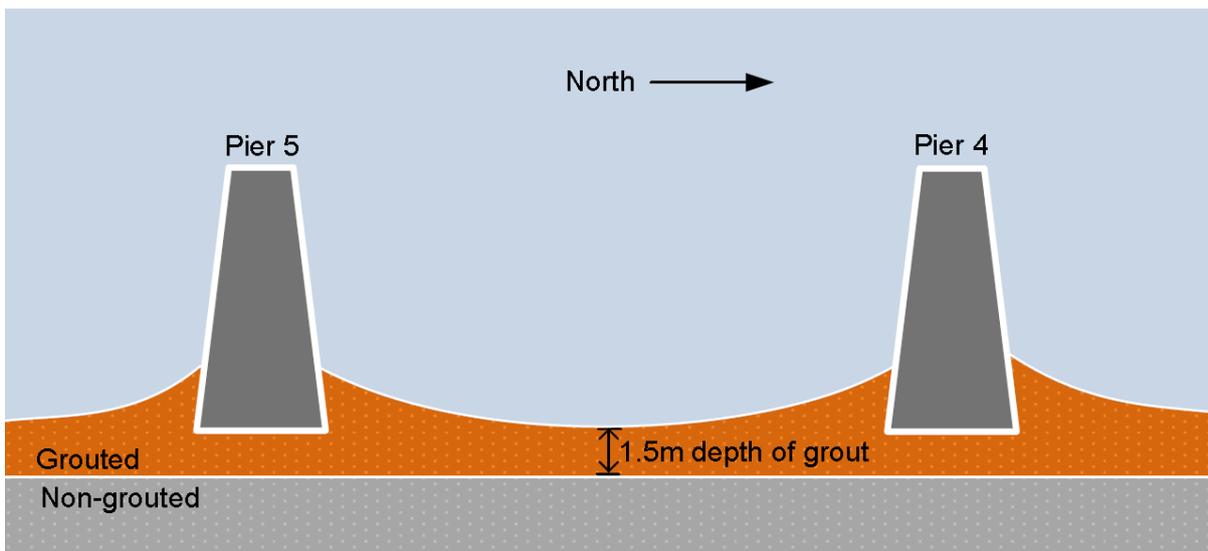
The Malahide Viaduct article in ICE Session 68-9 Volume 95, also noted, in relation to the grouting scheme, that “the general longitudinal profile dipped between piers to concentrate the main flow away from the piers while providing optimum protection to the piers foundations”. These features were retained for the grouting (see Figure 14).

Figure 14 – Elevation illustrating the dipped profile between the piers

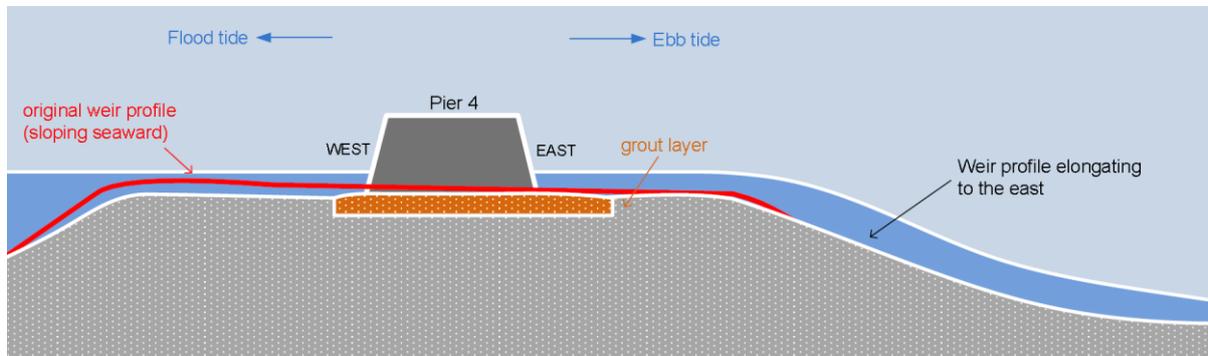
The stabilisation by the grouted rock armour was proved successful by the absence of observed scouring or potholing after the storms in February 1969, and the elongated profile on the east remained, (see Figure 15).

Figure 15 – Weir profile remains elongated to the east, with the grout layer (rock armour) stabilising the scouring

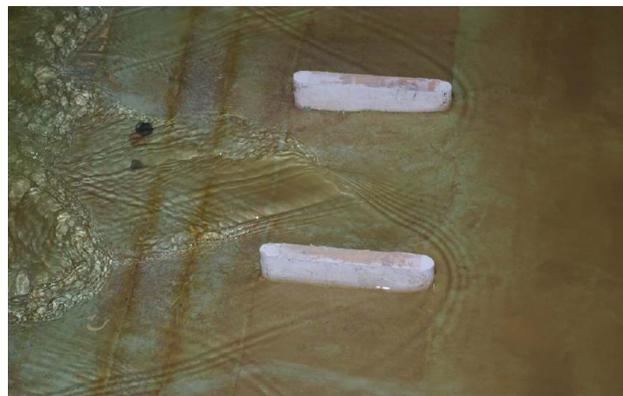
However, the 3-D 1:80, simulating the high spring *ebb tide* flowrate, showed that when the tide reached certain critical levels on the eastern side, a hydraulic jump formed between Pier 4 and Pier 5, the location of the collapsed pier (see Figure 18 and Photograph 8). Velocity measurements were taken from the model at the mid-point of the pier to the downstream side of the weir. These measurements were recorded in the model and scaled to the prototype giving values in the range of 4m/s to 5.5m/s.

Photograph 8 – 3-D model of movement of hydraulic jump

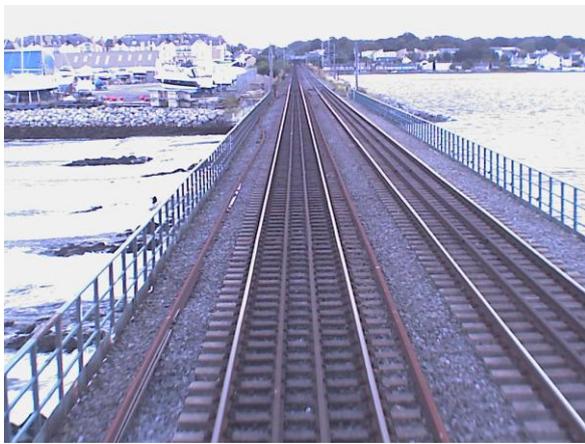
Photograph 13 – TRV still towards Dublin

IE's track and structures inspection requirements standard, Track and Structures Inspection Requirements, I-PWY-1107, states that the *Track Recording Vehicle (TRV)* has a six monthly track inspection rate. The TRV has travelled over the Malahide viaduct eight times, in each direction, since its first run in May 2007. The last run on the viaduct (both directions) was the 20th August 2009, the day before the collapse, at which time it recorded the track to be in a good condition (i.e. no defects were found and no significant changes in the vertical and horizontal *alignment*, *cross level* or *twist* which would have indicated that the viaduct was close to failure were recorded for the run or in any of the previous eight runs). Still photographs from the TRV video taken on the day before the collapse are illustrated below in Photographs 13 and 14.

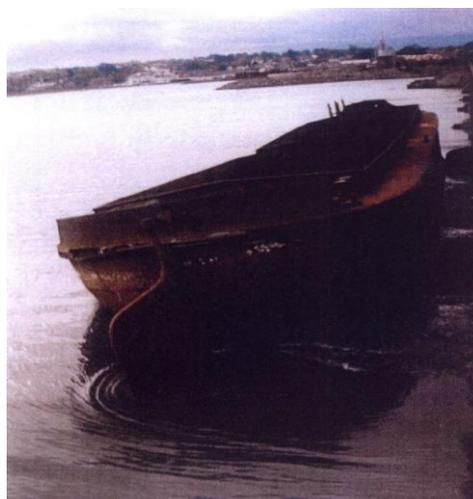
In 1982 a derelict barge, approximately 27m long, was abandoned against the seaward side of the Malahide Viaduct, (see Photograph 17). The barge was lodged against Piers 5, 6, 7, and at certain tides, the barge rubbed against these piers.

Photograph 17 – Derelict barge

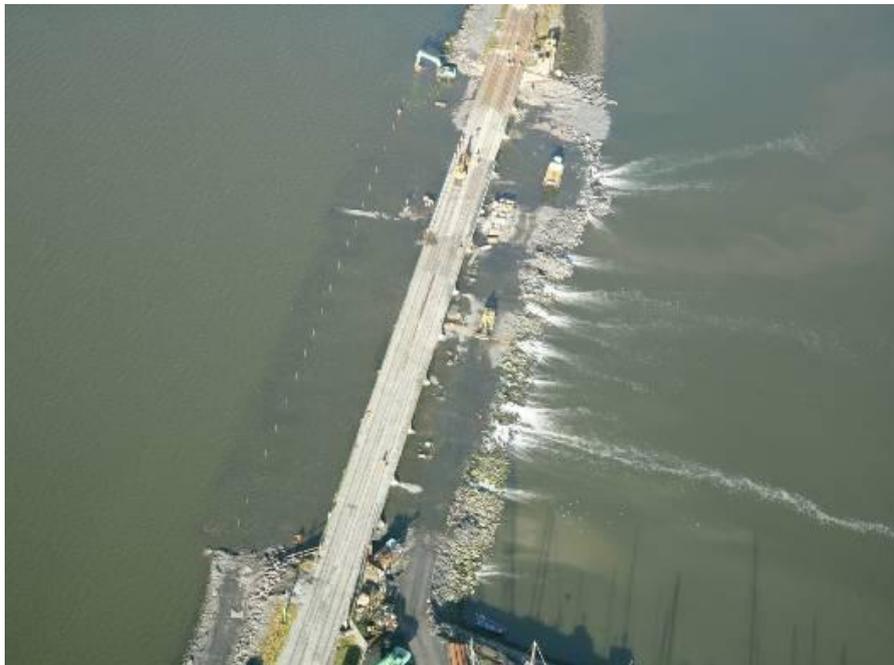
Photograph 19 – New weir profile

Several technical studies (e.g. geotechnical and hydrographical studies) were conducted and a programme of works to strengthen and maintain the weir has been completed (see Photograph 19).
